Preliminary Arborist Report

**300 Enzo Drive
San Jose, CA**

July 27, 2016

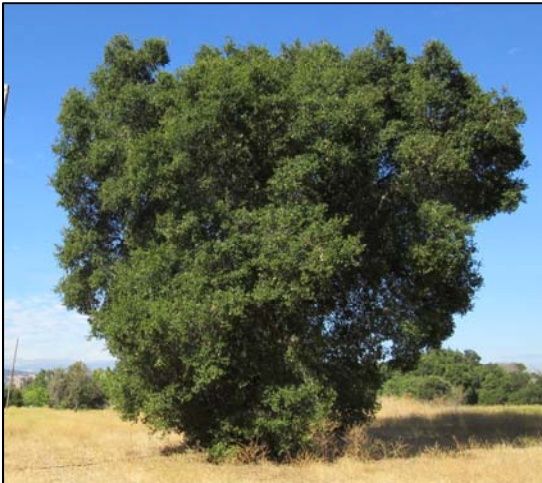
The site was dominated by coast live oak, with 61 trees (85 % of the trees evaluated). Trees were young to mature, with trunk diameters from four to 32 inches, and an average diameter of 14 inches for single-trunk trees. Larger trees were located along the southeast length of the site, while smaller trees tended to be concentrated along the fence line on the north and west perimeters. Forty-two (42) trees were in good condition, with dense crowns and good form and structure (Photo 1). Trees in fair condition (19 trees) had fair form and structure, and some had thinning crowns. Trees along the perimeter fence were crowded, leading to asymmetrical crowns. None of the trees were in poor condition.

Photo 1 (top left): Coast live oak #117 was in excellent condition with good form and structure.

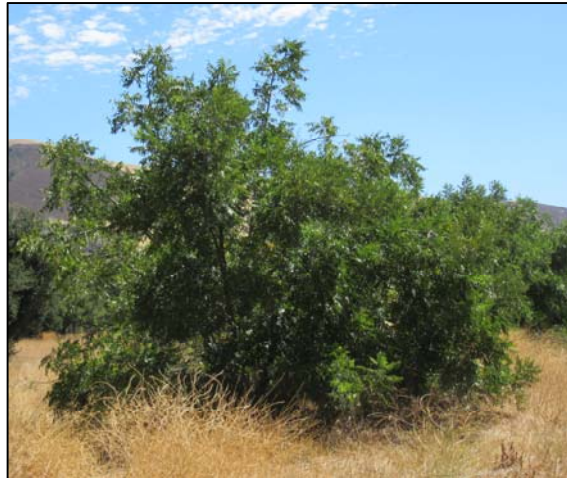
Nine California black walnuts were evaluated. The trees were remnants of what appears to have been a walnut orchard. English walnuts died and new trees sprouted from the California black walnuts rootstock. All had multiple trunks growing from old stumps, and all trees were in fair condition. They tended to have dense crowns and fair to poor structure (Photo 2).

Photo 2 (top right): California black walnut #016 was in fair condition, with multiple trunks growing from an old stump and a dense crown.

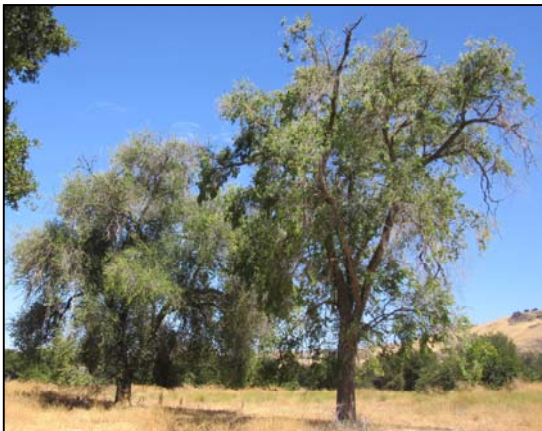
Three mature Siberian elms were evaluated at the site (28 in., 29 in., and 37 in. trunks). Trees were in poor condition, with significant amounts of twig and branch dieback throughout their crowns (Photo 3).

Photo 3 (bottom left): Siberian elms #119 (l) and #120 (r) were in poor condition with thin crowns and branch dieback.
