Preliminary Arborist Report

**4200 Dove Hill Road
San Jose CA**

May 2015

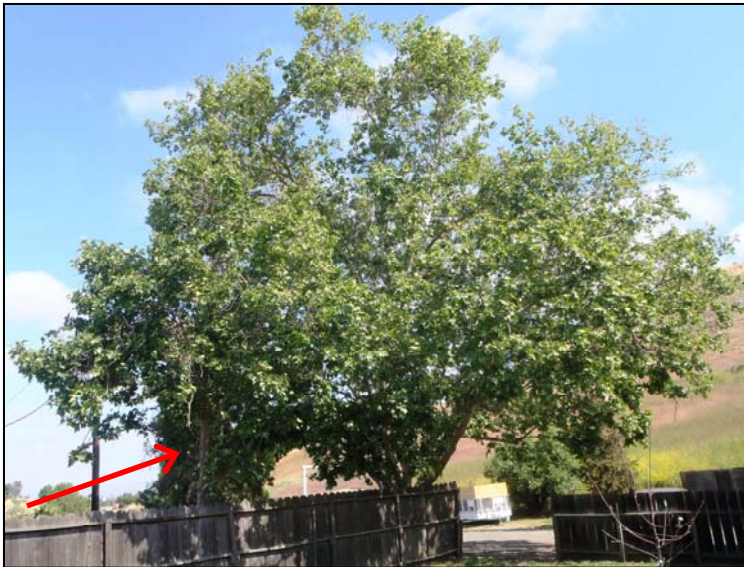
Two (2) London planes had been planted on the upper tier, adjacent to the house and parking. London plane #328 was the dominant tree, with a trunk diameter of 28". It was in good condition, with a full crown (**Photo 1**). London plane #327 was the subordinate tree, with a trunk diameter of 10". It had been suppressed by its larger neighbor and was in fair condition, with a one-sided form.

Photo 1: London plane #328 was the largest diameter tree assessed. It was in good condition, with a full crown. It had outcompeted its smaller neighbor, London plane #327 (arrow).
