Arborist Report

335 S Winchester Blvd.
San Jose, CA

February 5, 2019

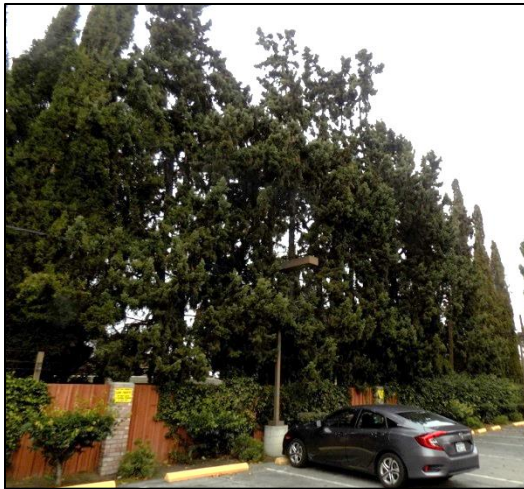
Sixteen cypresses (eight Italian cypresses and eight Arizona cypresses) were growing off-site along the western property boundary (35% of the population). These trees formed a dense hedge separating the two properties (Photo 1). The cypresses were in good condition (15 trees) with one tree in fair condition and none in poor condition. The sizes were estimated for all off-site trees, but the Arizona cypresses were larger than the Italian cypresses (average trunk diameter of 15" and 12", respectively).

Photo 1: Italian and Arizona cypresses were growing off-site near the western border of the property.

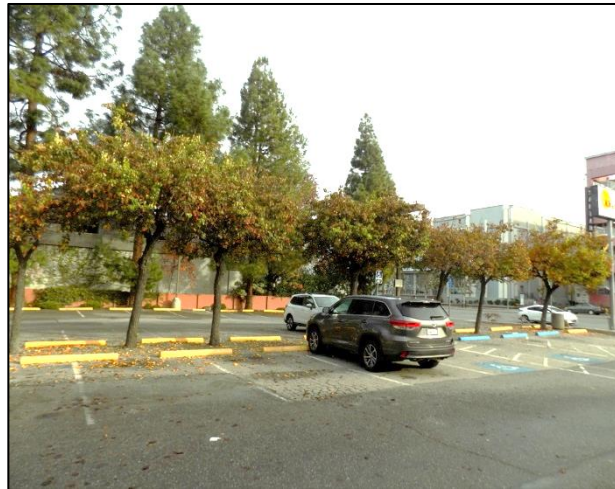
Eight evergreen pears (17% of the population) were growing in a parking lot median (Photo 2). They were in fair condition (7 trees) with one tree in poor condition and no trees in good

Photo 2: Evergreen pears #121-127 were growing in a parking lot median.

condition. The evergreen pears were relatively young (8" average trunk diameter). These trees had been harshly pruned with heading cuts used to keep the crowns small.

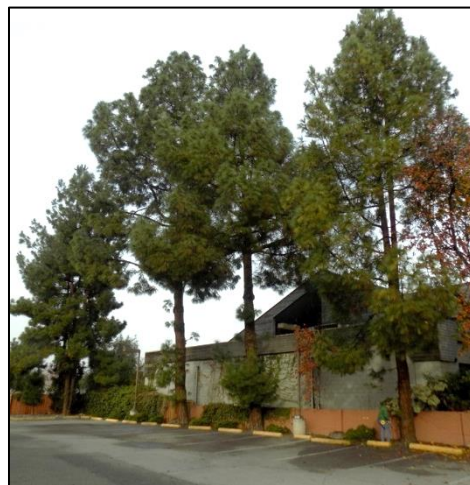
Seven Canary Island pines (15% of the population) were growing along the northern boundary of the property (Photo 3). They were in good (3 trees) to fair (3 trees) condition with one tree in poor condition. The pines were the largest trees assessed ranging from 19" to 28" in trunk diameter with an average of 23".

Photo 3: Canary Island pines #111-113 (right to left) were the largest trees assessed.
