# CERTIFIED ARBORIST REPORT

## Tree Assessment of Current Conditions

Date: July 10<sup>th</sup>, 2017

Project #JN4823 ST. JAMES PARK  
North 2<sup>nd</sup> Street and East St James Street  
San Jose, CA 95112

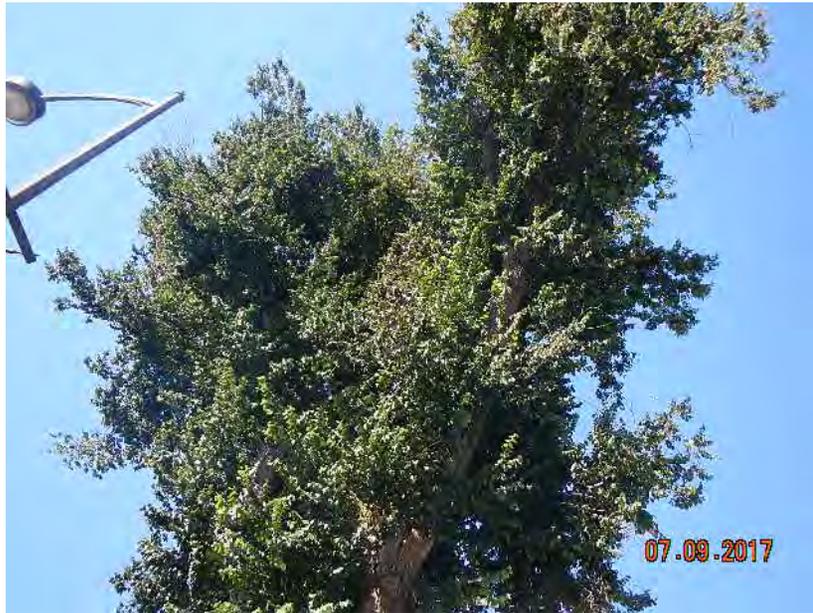
Tree #1 English Elm

**Observations:** Trees #1, 2, 42, 119, 121, 122 & 192 are mature trees and their size dominates the park. Previous limb failures have happened in all these trees. Decay sites and rodent damage are visible. Tree #2 has visible root damage and decay from previous sidewalk installation. Trees #1, 2, 119, 121 & 122 are leaning and this can be an indication of Poor Tree Architecture. Poor tree architecture is a growth pattern that indicates weakness or structural imbalance. There is dead wood in the canopy of these 5 trees and that could be from squirrel damage or an indicator of root impact. Deadwood in these trees needs to be removed. The English Elm is doing well in this area of San Jose and is a vigorous performer in the park. Providing a larger growing space would better the conditions and add quality-growing seasons to these trees. All 13 English Elms should be preserved and protected. It is recommended that trees #1, 2, 119, 121 & 122 have a Risk Assessment performed by qualified Arborist to evaluate the chances of failure and provide specific recommendations.

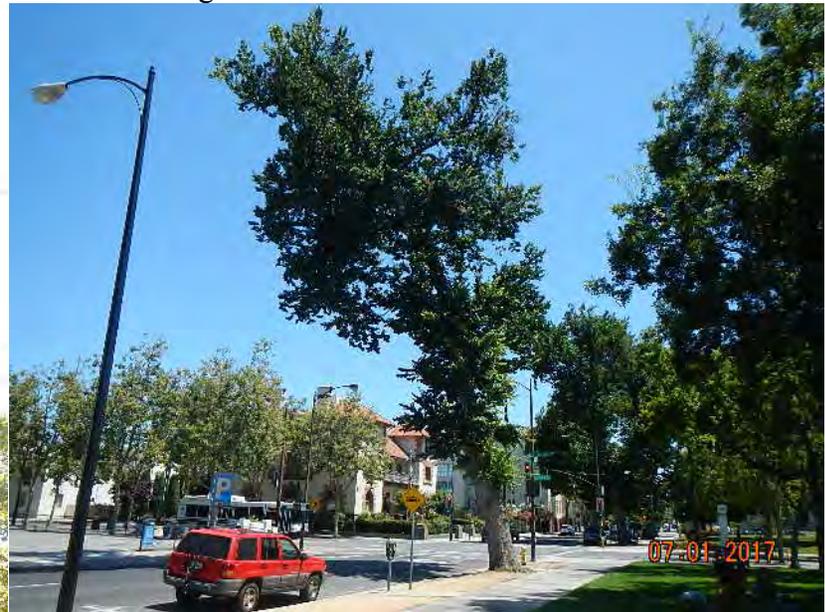
Tree #2 *Ulmus procera* English Elm showing lean.

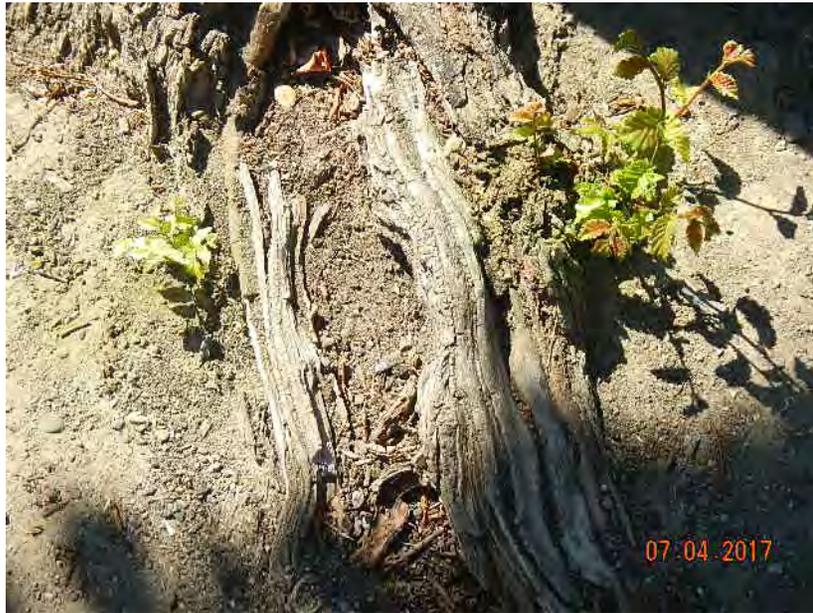
Tree #2 *Ulmus procera* English Elm buttress roots showing decay at sidewalk.

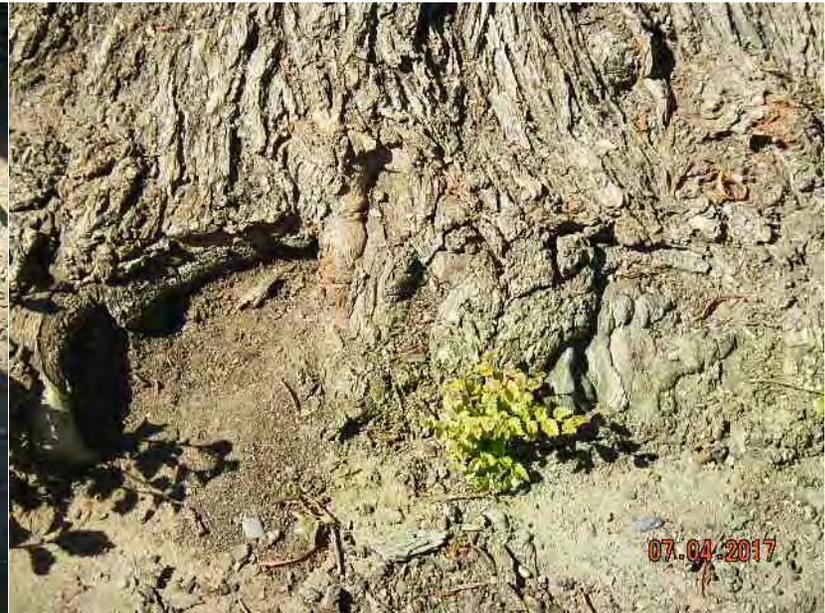
Tree #2 *Ulmus procera* English Elm buttress roots showing decay at sidewalk.

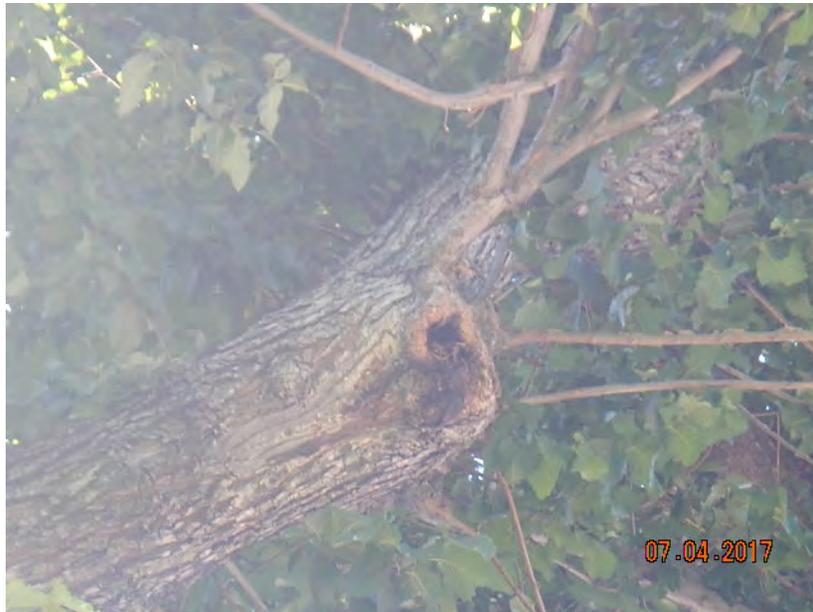
Tree #2 *Ulmus procera* English Elm previous limb failure and decay site at sidewalk.

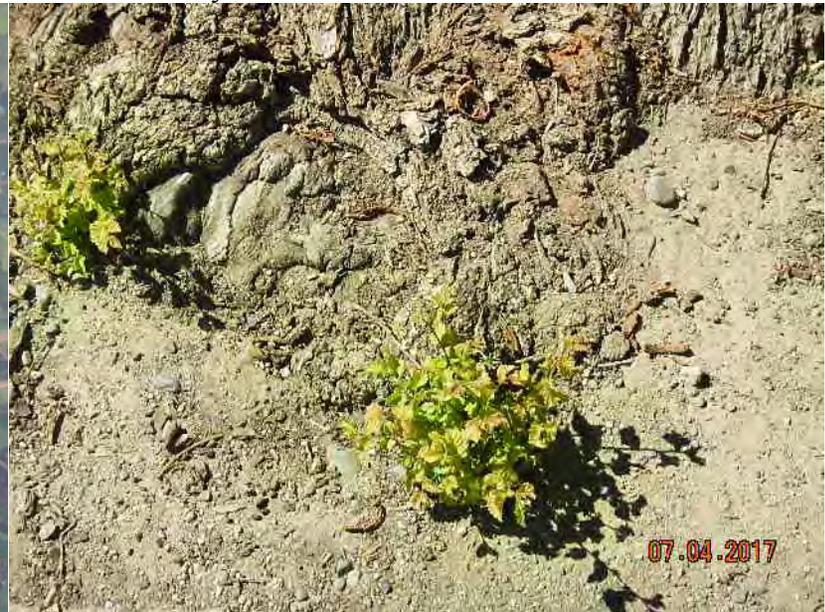
Tree #2 *Ulmus procera* English Elm buttress roots showing decay at sidewalk.

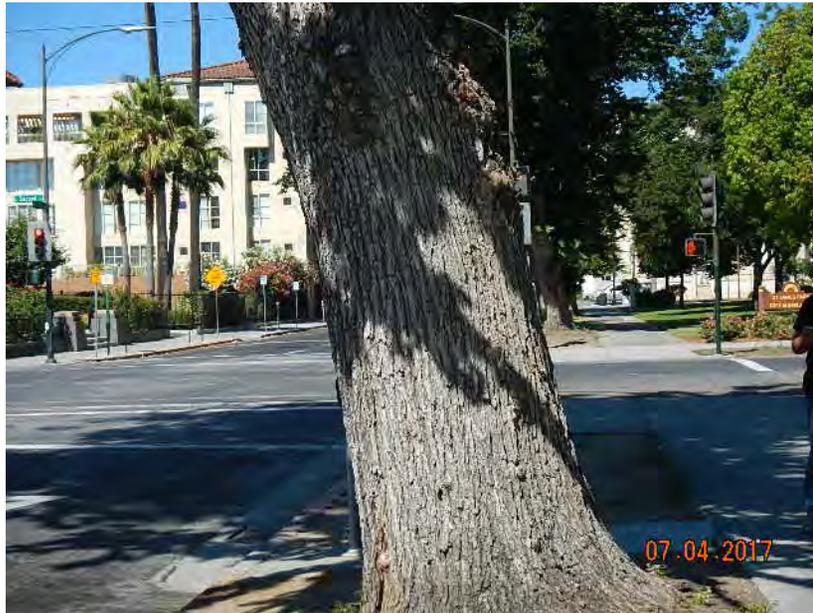
Tree #2 *Ulmus procera* English Elm buttress showing lean at sidewalk.

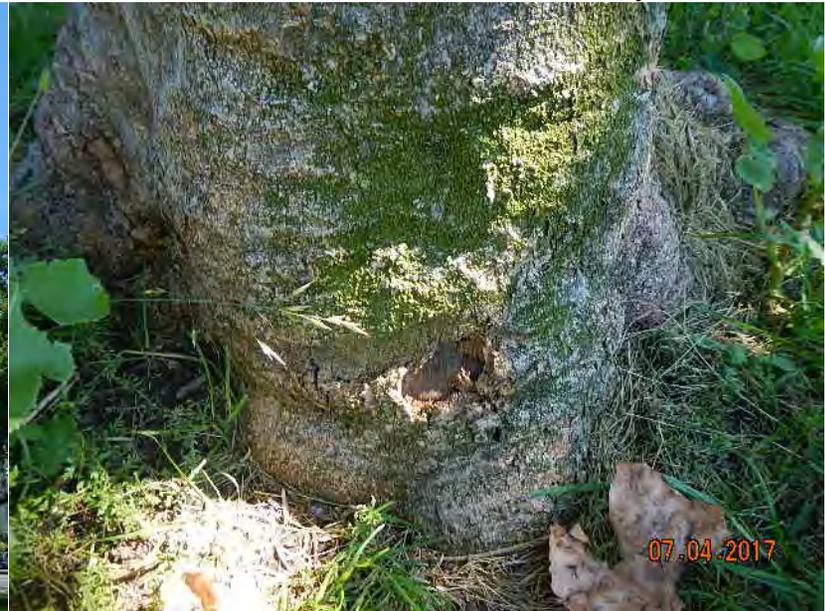
Chinese Hackberry stem damage by mower or other equipment.

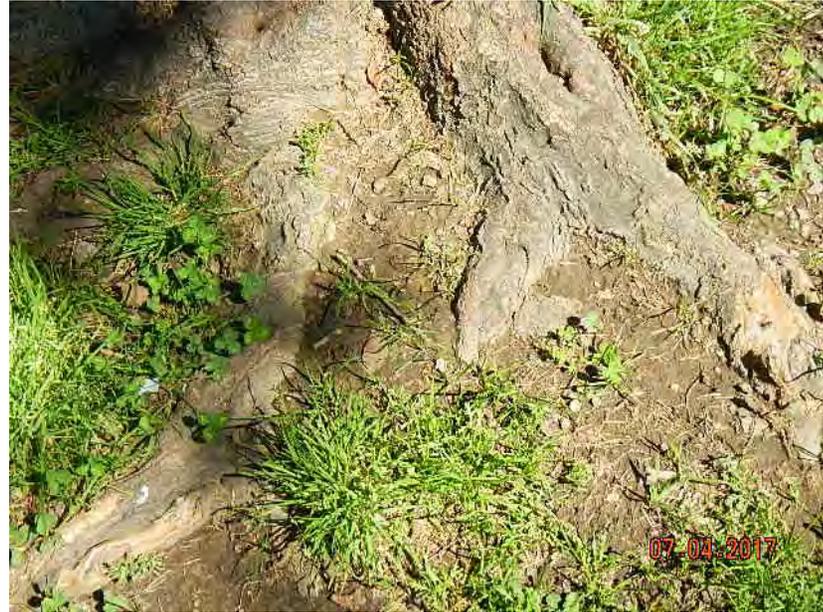
Tree#3 *Celtis sinensis* Chinese Hackberry possible stem damage that has sealed up.

Chinese Hackberry buttress root damage from mowers

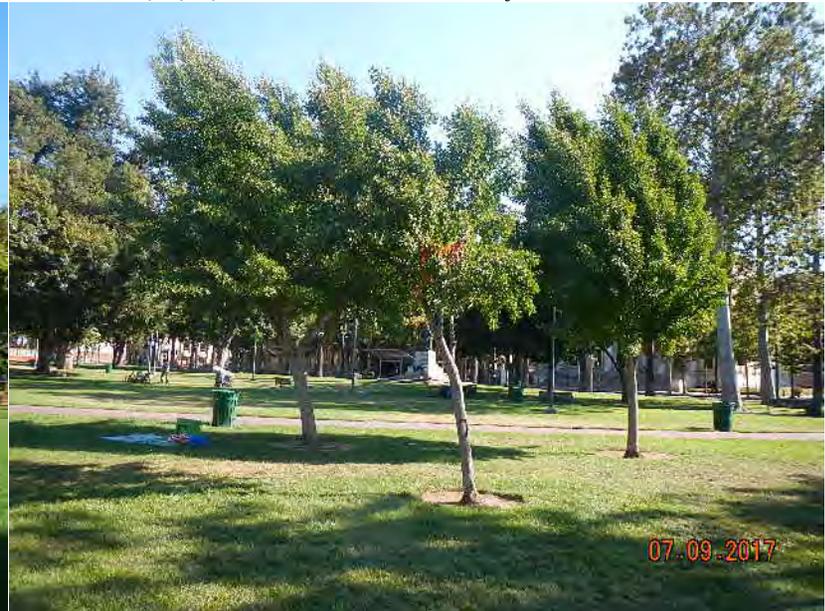
Tree #12, 13 & 14 *Ginkgo biloba* Ginkgo

**Observations:** Trees # 12, 13 & 14 are still young trees and should be preserved at this time. All three trees have damage to their stems from mowers and other vehicles. There also seems to be a level of vandalism to the trees by persons not aware of what they are doing. These impacts could cause the trees to die if the impacts continue.

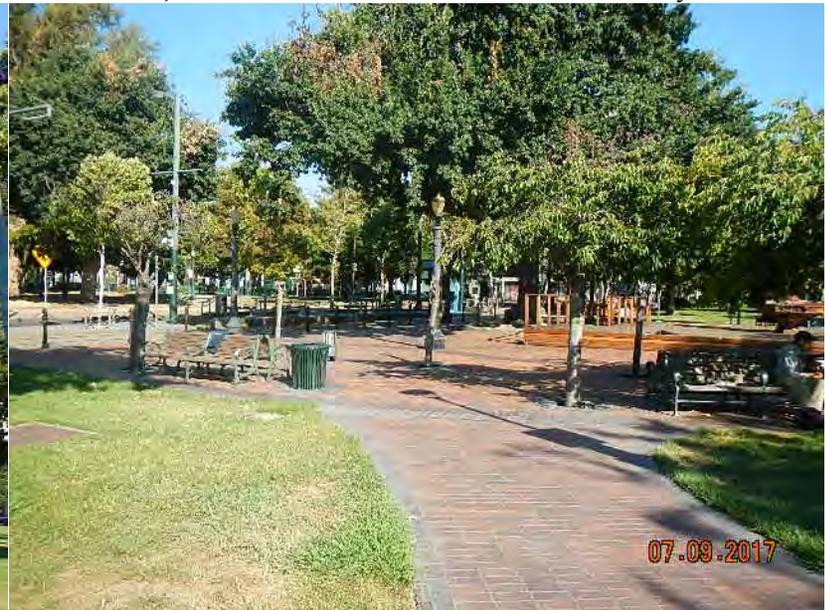
Tree #25, 26, 27, 28, 29 & 30 *Prunus serrulata* Flowering Cherry

**Observations:** Trees #25, 26, 27, 28, 29 & 30 are either dead or severely stressed and removal is recommended.

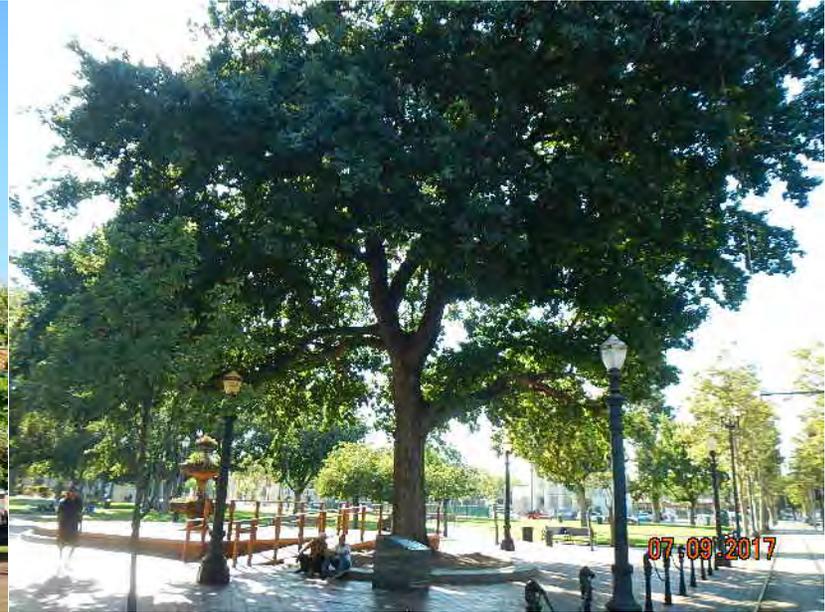
Tree #31 *Quercus macrocarpa* Bur Oak, Heritage Tree

**Observations:** Tree #31 & 43 are listed as heritage trees and all these trees are recommended to be retained and protected. Tree #31 has Bark Beetle Strikes and squirrel damage. Tree #31 is a great specimen and in “Best” condition. This tree has also had limb failure and has decay sites.

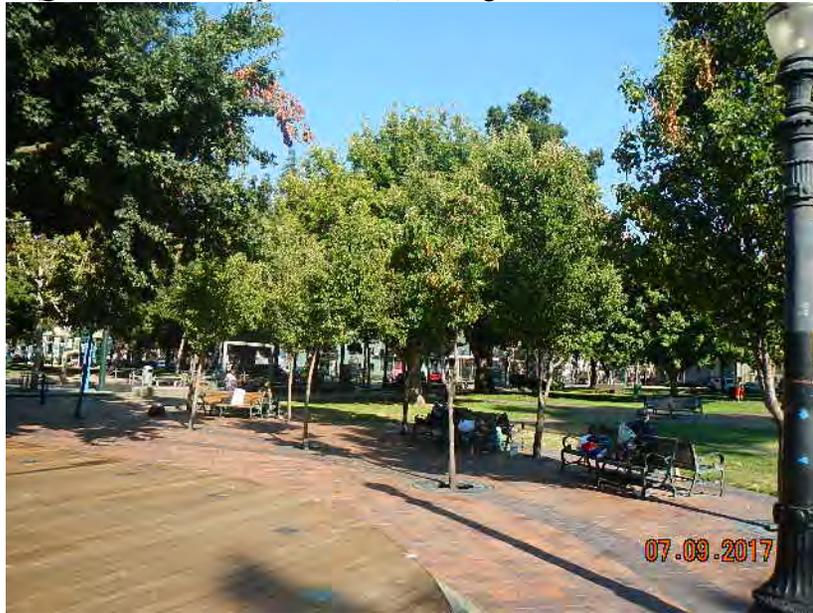
**Observations:** Trees #32, 33, 34, 35, 36, 37,38, 39 & 40 are infected with fire blight and severely stressed and removal is recommended.

Tree #32, 33, 34, 35, 36, 37, 38, 39, & 40 *Pyrus calleryana* Flowering Pear.

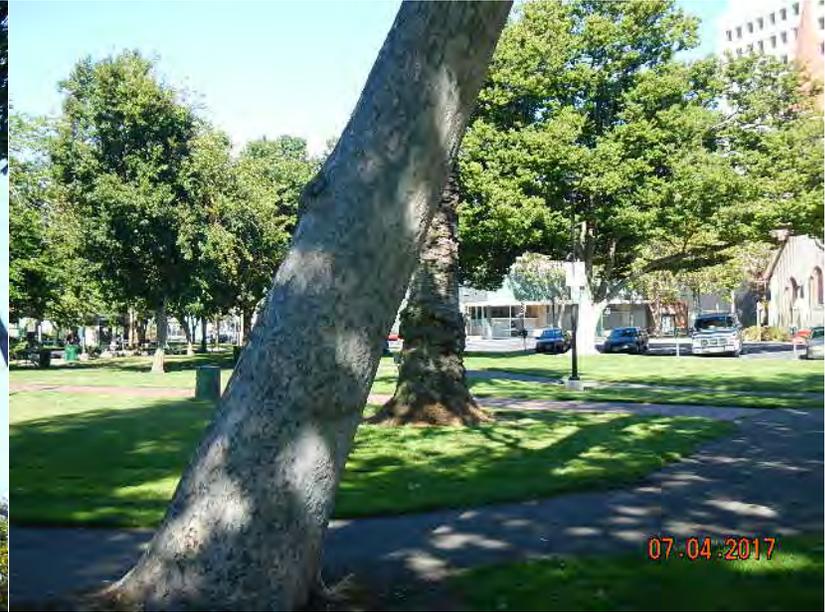
**Observations:** Trees #15, 16 & 49 Are very large specimens. Tree #15 has a limb that is cracked and should be assessed for cause of damage and strength. Pruning to reduce the limbs weight is recommended. Tree #49 has a significant lean and should have a Risk Assessment by qualified Arborist to evaluate the chances of failure and provide specific recommendations.

Tree #49 *Platanus racemosa* California Sycamore with lean.

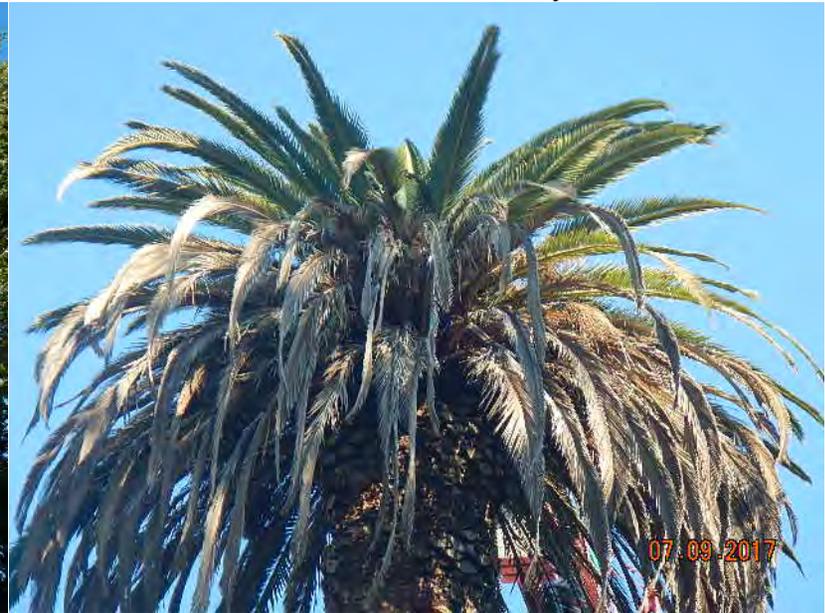
**Observations:** Tree #50 Appears to be Chlorotic and lacking vigor. Holes noted in the stem should be investigated to assess if they are degrading the structural integrity of the tree. It would be my guess that the tree is sound at this moment as it survived severe wind and weather conditions in the past storm weather earlier this year. There should be an appropriate risk assessment performed on this tree to affirm its value and safety.

Tree #50 *Phoenix canariensis* Canary Island Date Palm lacking vigor.

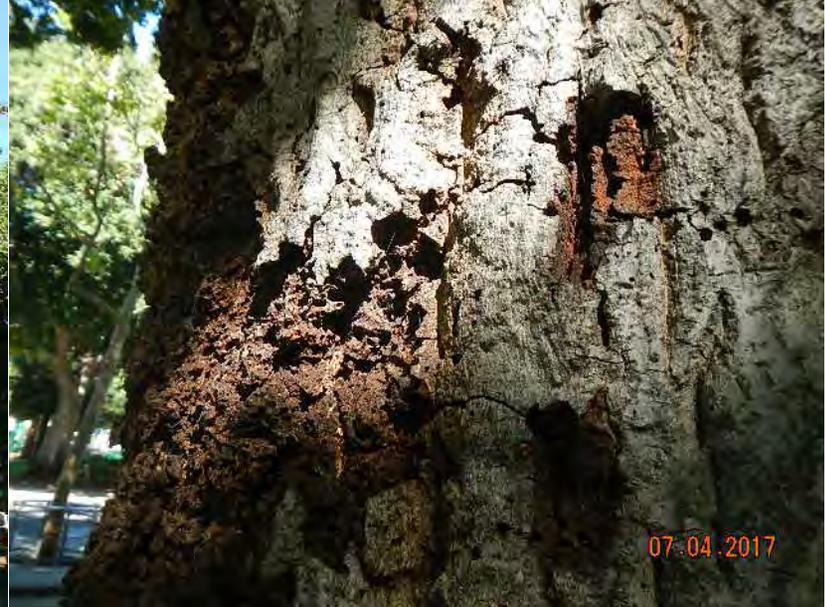
Tree #54 *Quercus agrifolia* Coastal Live Oak Bark Beetle Strikes

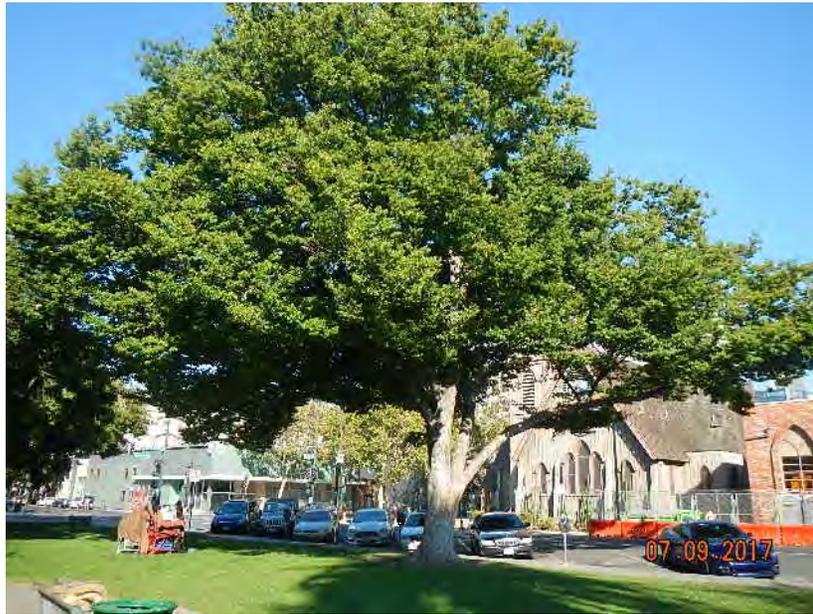
Tree #57 *Zelkova serrate* Sawtooth Elm

**Observations:** Tree #57 is a spectacular specimen. There have been recent limb failures and some in the past. There is a cable in the tree that needs to be addressed. Cabling and bracing does not repair a hazard tree, but when done correctly by a trained arborist, it can extend the time a tree or its parts are safe. This tree would benefit from pruning to reduce the limb end-weights, especially where the cable is attached. The health of this tree at the moment is right to help redistribute the tree's weight and direction to improve tree architecture.

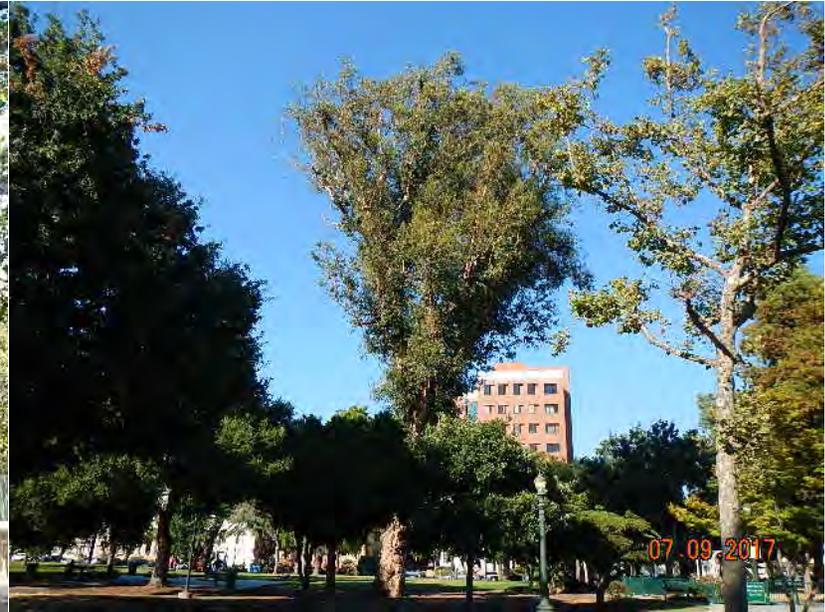
Tree #183 *Eucalyptus spp.* Eucalyptus

**Observations:** Tree #183 is has been rated “Poor” and could be considered a candidate for removal.

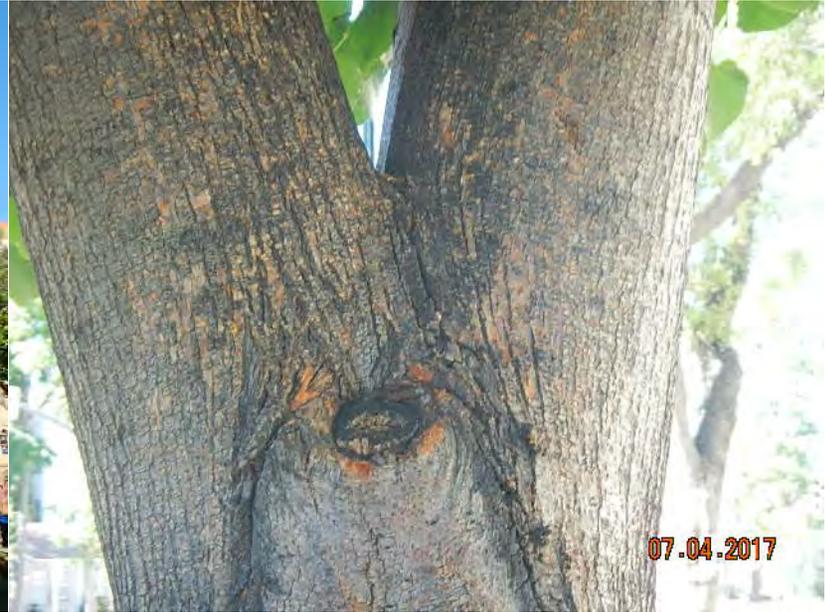
Tree #124, 125 & 126 *Tillia cordata* Tillia included bark.

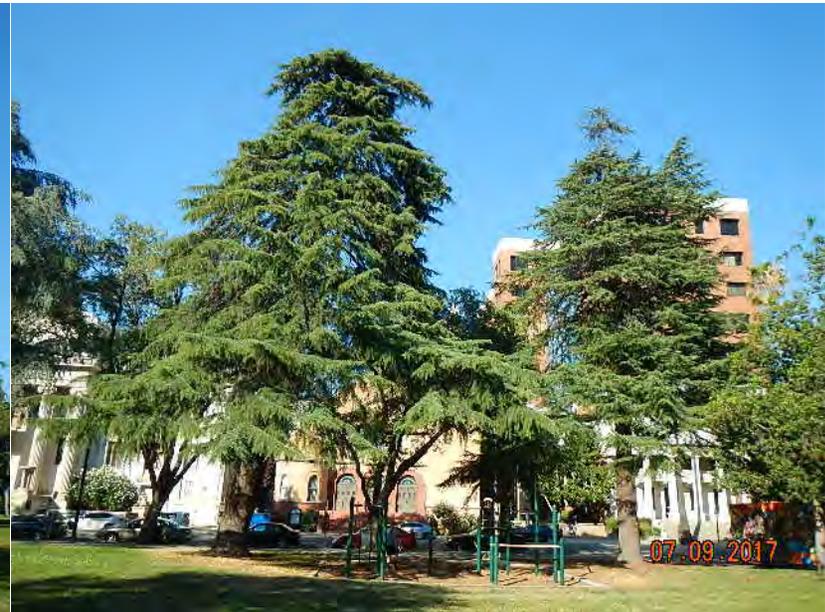
Tree #219 & 220 *Cedrus libani* Lebanese Cedar

**Observations:** Trees # 219 & # 220 are in poor condition due to stresses from environmental impacts and should be protected and reassessed as a possible candidate for removal in the next phase of development as it evolves.

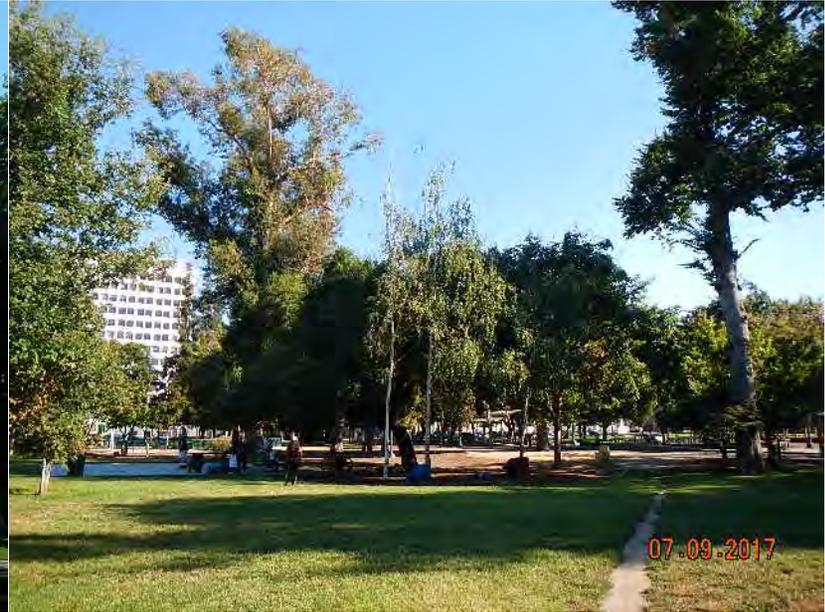
Tree #188, 189 & 190 *Betula spp.* European Birch

**Observations:** Trees #188, 189 & 190 are moderate trees and listed to be protected, but, their close proximity to tree #187 makes them a candidates for removal.

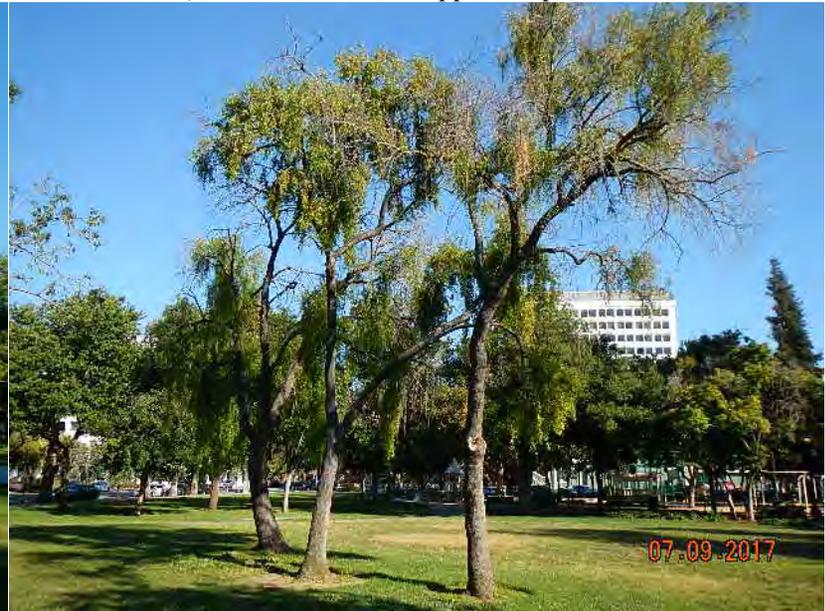
Tree #223, 224 & 225 *Maytenus boaria* Mayten

**Observations:** Trees # 223, 224 & 225 are in serious stress and decline from drought and environmental impact and are recommended for removal.

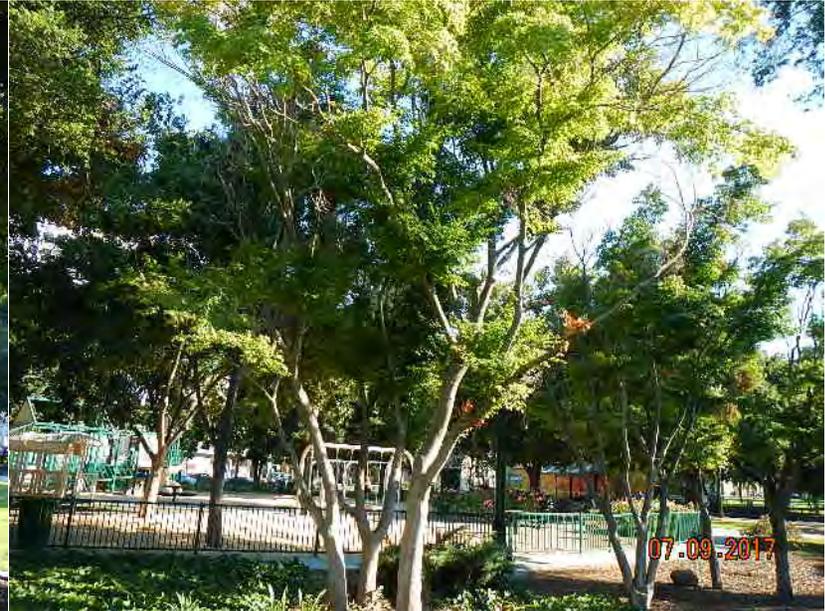
Tree #178 & 179 *Acer palmatum*, Japanese Maple limb dieback.

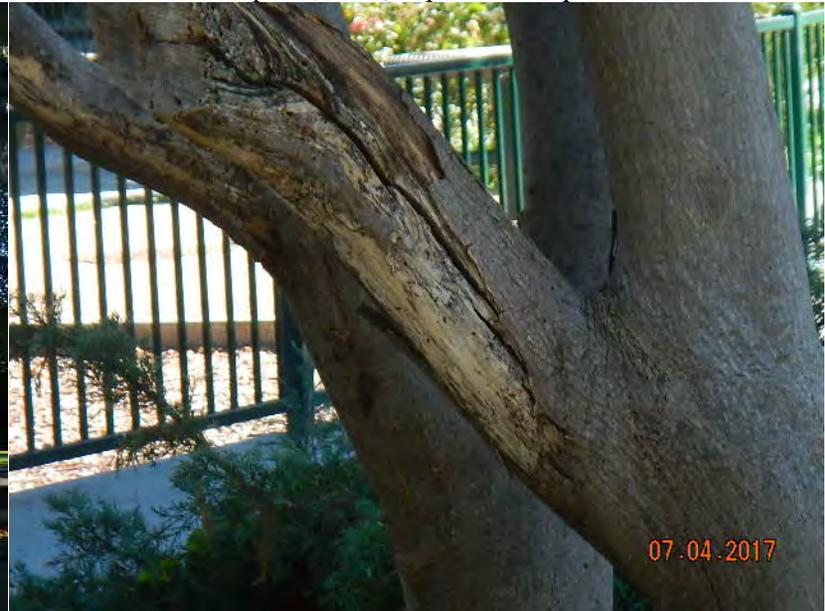
Tree #177 *Acer palmatum*, Japanese Maple, drought damaged limbs.

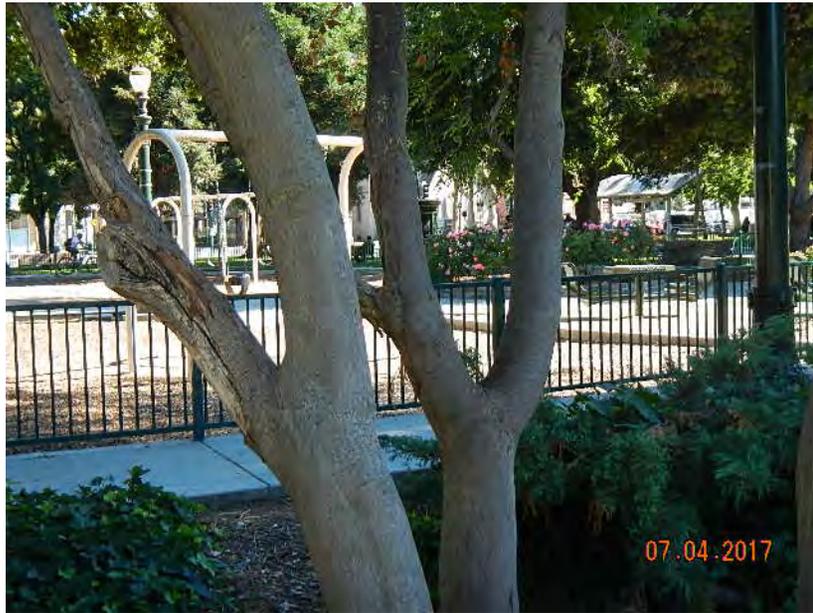
Tree #177 *Acer palmatum*, Japanese Maple, drought damaged limbs.

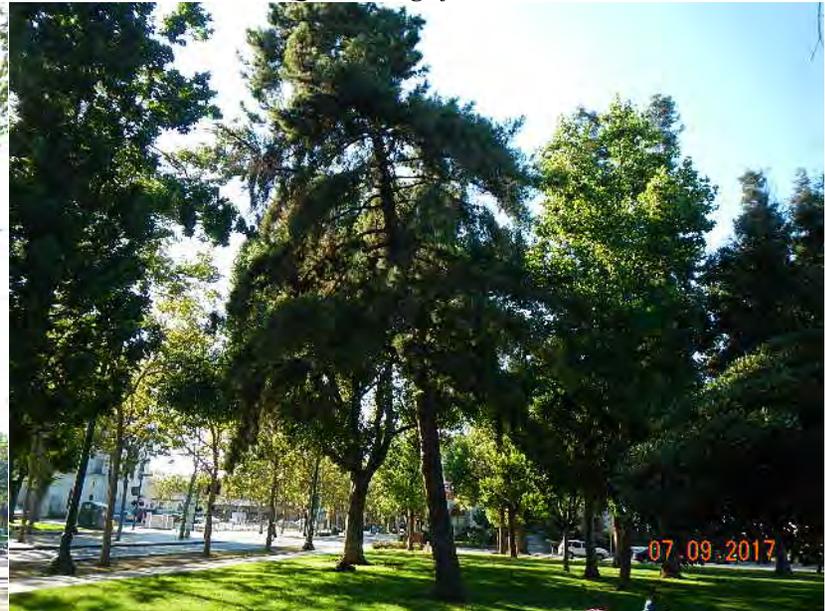
Tree #195 *Pinus radiata* Monterey Pine

**Observations:** Tree #195 is in Fair condition and should be protected and retained at this time. Historically this type of pine trees is overwhelmed by pests and scums to exterior impact in this area and this tree will most likely do the same but not for awhile, I believe.

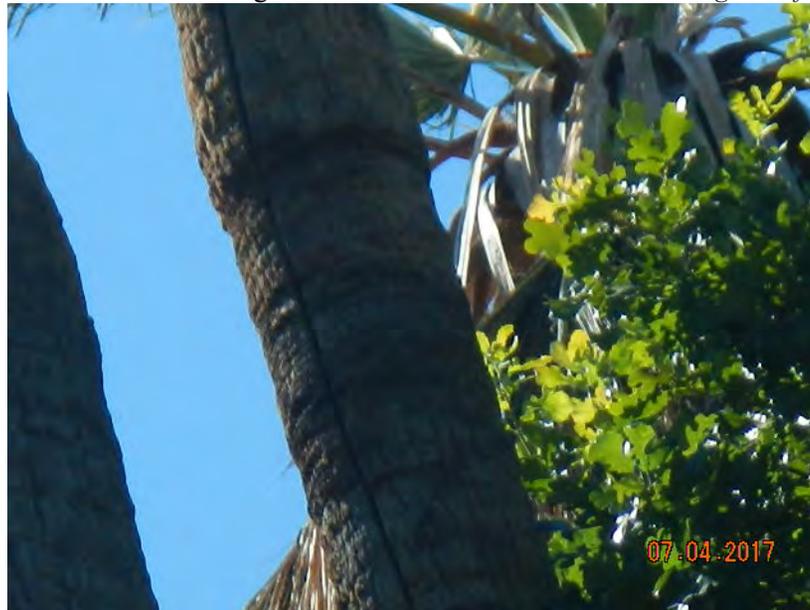
**Observations:** All 21 trees #62 through 82 are Heritage Trees. Tree #65 & 69 have visible cracks running vertical on the eastern side of the tree stem and 55” feet above grade. Cracks are an indicator of failure in structures and in plants. Additional assessment is recommended on all 21 trees for structural integrity. Trees #69 & 70 are Chlorotic and Black Scale was noted in the trees. All 21 California Fan Palms on the site should be preserved and protected.

Tree #69 *Washingtonia filifera* California Fan Palm crack/split

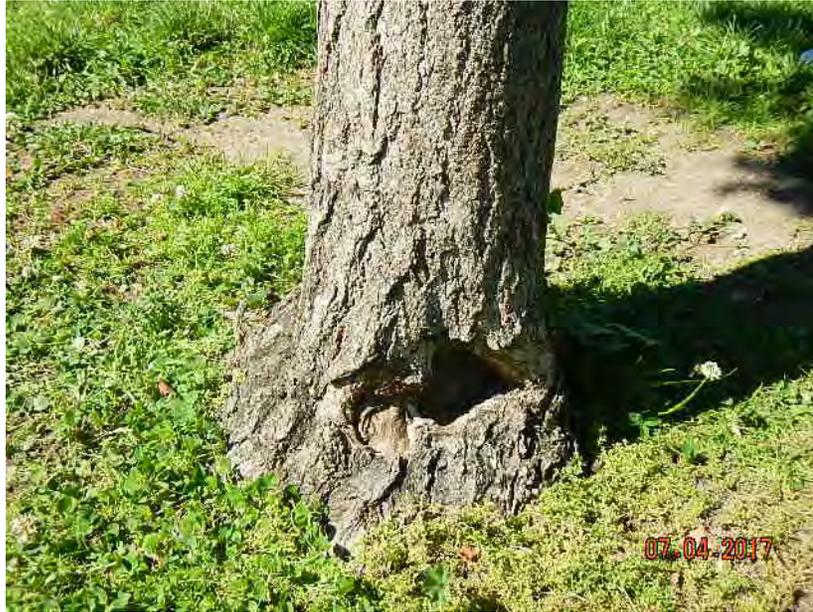
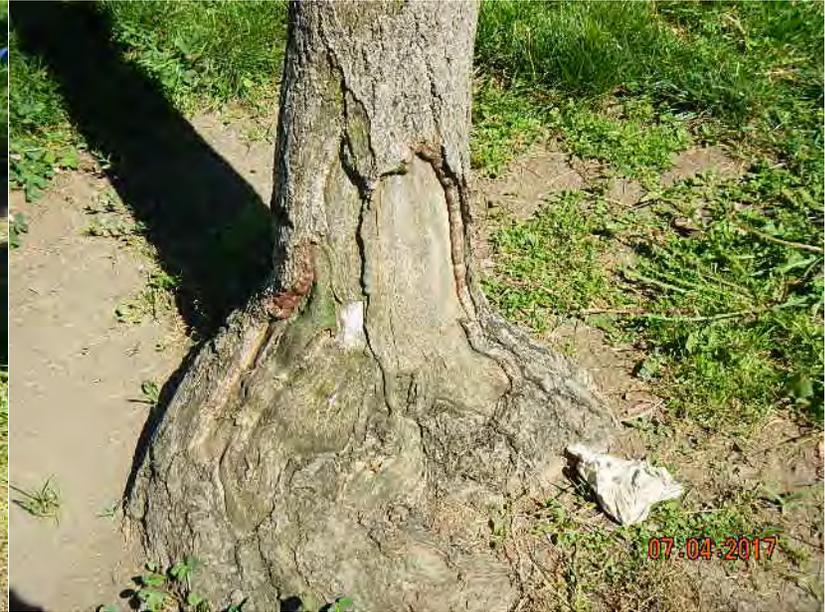
Stem damage from mowers and other means on Ginkos.

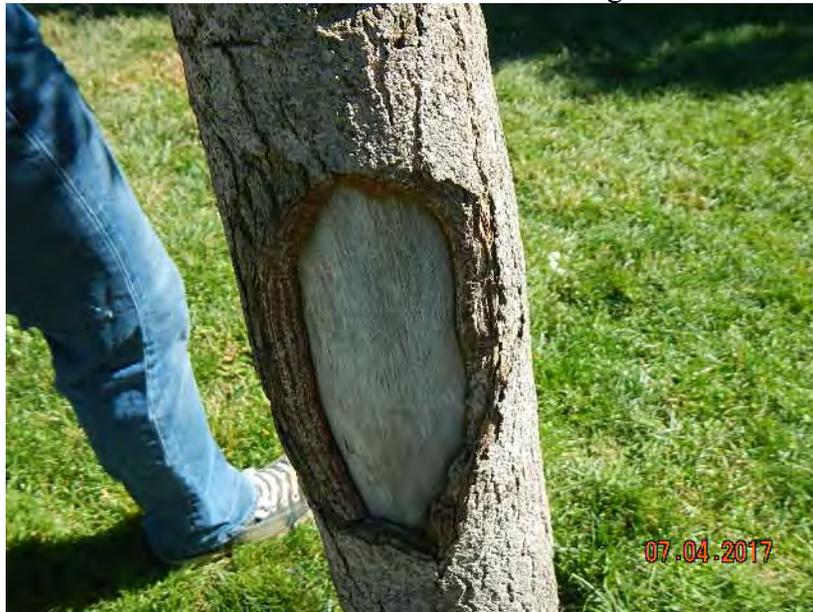
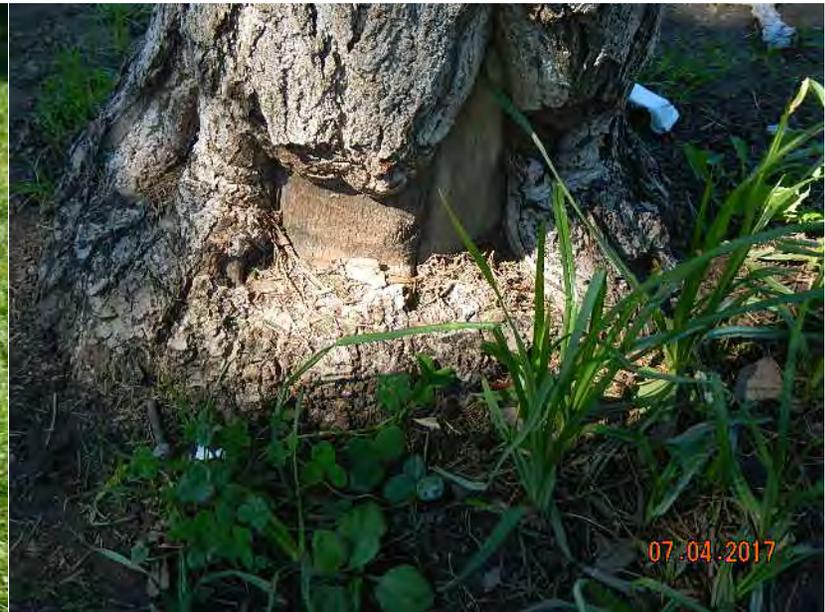
Stem damage from mowers and other means on Ginkos.

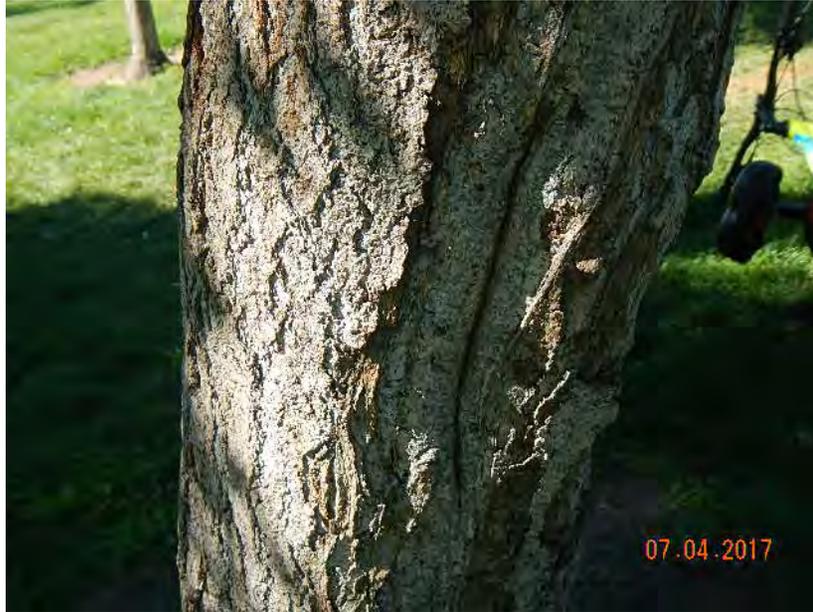
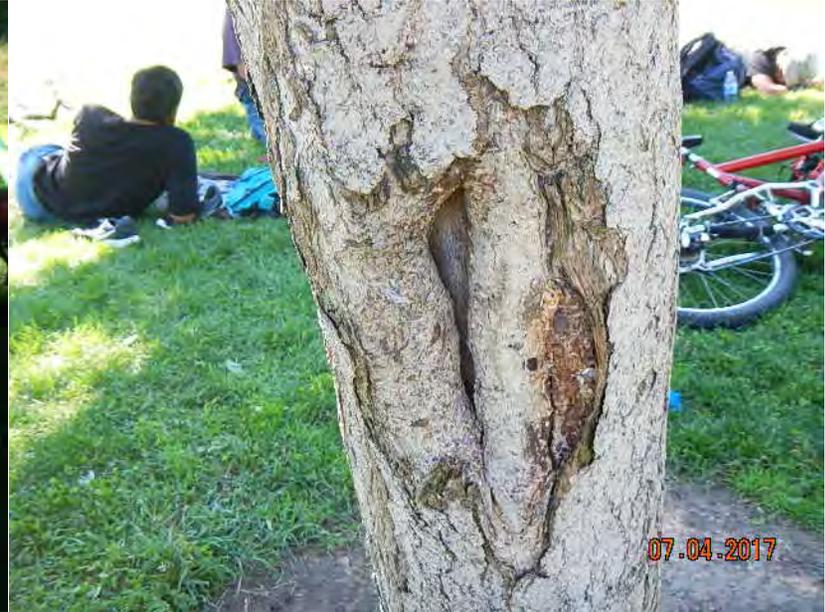
Stem damage from mowers and other means on Ginkos.

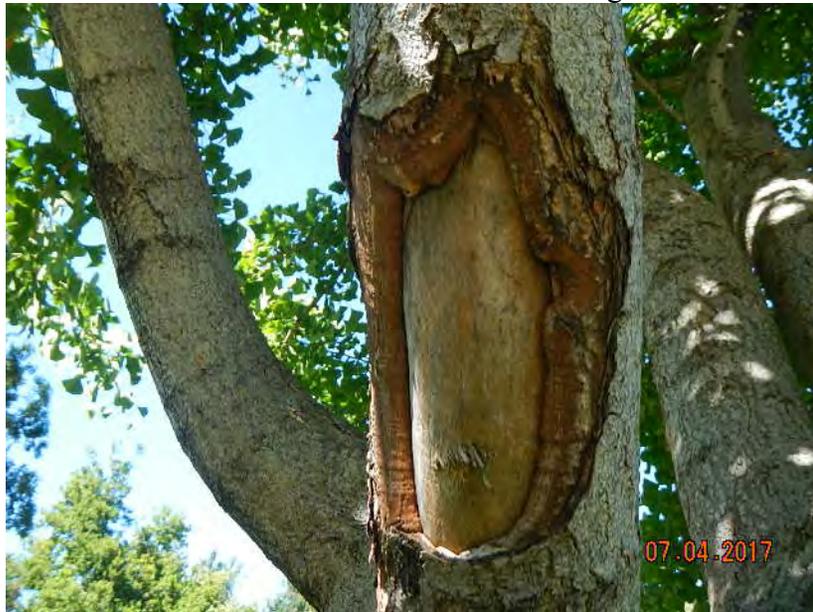
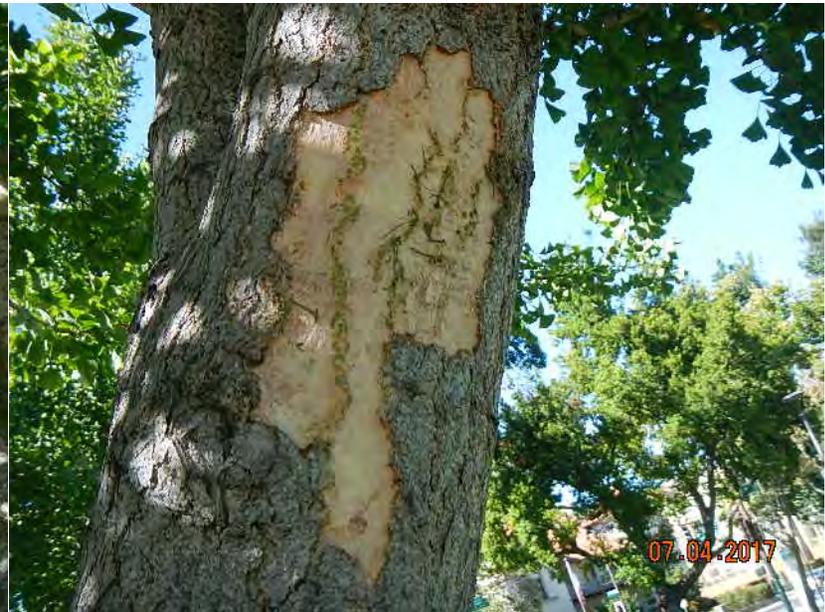
Stem damage from mowers and other means on Ginkos.

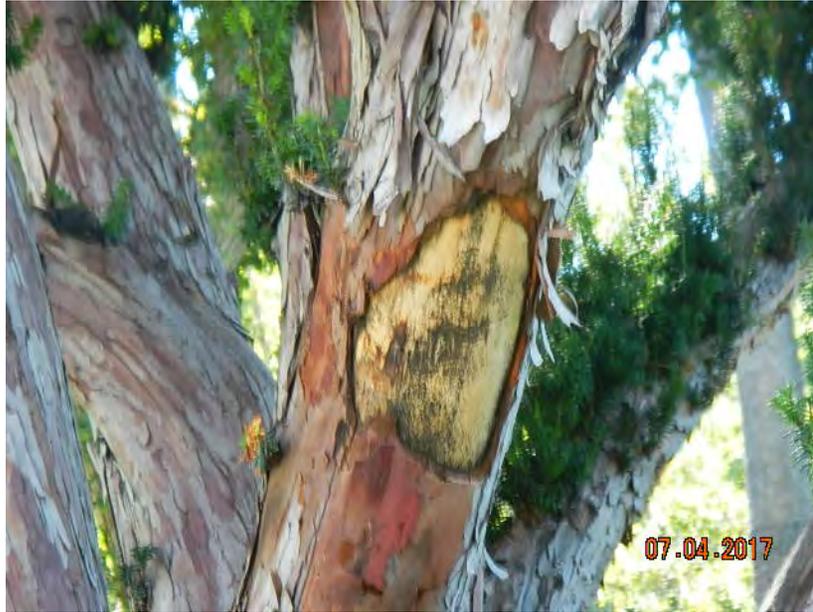
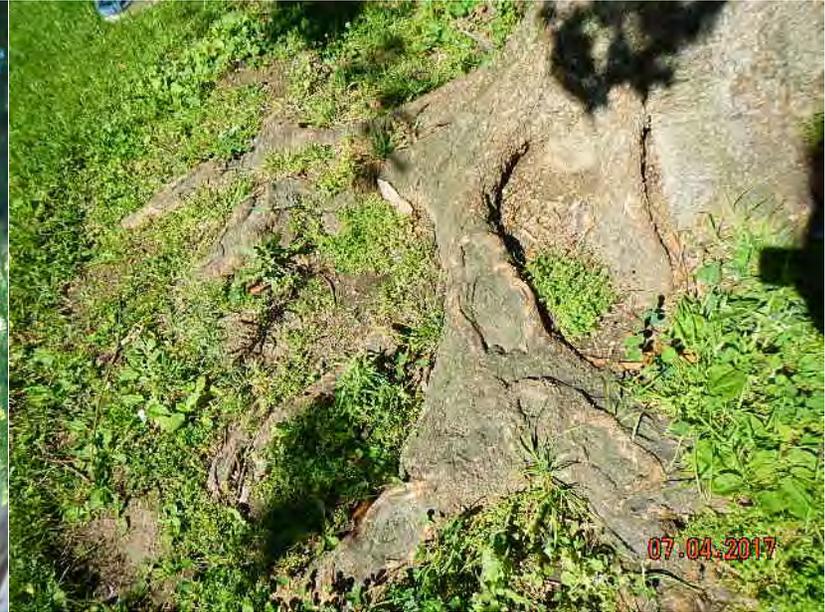
Stem damage from mowers and other means on Celtis.

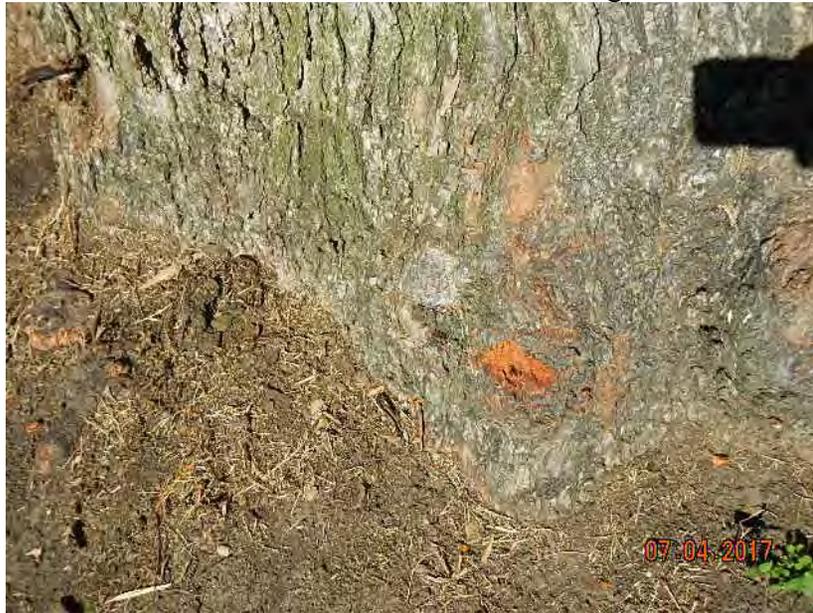
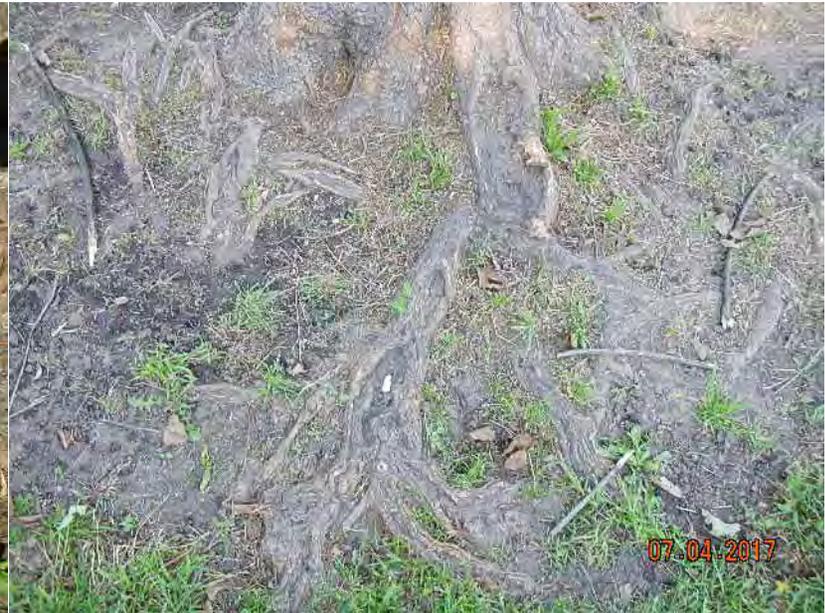
Stem damage from mowers and other means on Celtis. .

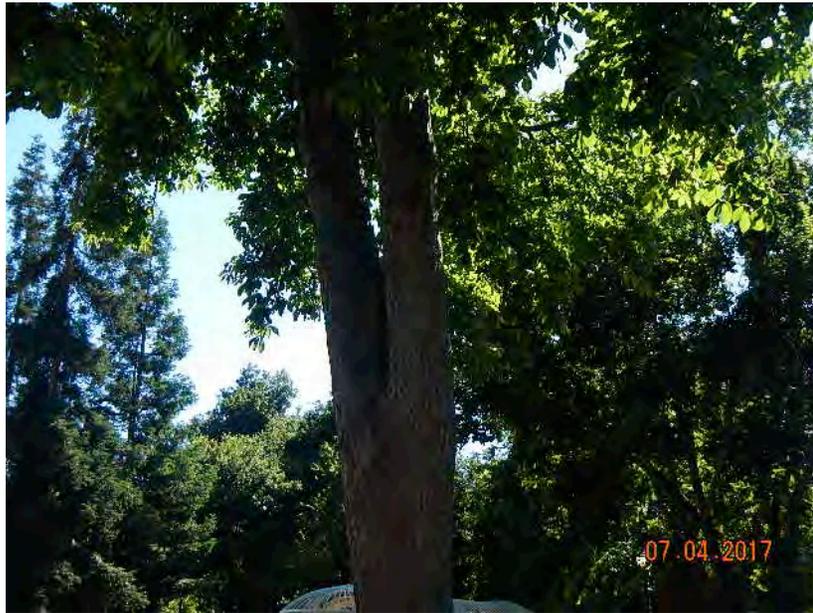
**Observations:** Tree #174 is a spectacular specimen and should be preserved. It has included bark and co-dominant leaders. One of the leaders should be subordinated so that the tree can be retained.

Tree #174 *Aesculus glabra* California Buckeye with co-dominant leaders.

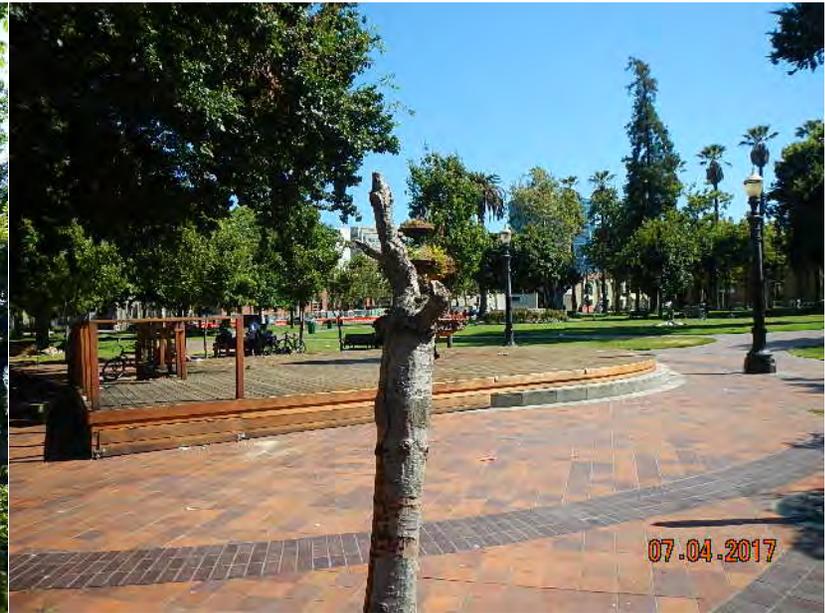
Flowering Cherry to be removed.
