# CERTIFIED ARBORIST REPORT

## Tree Assessment of Current Conditions

Date: July 10<sup>th</sup>, 2017

Project #JN4823 ST. JAMES PARK  
North 2<sup>nd</sup> Street and East St James Street  
San Jose, CA 95112

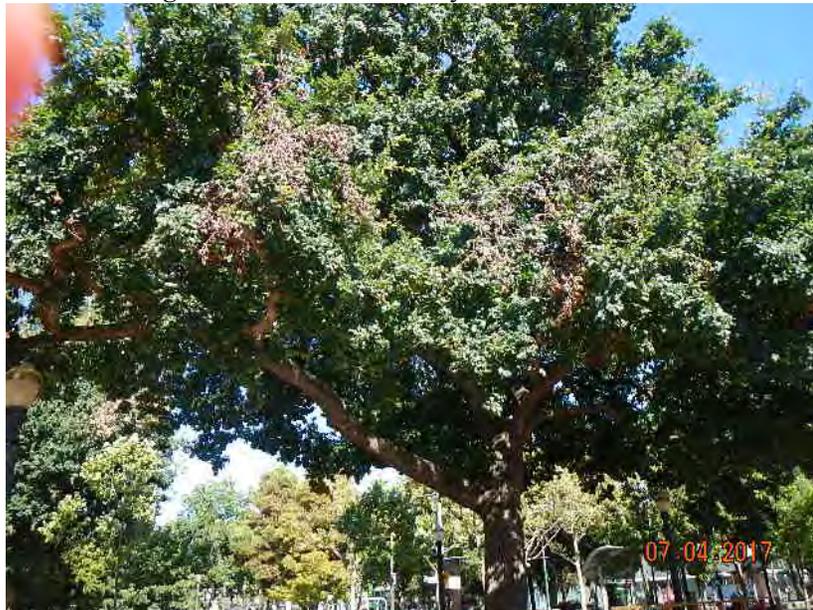
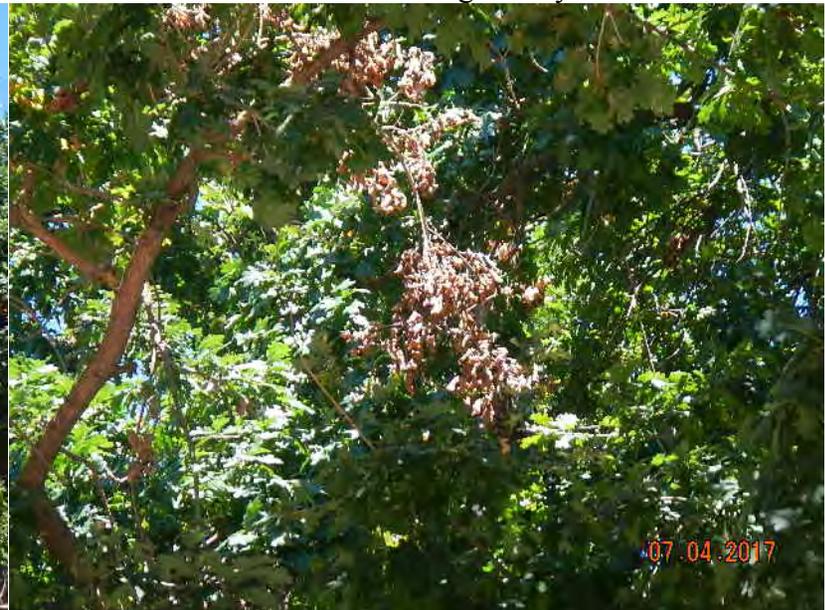
**Squirrel Damage** – Squirrels are damaging the trees due to over population. Squirrels are gnawing on the limbs of the trees and damaging the cambium layer. In some instances the it is only small twigs that are damaged, die and fall off. In other cases it is branches and limbs that are dying. These limbs have to be removed or they eventually fall if left in the tree. Squirrel populations should be controlled to reduce the impact on trees.

Squirrel damage in Oaks and Celtis trees causing structural damage to trees by gnawing on bark and young stems.
