# CERTIFIED ARBORIST REPORT

## Tree Assessment of Current Conditions

Project # WEST JULIAN STREET

440 West Julian Street

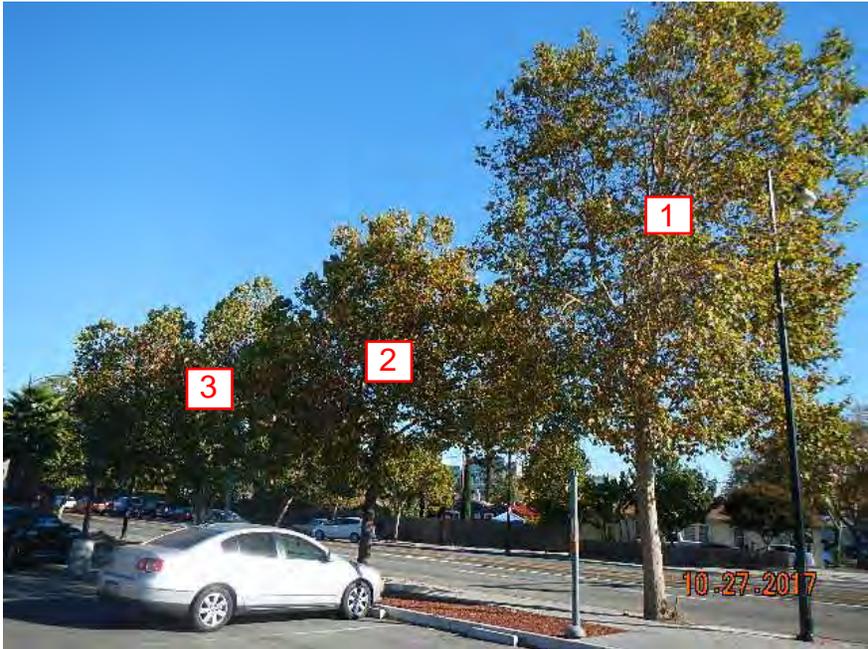
Tree #1, #2 & #3 *Platanus acerifolia*, London Planetrees

**Observations:** Trees #1, #2, #3, #10, #11 #22 & #23 are street trees and should be protected during any development of the site. Tree #22 has a broken limb hanging from it and is considered a “widow maker”. This broken hanging limb should be removed by a trained certified tree worker as soon as possible and practical. Health and structure are other wise acceptable. It would appear that utility trenching was performed in the tree protection zones of trees #1, #2, #3 in the past, as well as new sidewalks or sidewalk repair. This can be an impact on buttress roots and these trees should be monitored for risk assessment.

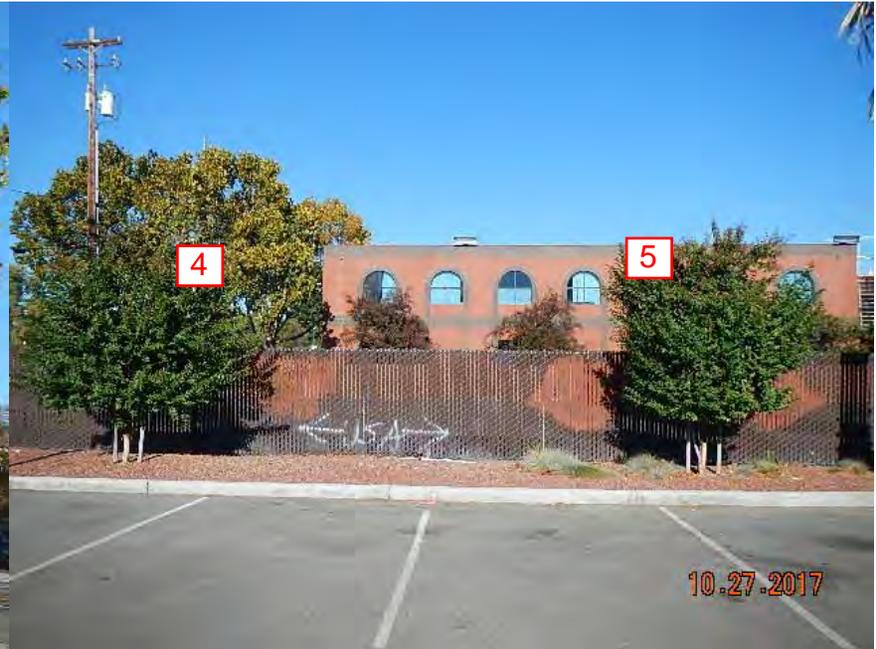
Tree #4 & #5 *Lagerstroemia indica*, Crepe myrtle

**Observations:** Trees #4, #5 & #7 are in good health and structure and are somewhat newly planted trees. These trees should be protected.

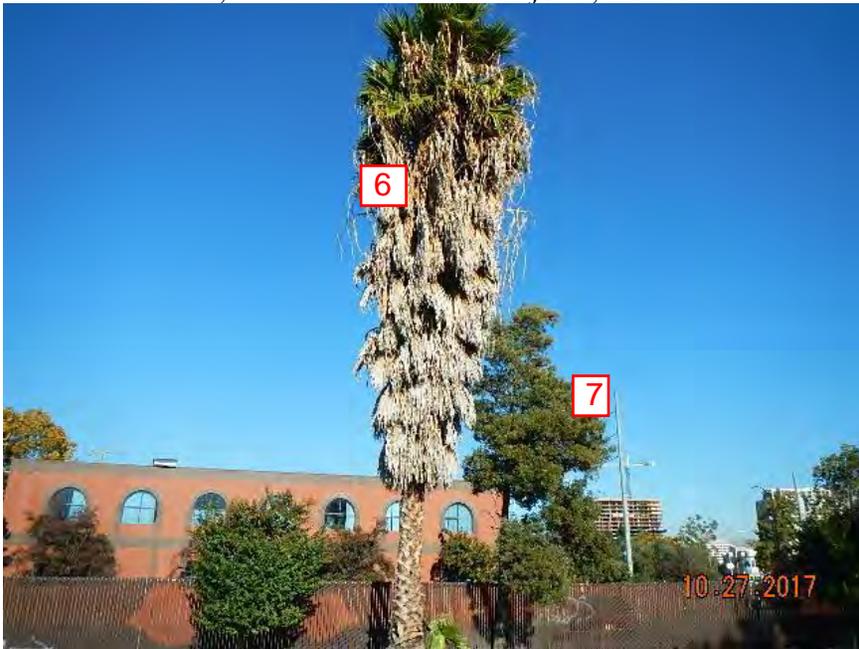
Tree #6 *Washingtonia robusta*, Mexican Fan Palm & Tree #7 *Acacia melanoxylon*, Black Acacia.

**Observations:** Tree #6 is most likely a volunteer and is adapting well to the site and conditions. Placement is not exceptional nor is the structure and removal would be an option.

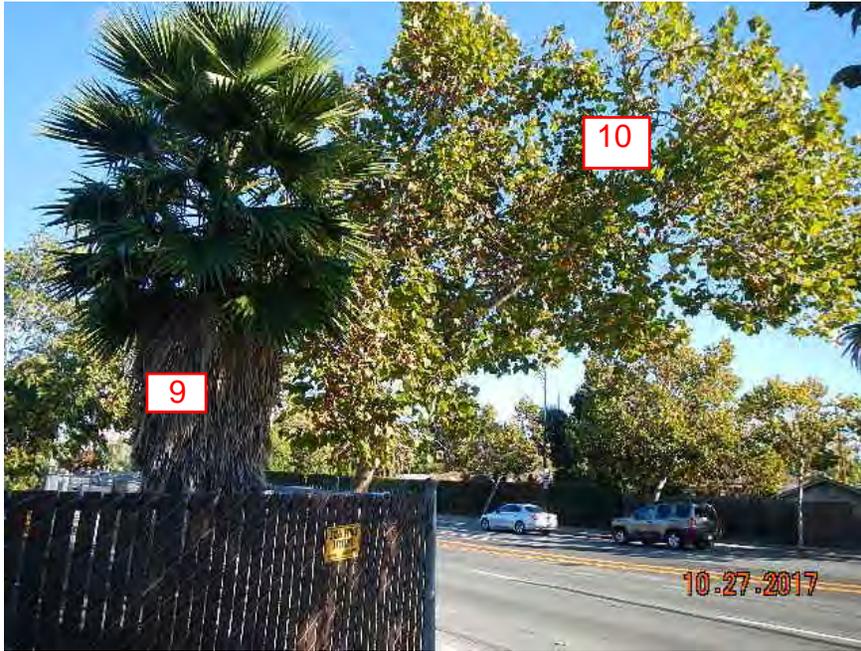
Tree #9 *Washingtonia robusta*, Mexican Fan Palm & Tree #10 *Platanus acerifolia*, London Planetree

**Observations:** These trees #6, #9, #12, #55, #61 & #63 are rated fair specimens, most likely volunteers and would be candidates for removal and replacement with a more human scale tree.

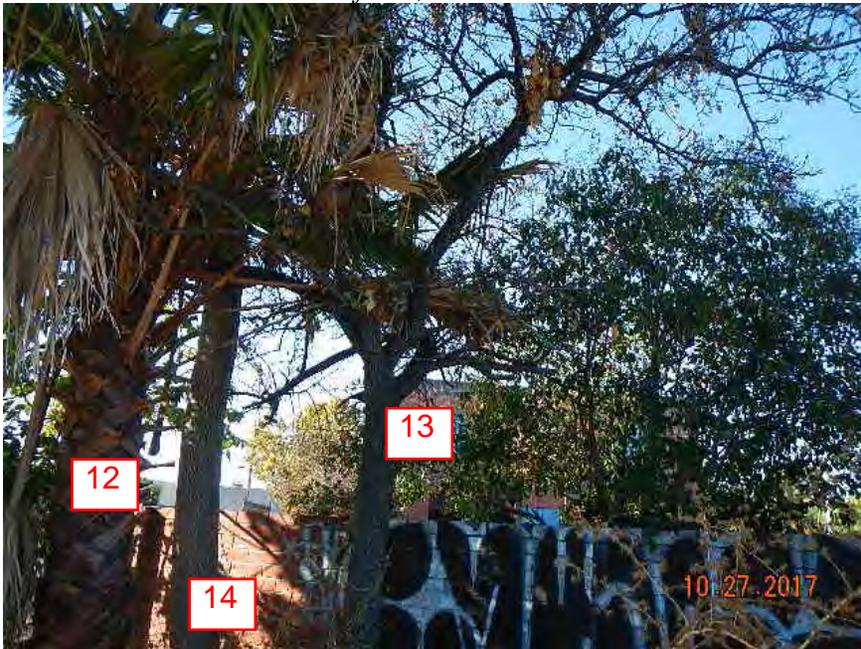
Tree #12 *Washingtonia robusta*, Mexican Fan Palm, Tree #13 *Pyrus kawakamii*, Evergreen Pear & Tree #14 *Ailanthus altissima*, Tree of Heaven

**Observations:** Tree #14, #37 through #54, all *Ailanthus* trees are invasive and unsuitable trees in the current and proposed use. They all have been recommended for removal if possible.

**Observations:** Tree #13 is dead and removal is recommended. Trees #17 & #18 are severely stressed, fire blight was noted and rated very low on health ratings and removal is recommended.

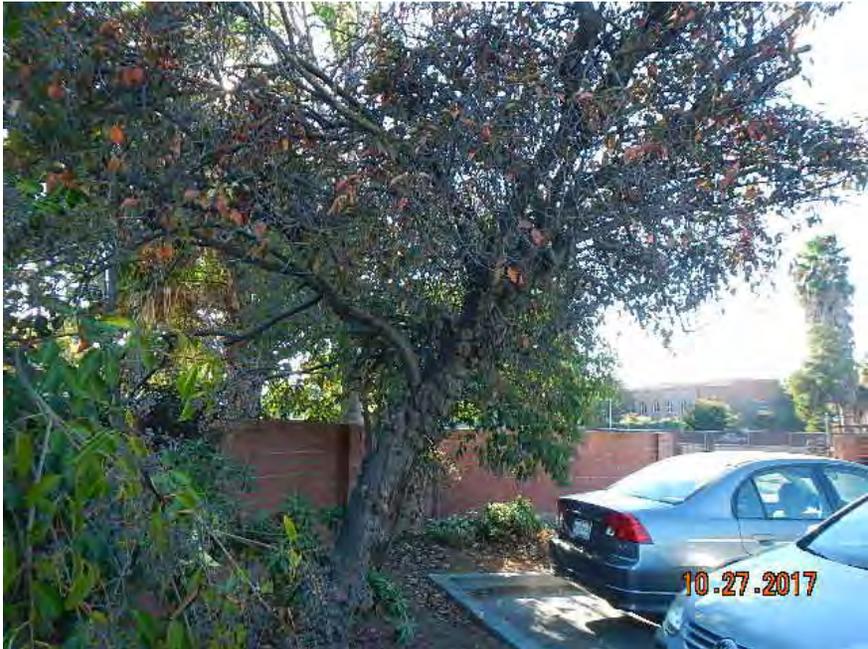
Tree #15 *Prunus blireiana*, Flowering Plum.

**Observations:** All 5 *Prunus blireiana* Flowering Plum trees, #15, #16, #19, #20 & #21 are stressed and show numerous canker like growths and nodules on the stem, stressed and thinning canopy, with tip and branch die back. These trees have lived their lives to the fullest. This tree is considered a short-lived tree and is in its prime at about 15 -20 years old if conditions are ideal. These trees are recommended for removal and replacement with an appropriate cultivar or alternate species.

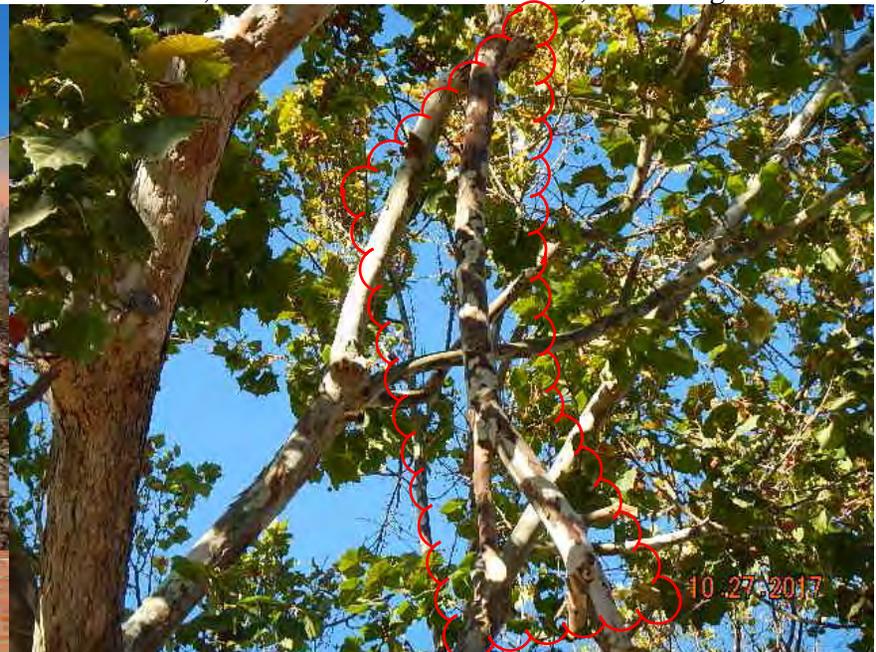
Tree #22 *Platanus acerifolia*, widow maker/broken limb that is hanging in the tree canopy, suggest removal ASAP.

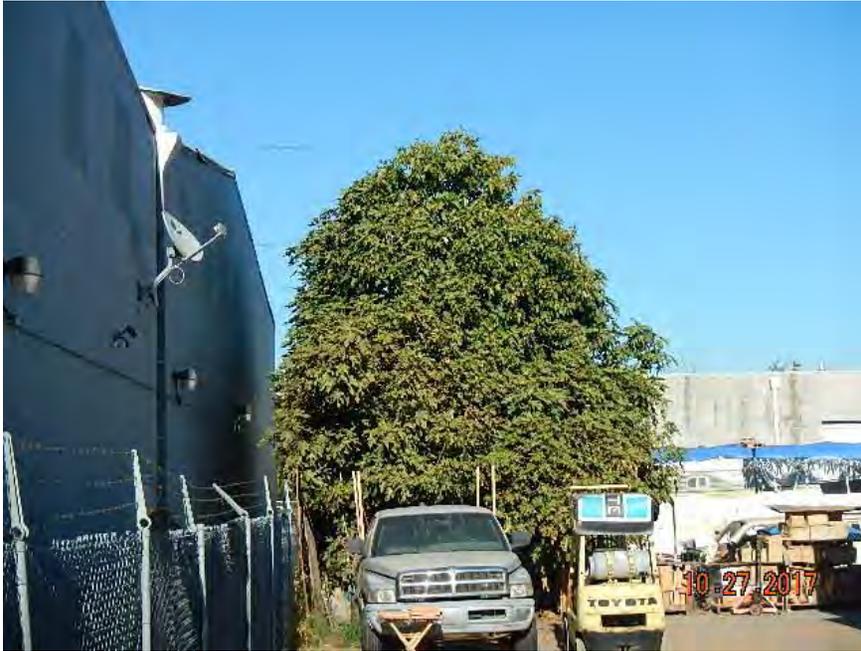
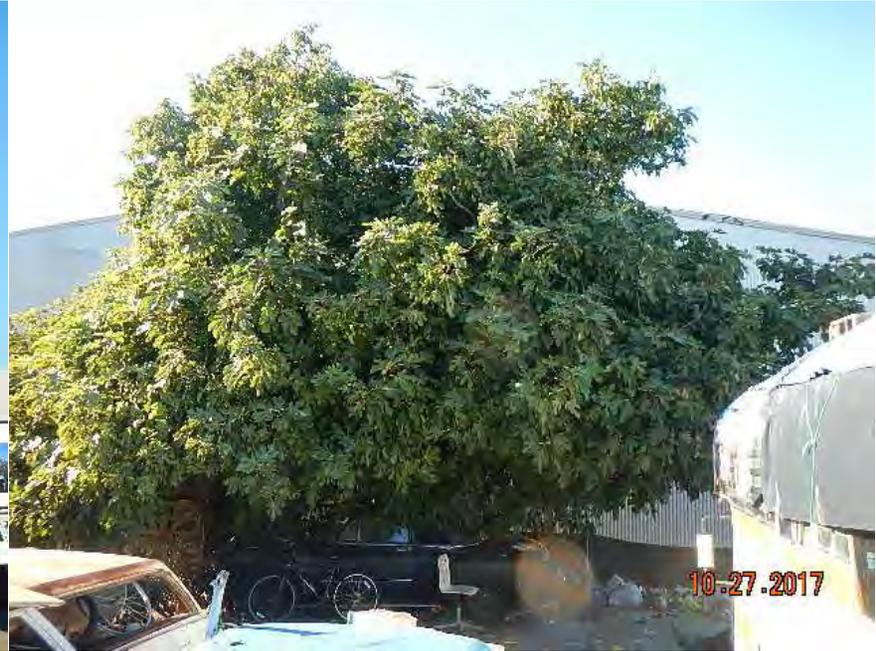
Tree #56 *Ficus carica*, Common Fig.

**Observations:** Tree #56 is a spectacular specimen and should be preserved. It has included bark and co-dominant leaders. One of the leaders should be subordinated so that the tree can be retained.

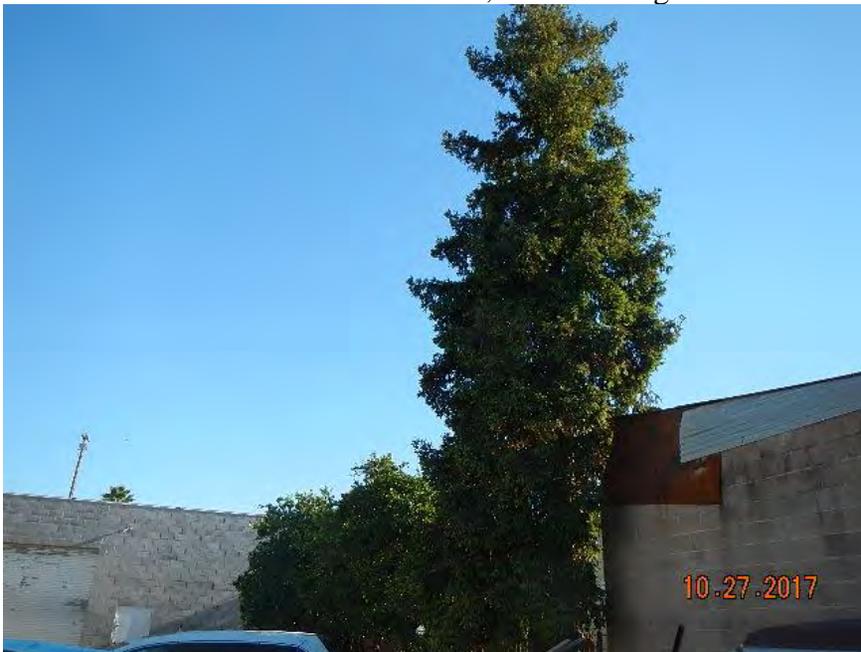
Tree #57 *Sequoia sempervirens*, Coastal Redwood.

**Observations:** Tree #57 is stressed by environmental impacts such as drought stress, crowded growing conditions and hardscape encroachment. This tree will thrive if the paving around it were removed, mulch installed and appropriate supplemental irrigation were applied. This tree should be preserved and incorporated into the properties development if possible.

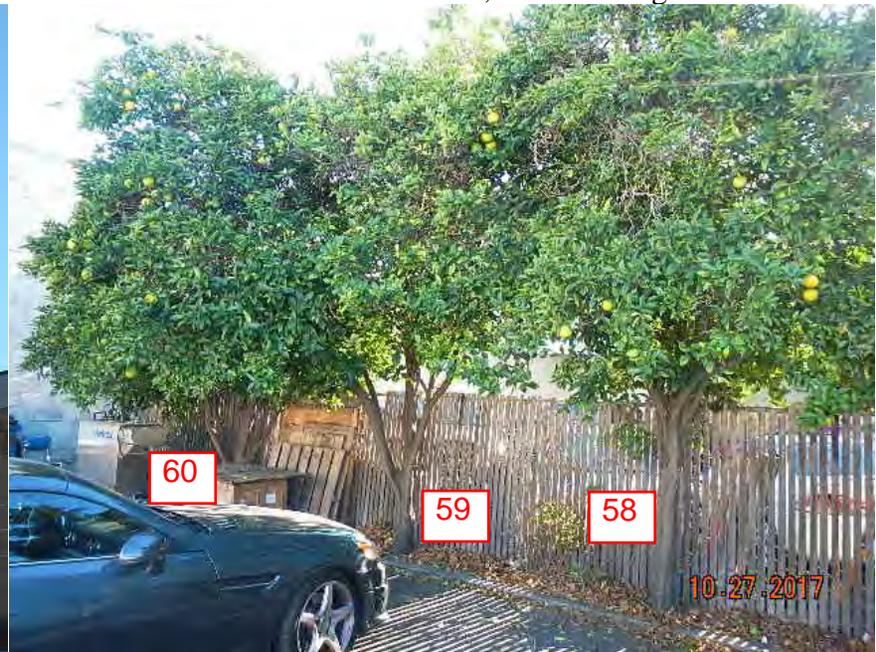
Tree #60, #59 & #58 *Citrus*, Citrus

**Observations:** Trees #58, #59, 60 & 64 are in fair condition. Normally expected pests and environmental impacts damage are visible. They pose no safety hazard. Retention and protection is suggested.

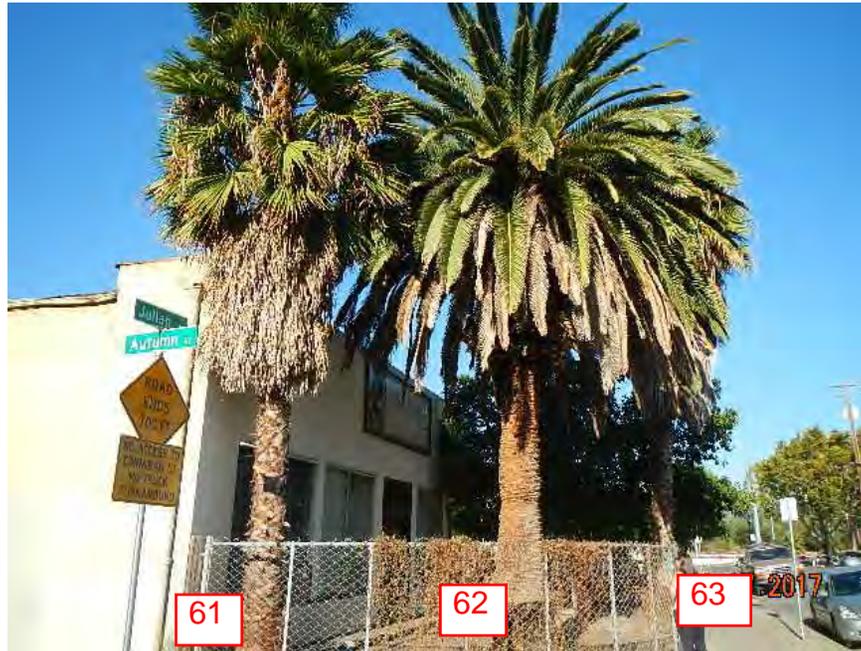
Tree #61 & #63 *Washingtonia robusta*, Mexican Fan Palm, & Tree #62 *Phoenix canariensis*, Canary Island Date Palm

**Observations:** Trees # 62 is in fair health and an above average specimen. Retention and protection is recommended.

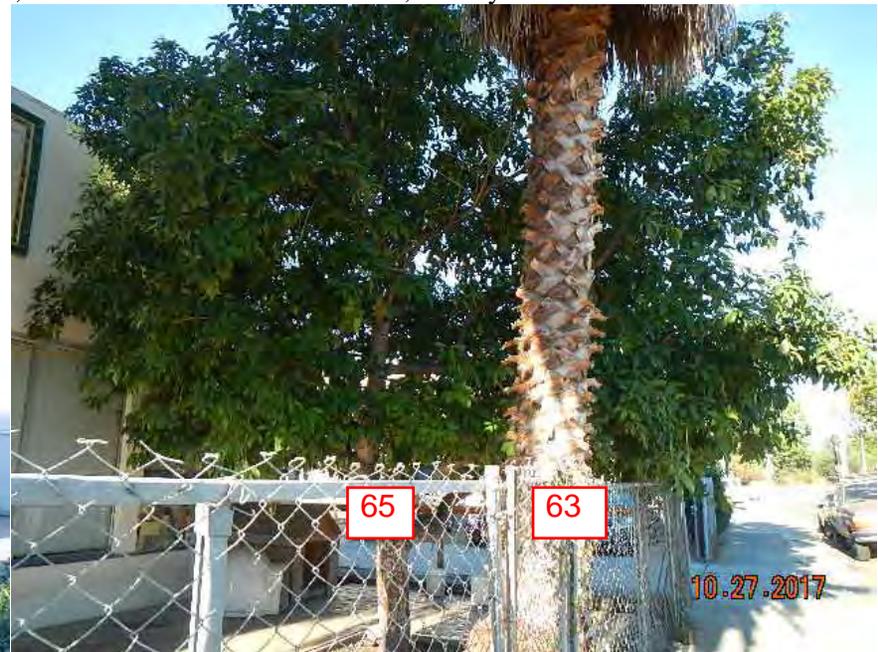
Tree #65 *Persea Americana*, Avocado & Tree #63 *Washingtonia robusta*, Mexican Fan Palm,

**Observations:** Tree #65 is in fair health and structure from what can be observed from outside of the chain-link fence that runs the perimeter.
