Kielty Arborist Services LLC

September 15, 2016

Site: 1705 Berryessa Road, San Jose, CA 95133

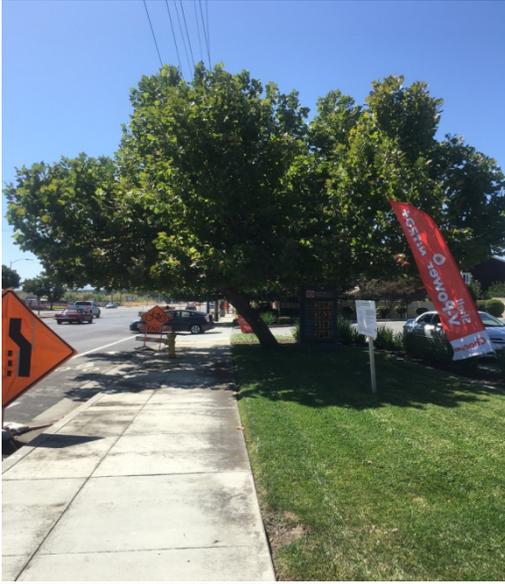
The existing driveway on this site near tree #1 will be removed and replaced at the location of street tree #2. American sycamore #2 will need to be removed to facilitate the construction of the new driveway entrance. Once the existing driveway is removed the once compacted area should be replaced with quality top soil and compost in order to allow for future root growth into this area for tree #1. This will benefit the tree. Removal of the old driveway must be done by hand when within 15 feet from this tree. The site arborist must also be called out to the site when this work is to take place.

Showing sycamore tree #2

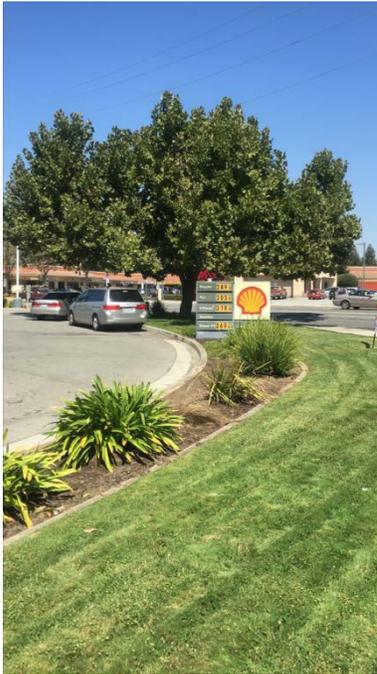
American sycamore #3 is in close proximity to the proposed parking area. Root cutting would likely need to take place. The site arborist must be on site when this work is to take place. The cut for the proposed parking area would be a corner cut out to the tree's root zone, affecting an estimated 20% of the trees root zone. This tree will need to be mitigated through pruning and an irrigation schedule. The tree has large heavy lateral leaders that extend 10 feet into the street. A lightening of the lateral leaders would need to take place before the start of construction. Impacts to this tree are expected to be moderate.

Showing sycamore #3

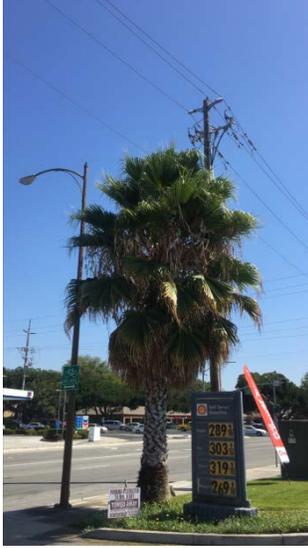
Mexican fan palm #4 will likely need to be removed in the near future as this tree is growing underneath utility lines. Palm trees that are topped will die as they only have one apical meristem. Once this meristem is removed the tree will die. This is why palm trees should not be grown under utility lines as they will eventually need to be topped and will die as a result. Minor work is proposed near this tree in order to make room for parking. Root cutting would likely take place at least 5 feet from the tree. This tree is recommended to be removed as it was planted in the wrong location and will soon need to be removed regardless of construction as the tree will be interfering with utilities.

Showing palm tree underneath utilities
