Arborist Report

RE: TREE IMPACT ASSESSMENT

Santa Teresa Village
7028 Santa Teresa Blvd, San Jose, CA 95139

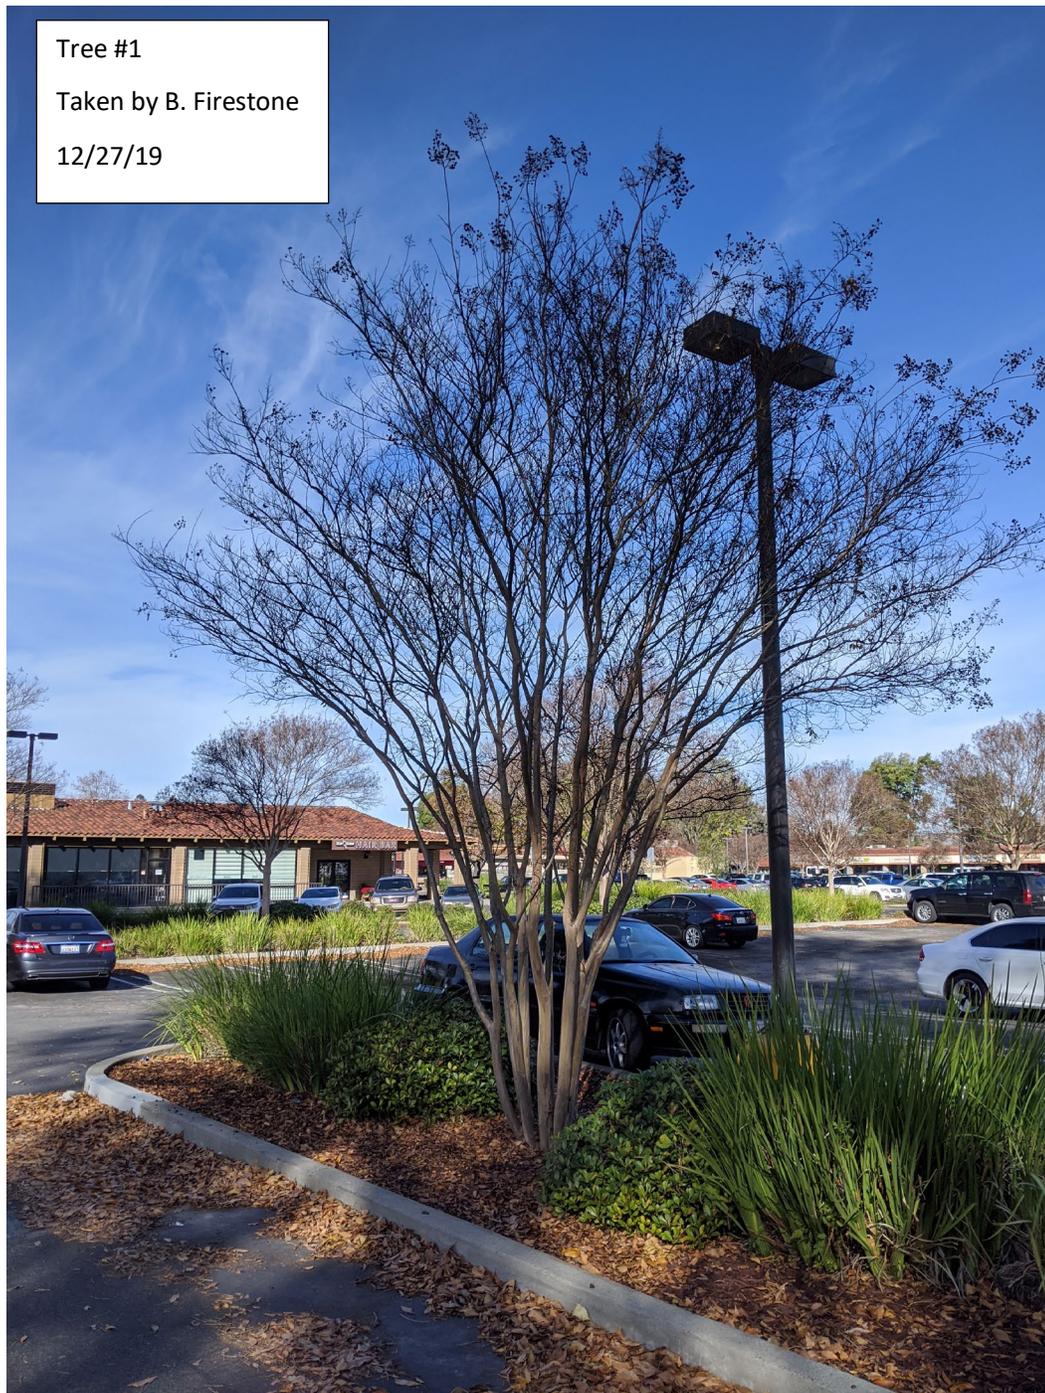
For the purposes of this report, I labeled the trees #1 - #4 (see Photos A – D). Trees #1 - #3 were crape myrtles and Tree #4 was an Australian willow. All trees were in small parking lot islands; #1 and #4 were growing in 4' strips and Trees #2 and #3 were in 4' x 4' spaces. Please see the attached Tree Inventory and Site Map for the locations and basic attributes of the four trees identified for removal at the project site.

Retention of trees #1 - #4 would not be possible if the project were to move forward as planned. Therefore, I assigned a “severe” impact rating to these trees, with “low” suitability for retention. From review of the proposed plans, I understood that there would be a significant net increase in new trees and urban forest benefits if the project were to move forward (see plan sheet L1). **With these considerations in-mind, removal of Trees #1 - #4 would be justified for the economic development of the parcel.**
