**GEOTECHNICAL INVESTIGATION
PROPOSED 9-UNITS RESIDENTIAL STRUCTURES
ARAUJO AVENUE AND PIETRO DRIVE
SAN JOSE, CALIFORNIA**

Subject: **GEOTECHNICAL INVESTIGATION**
Proposed 9-Units Residential Structures
Araujo Avenue and Pietro Drive
San Jose, California

**PHASE I ENVIRONMENTAL SITE
ASSESSMENT REPORT**

SCOPE OF WORK
PHASE II ENVIRONMENTAL SITE ASSESSMENT
ARAJUO RESIDENTIAL PROJECT
SAN JOSE, CALIFORNIA
SEPTEMBER 8, 2015

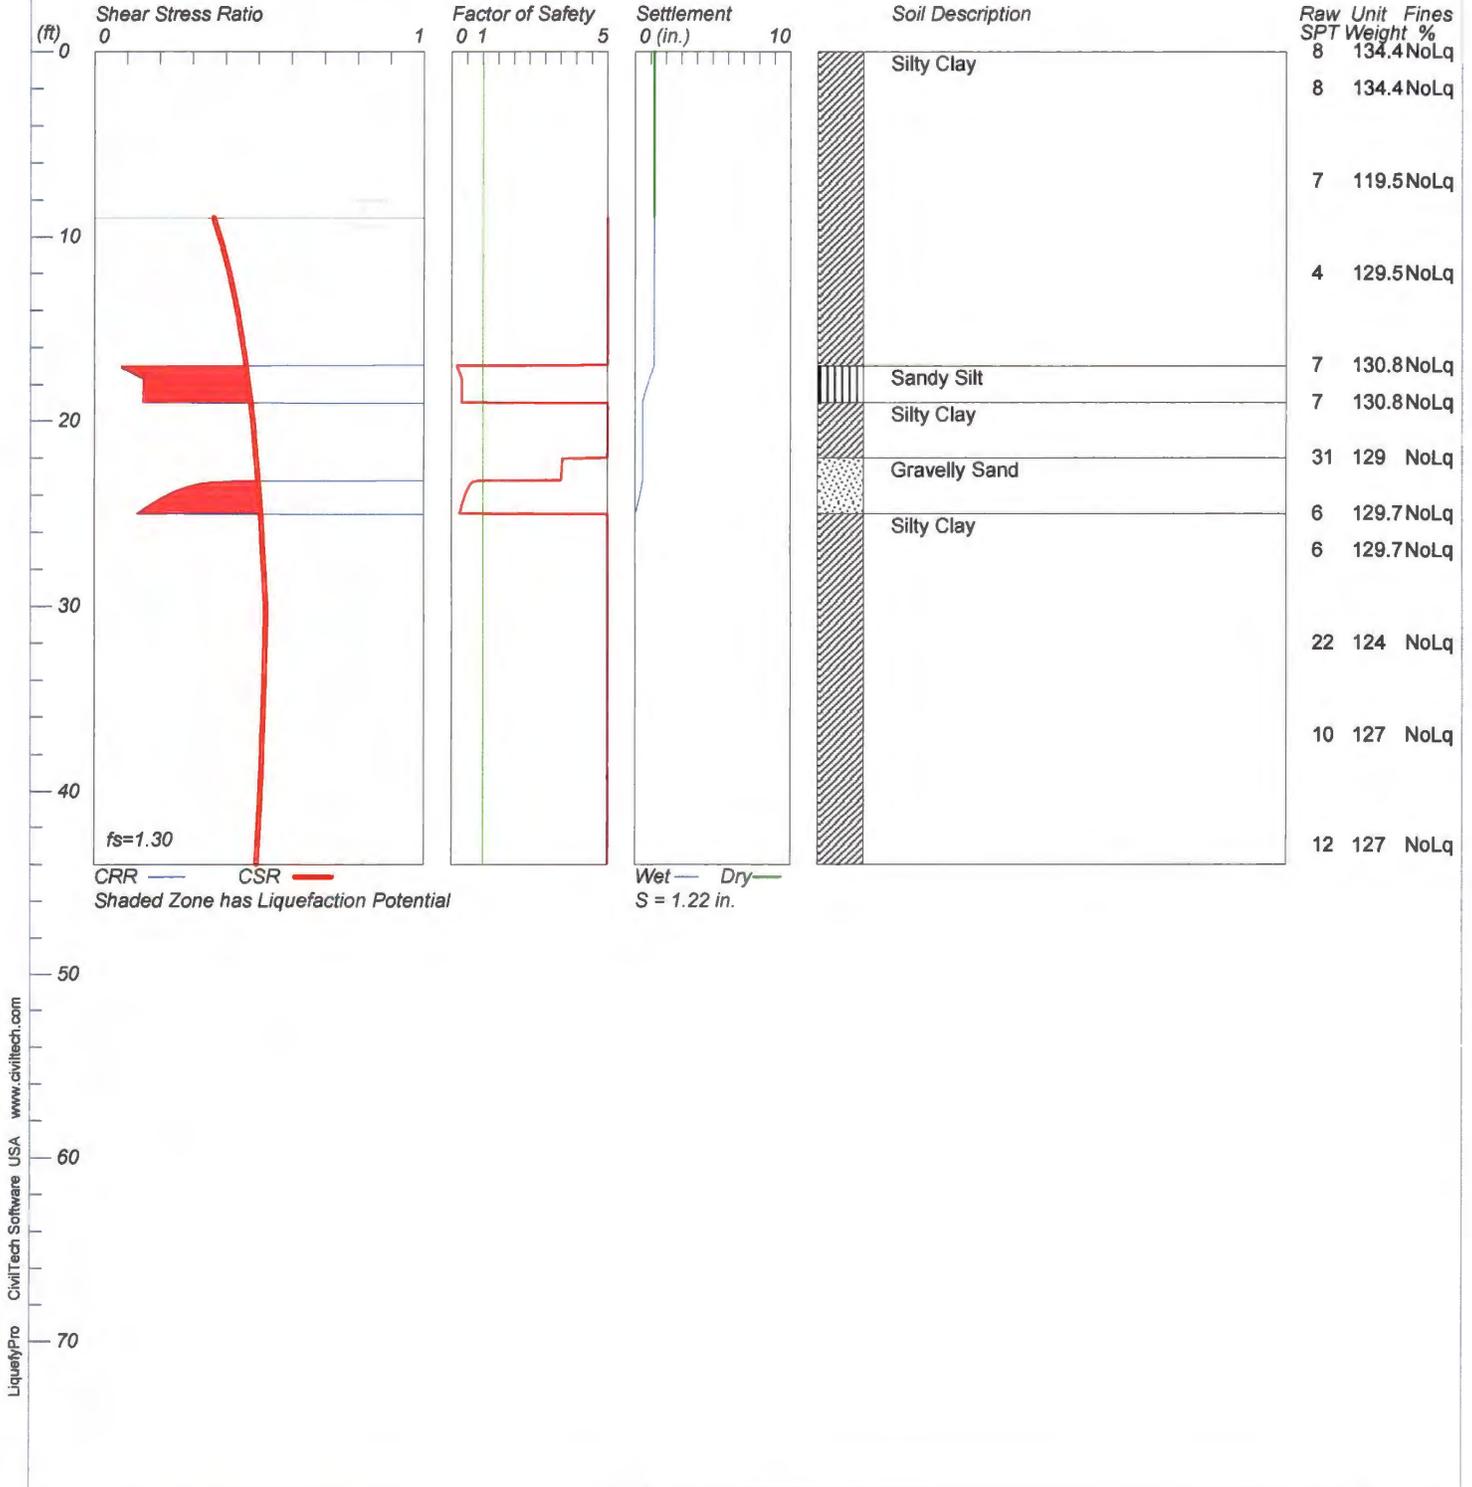
Araujo avenue 9_Boring 3_San Jose_3202.sum

Hole No.=3 Water Depth=9 ft

Magnitude=7.9
Acceleration=0.57g

We have conducted a liquefaction for the site based on procedures outline in the CGS Special Publication 117A (2008), Guideline for Evaluating and mitigating Seismic Hazards in California,

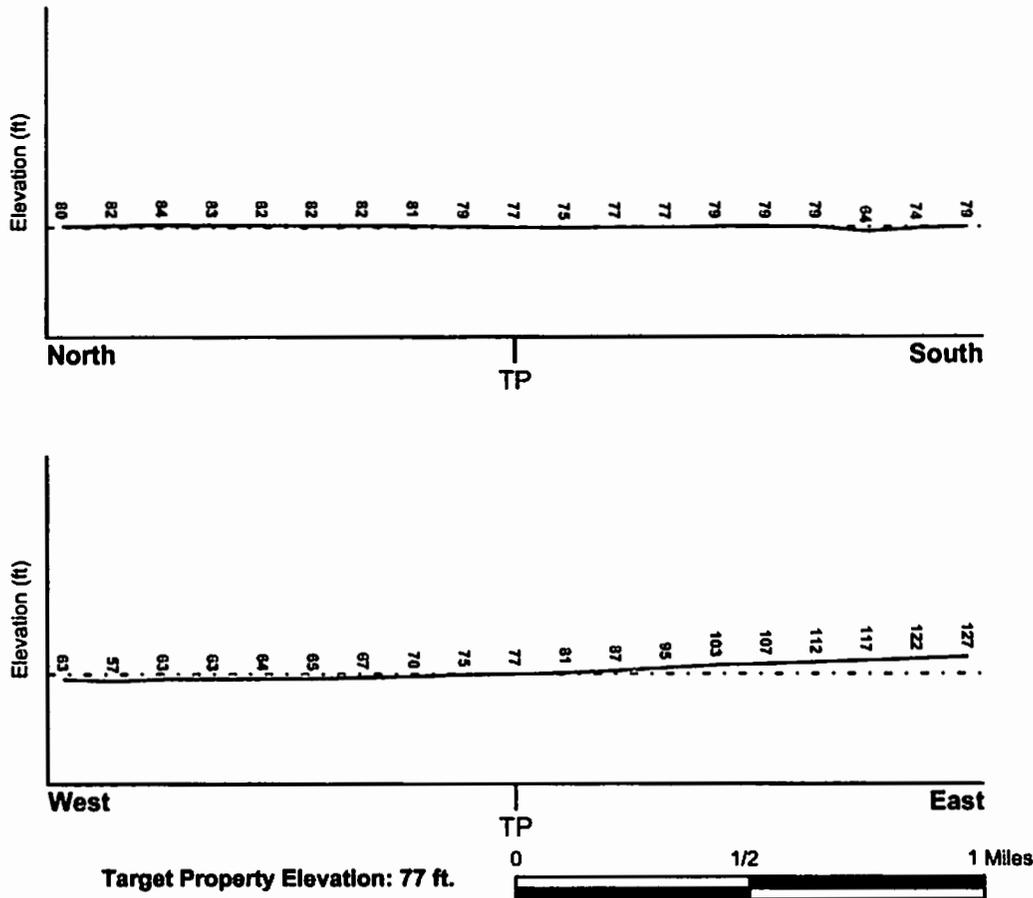
SURROUNDING TOPOGRAPHY: ELEVATION PROFILES

General Topographic Gradient: General West

Source: Topography has been determined from the USGS 7.5' Digital Elevation Model and should be evaluated on a relative (not an absolute) basis. Relative elevation information between sites of close proximity should be field verified.

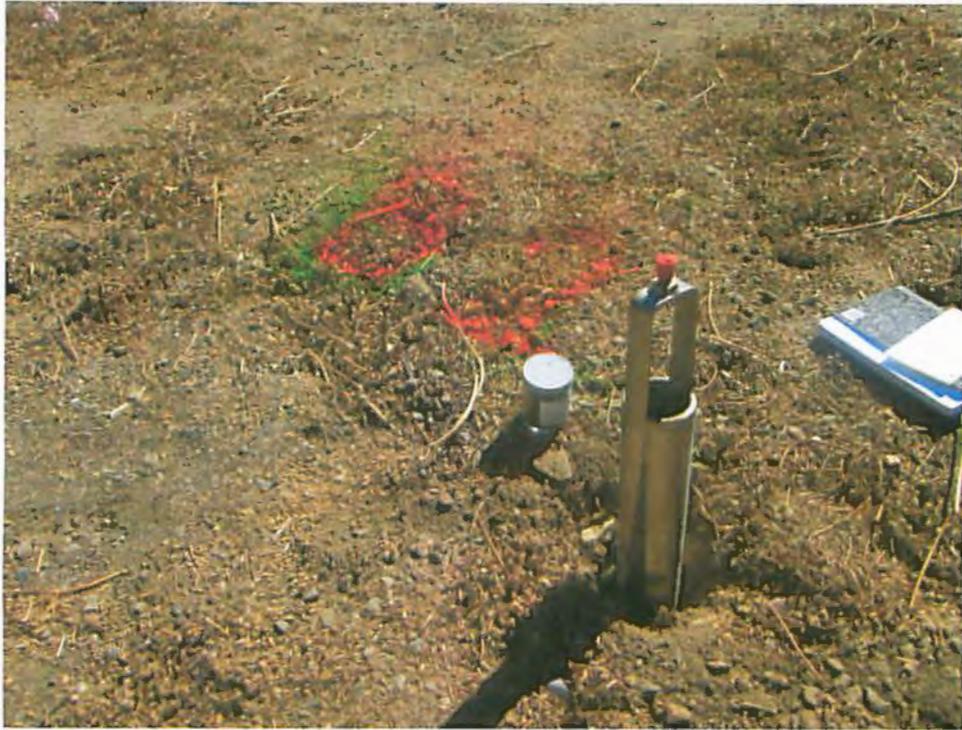
Photo 3: Sampling Location and Sample Container at Boring 1

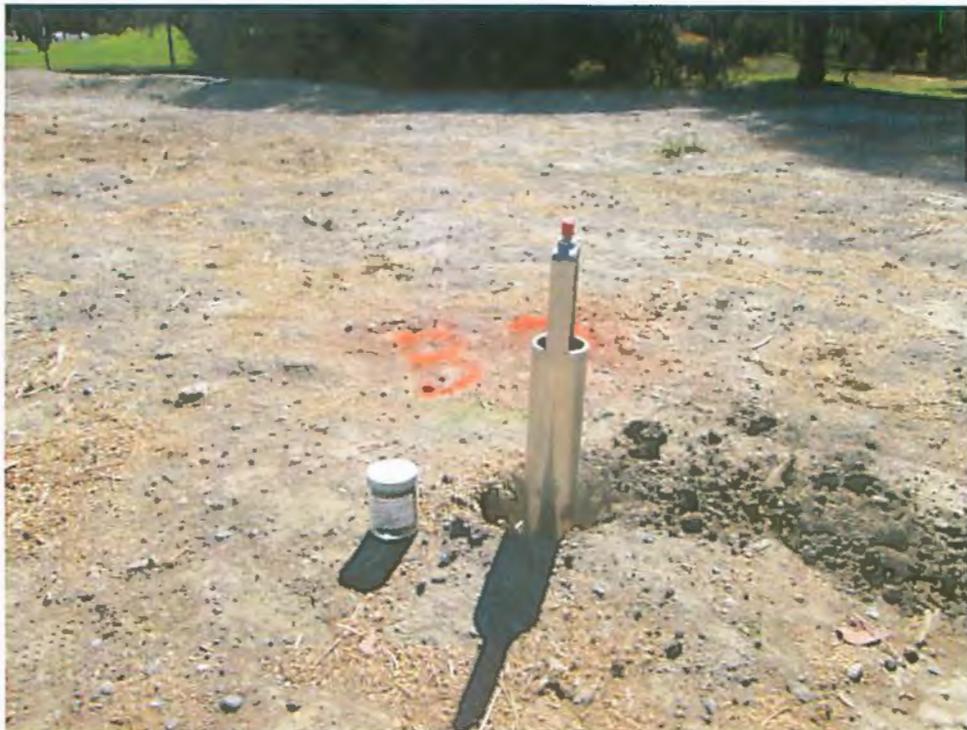
Photo 4: Sampling Location and Sample Container at Boring 2

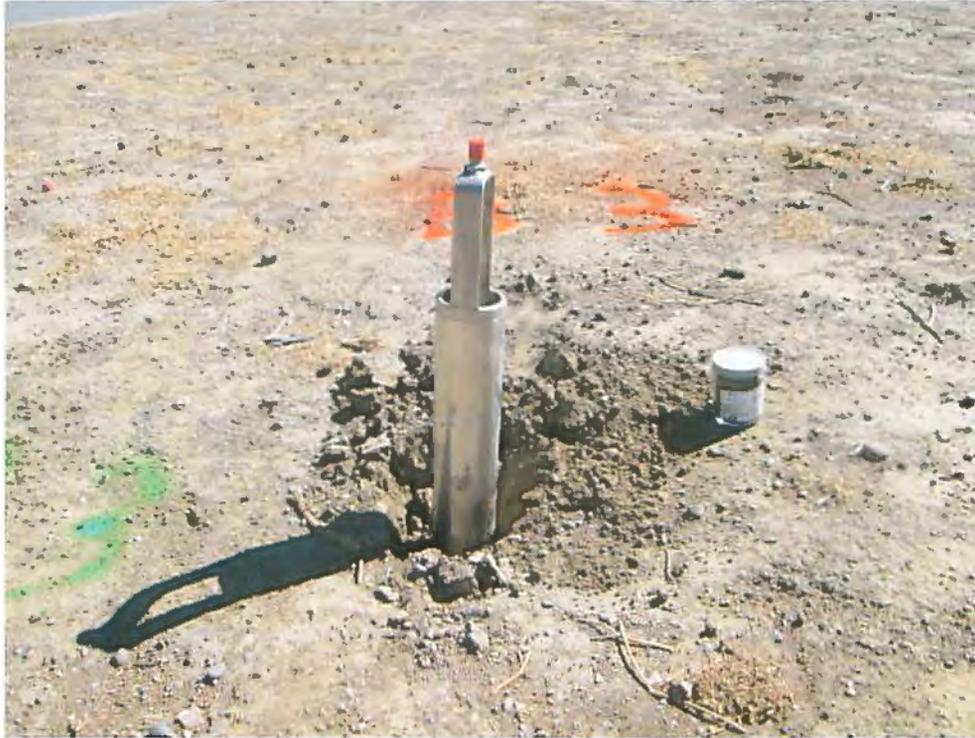
Photo 5: Sampling Location and Sample Container at Boring 3

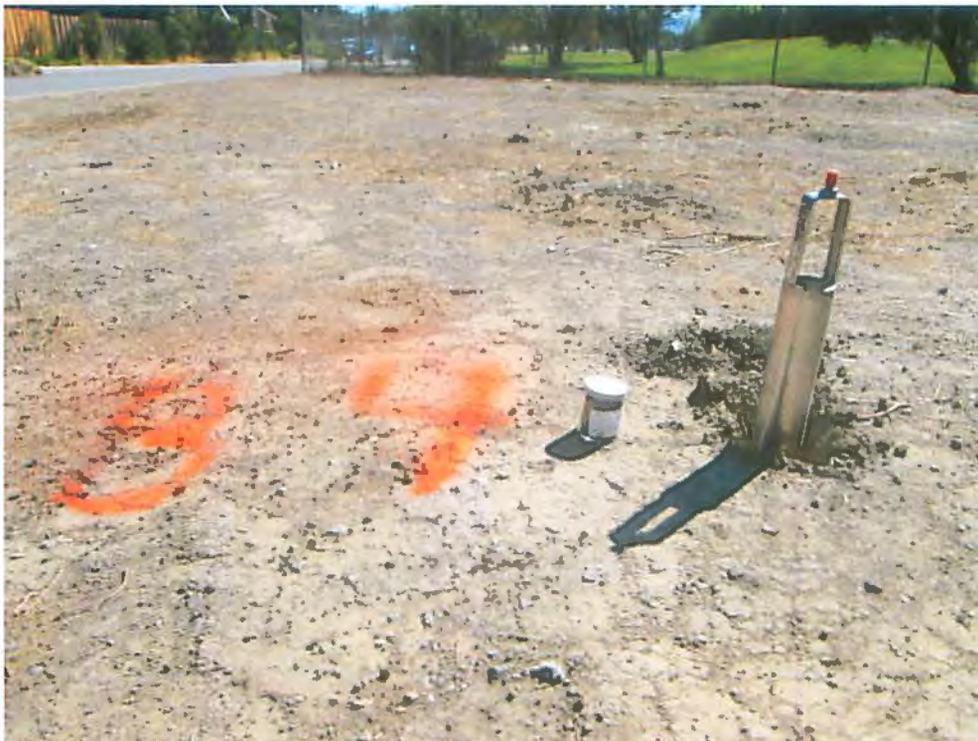
Photo 6: Sampling Location and Sample Container at Boring 4

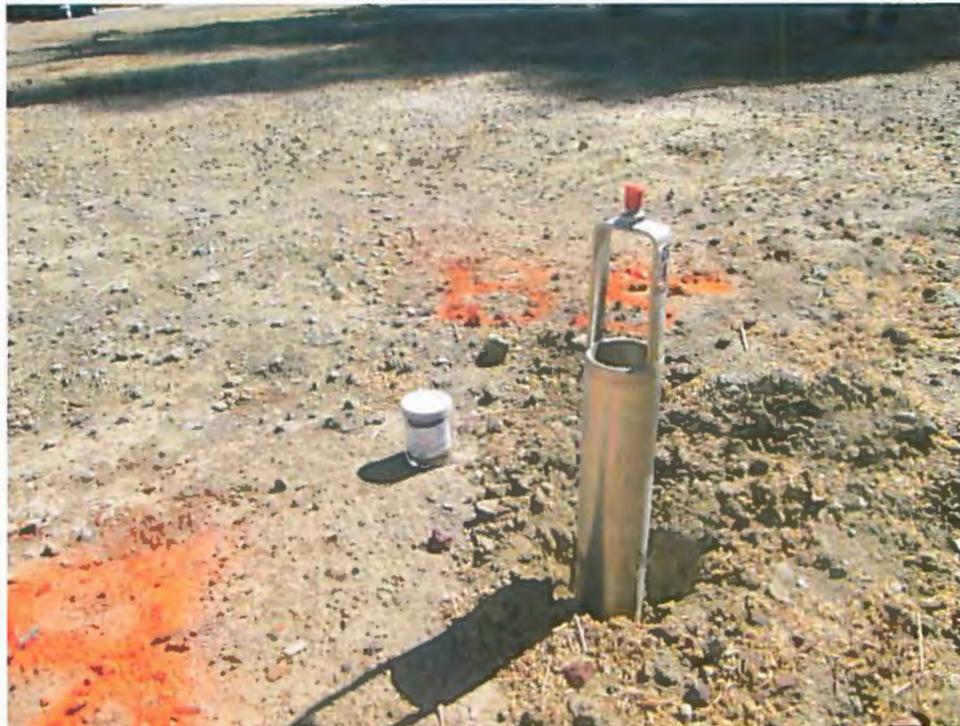
Photo 7: Sampling Location and Sample Container at Boring 5

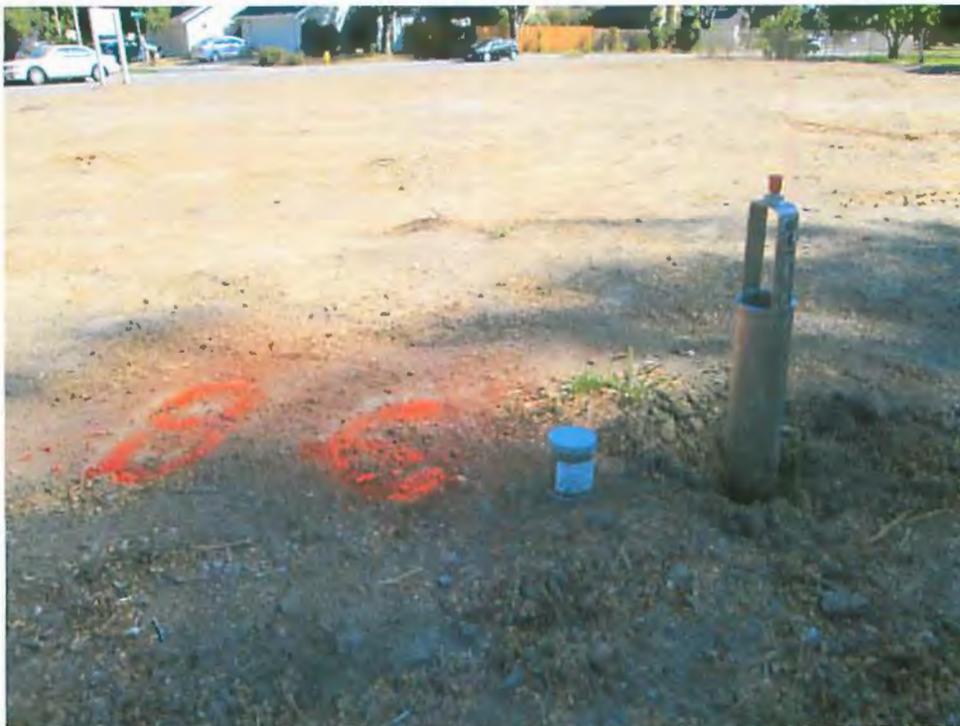
Photo 8: Sampling Location and Sample Container at Boring 6

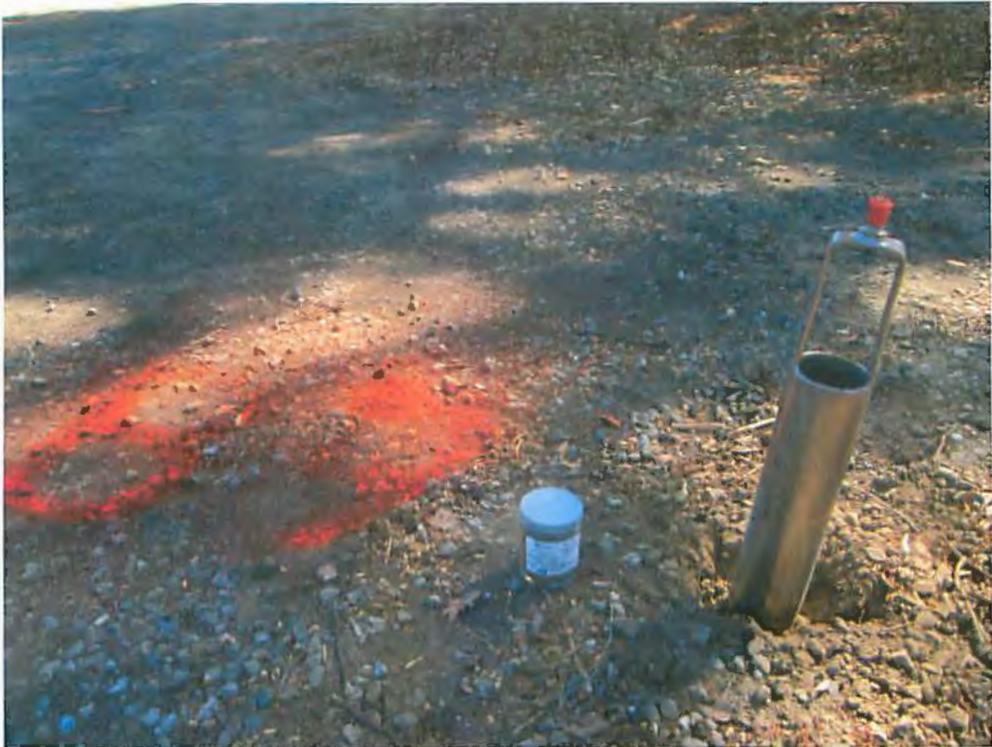
Photo 9: Sampling Location and Sample Container at Boring 7

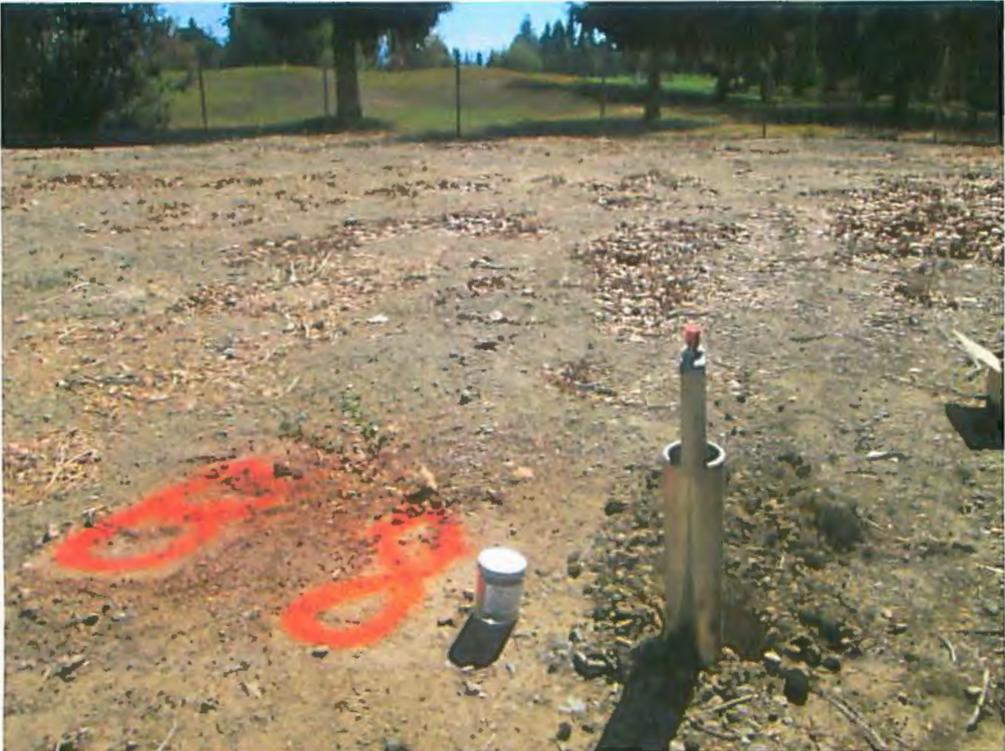
Photo 10: Sampling Location and Sample Container at Boring 8
