<b>TYPE OF SERVICES</b>	Limited Environmental Site Assessment
<b>LOCATION</b>	Center for the Performing Arts 255 South Almaden Boulevard San Jose, California
<b>CLIENT</b>	David J. Powers & Associates
<b>PROJECT NUMBER</b>	118-153-1
<b>DATE</b>	November 21, 2023

**Limited Environmental Site Assessment**  
**Center for the Performing Arts**  
**255 South Almaden Boulevard**  
**San Jose, California**

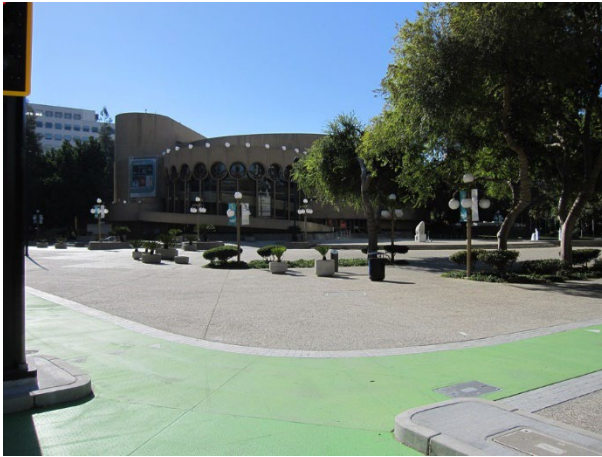
Photograph 1. Proposed sign location (northern corner of the Site).

An auto repair shop (Bill's Auto Electric Service) was identified as a former occupant of 252 Park Avenue (1955-1963), and W.A. Curtis was identified as a former occupant of 256 Park Avenue (1950). These addresses were formerly located on the northern corner of the Site, at or near the proposed northernmost sign location. W.A. Curtis was listed as a "cleaner." It's not clear, however, if that was his or her occupation or if a dry cleaning business operated at that address.

If odorous, stained soil, unknown structures, or other environmental concerns are noted during future earthwork activities, excavation work should stop and an environmental professional be contacted to observe Site conditions. Soil that is generated should be temporarily placed on top of and covered by plastic sheeting, and properly disposed and profiled via analytical testing per the accepting facility's requirements. Prior to the start of earthwork activities, we also recommend preparing a Health and Safety Plan (HSP) to establish appropriate management practices for handling impacted soil or previously unidentified structures if encountered during construction activities. The HSP should reference this limited ESA and identify the environmental professional who will be contacted.

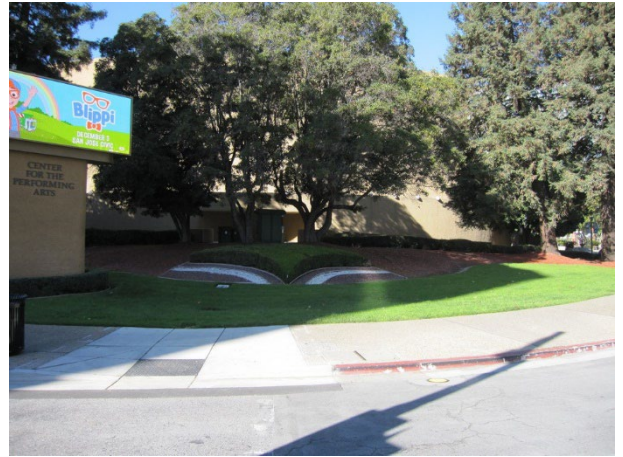
Photograph 2. Proposed sign location (eastern corner of the Site).

Former addresses located at or near the proposed sign location at the eastern corner of the Site included 251, 253 and 255 San Carlos Street and were formerly occupied by a gasoline station (1930-1940) and used car dealers (1940-1963).
