TYPE OF SERVICES	Phase I Environmental Site Assessment Tamien Station Transit-Oriented Development
LOCATION	1197 Lick Avenue San Jose, California
CLIENT	UrbanCo Tamien LLC
PROJECT NUMBER	183-10-1
DATE	September 18, 2017

Type of Services	**Phase I Environmental Site Assessment** **Tamien Station Transit-Oriented Development**
Location	**1197 Lick Avenue** **San Jose, California**
Client	**UrbanCo Tamien LLC**
Client Address	**1871 The Alameda, Suite 200** **San Jose, California 95126**
Project Number	**183-10-1**
Date	**September 18, 2017**

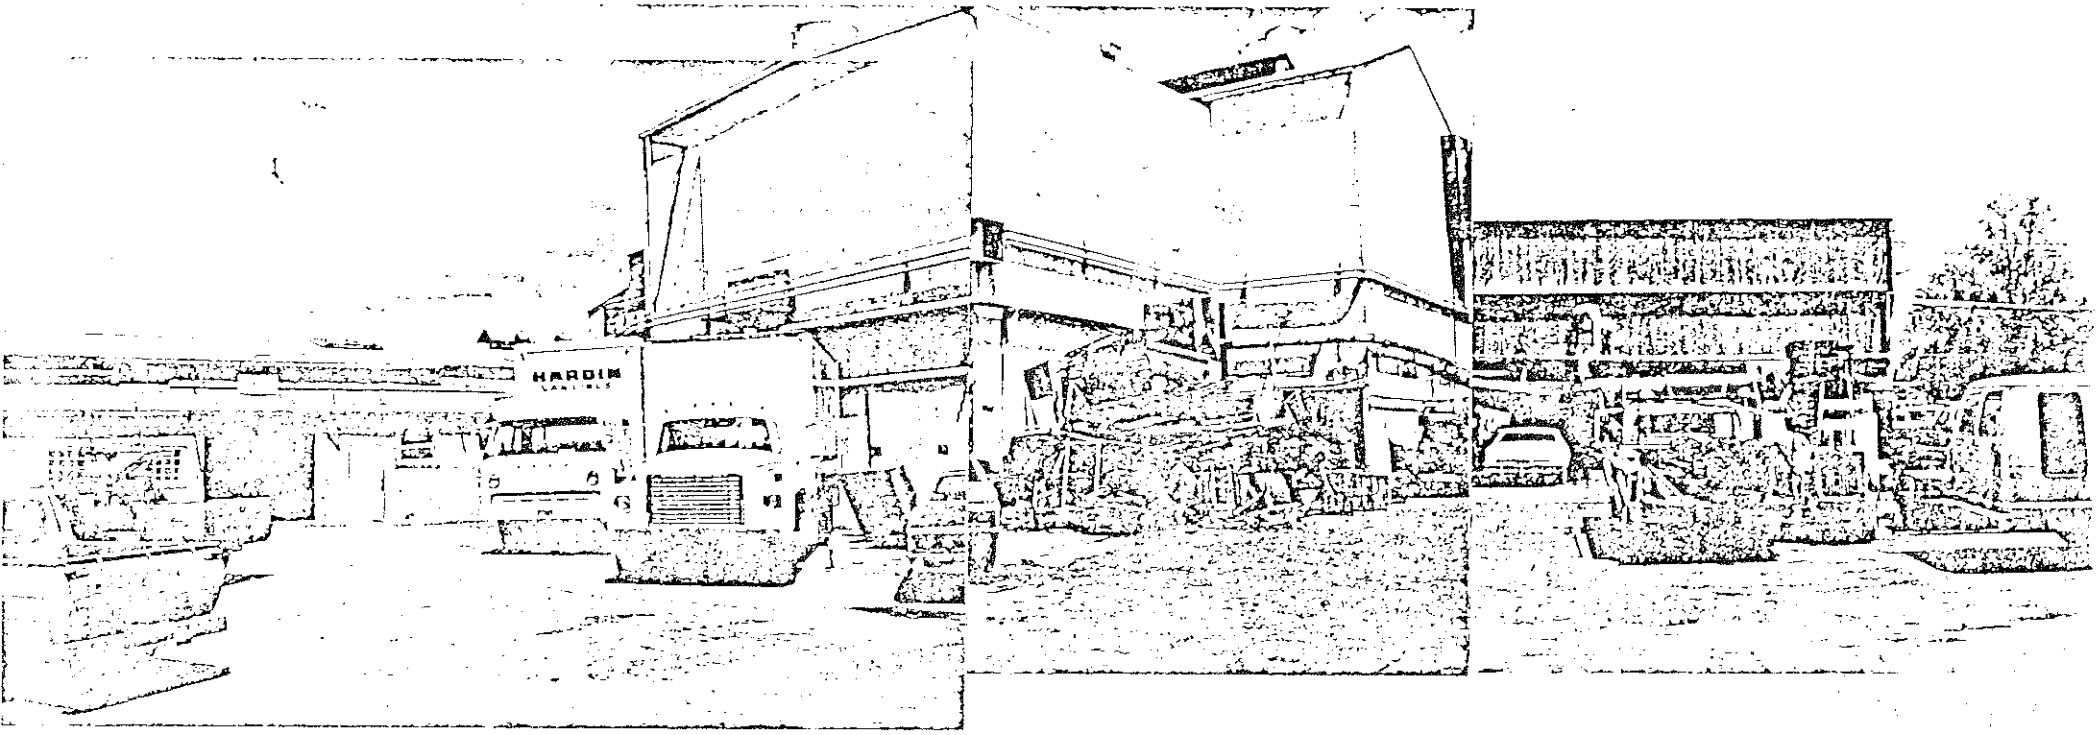
K: Close to SW corner of facility. Paint shop, parking lot, disassembled vehicles, scrap metal, truck bodies. Small auto body repair shop. Building appears to have been warehouse. No visible piping.

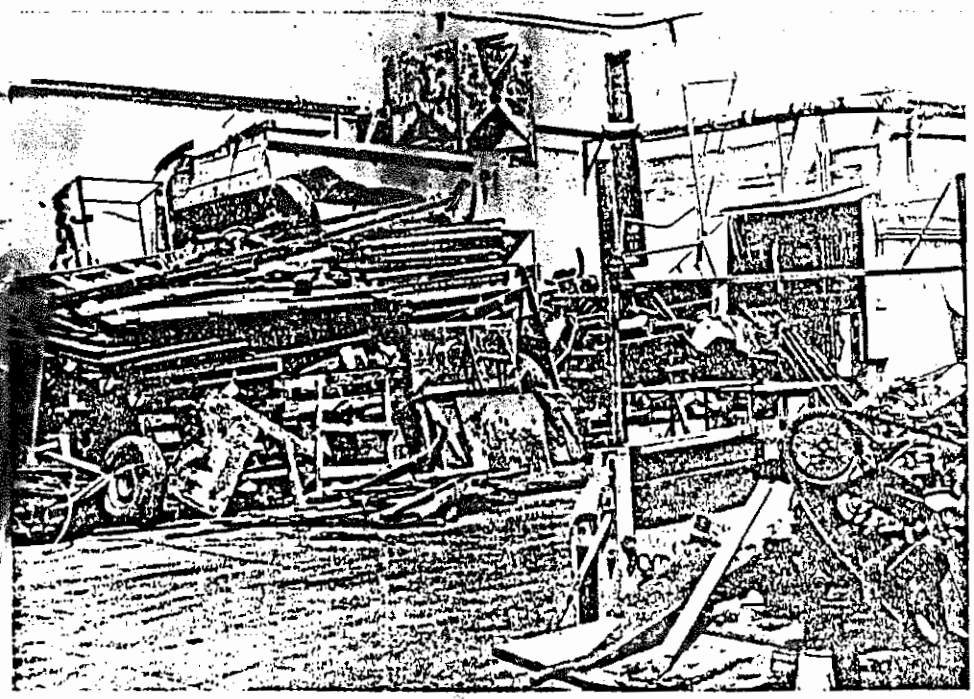
A: Auto repair shop: No visible asbestos piping coming from boiler plant in this area. However, there are engines and transmissions lying in the work area. There may be some asbestos residue associated with these processes. Inside the shop there is no visible asbestos-covered piping. However, there are holes in the common wall between the auto shop and boiler suggesting piping had passed through this area.

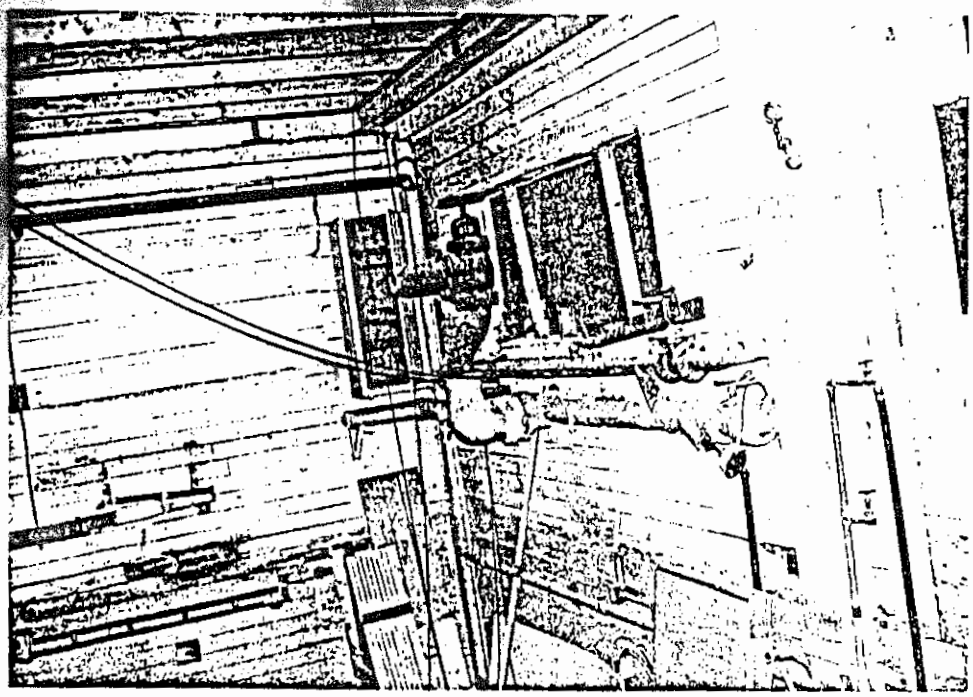
: Vacuum area, second level: There is approximately 25 feet of coated pipe in the area. Holes in the floor suggest that piping at one time passed through the floor. Third floor of the vacuum area is reportedly an artist's studio. It contains a number of items suggesting it might be inhabited. There is no visible insulation in the area, however, there are some holes suggesting piping existed here.

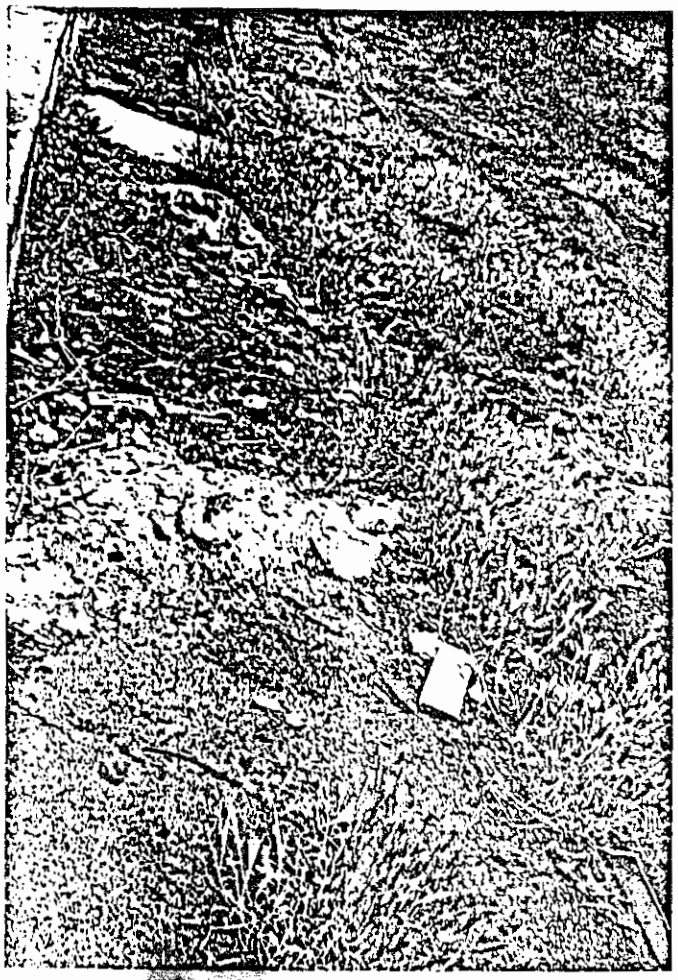
: Trash laying along train tracks (Samples 7750) to NW corner of building. Photo, ee grass in photo along with railroad track.

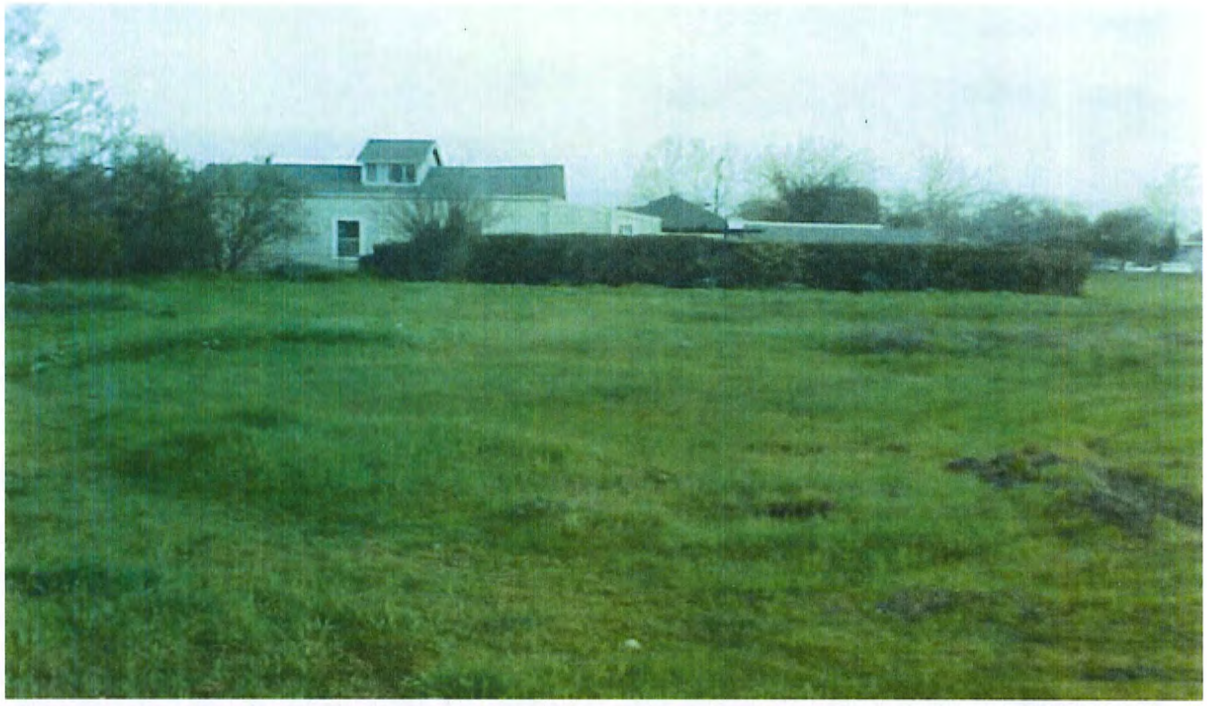
Photograph No. 1: Looking Easterly across northern portion of site.

Photograph No. 2: Looking Southeasterly across site from Northwest corner.
