EVERGREEN • EAST HILLS VISION STRATEGY

GEOTECHNICAL REPORTS

**FEASIBILITY-LEVEL
GEOLOGIC HAZARDS ASSESSMENT
ARCADIA PROPERTY
SAN JOSE, CALIFORNIA**

SUBJECT: Feasibility-Level Geologic Hazards Assessment for the Arcadia Property, San Jose, California

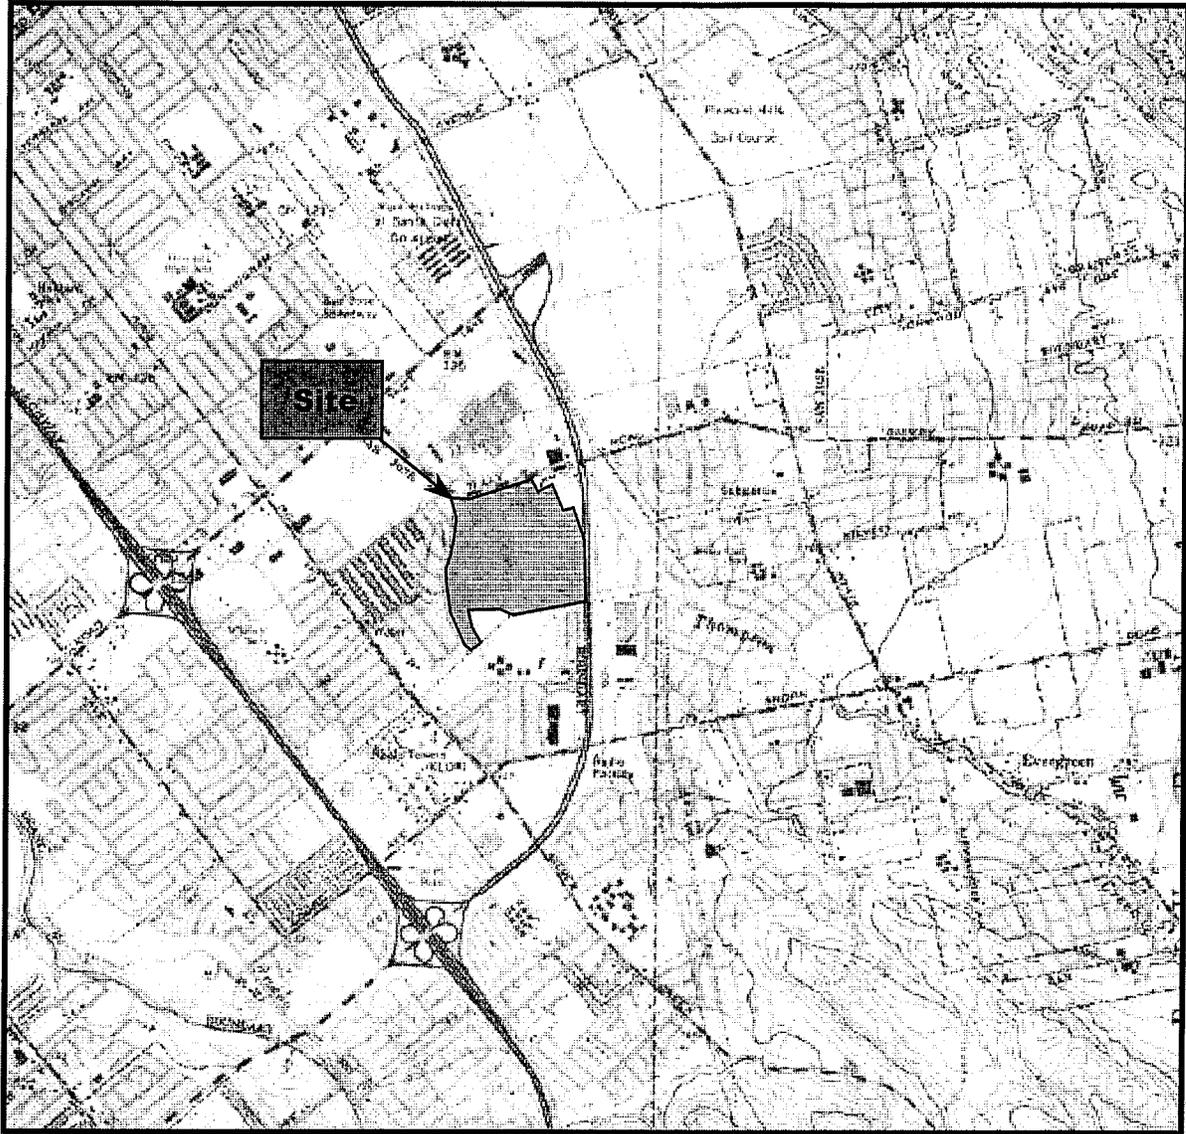
Site Vicinity Map
 Arcadia
 Quimby Rd. & Capitol Expressway
 San Jose, California

This report presents the results of our feasibility-level geologic hazards assessment for the Arcadia Property in San Jose, California. The location of the project site with respect to surrounding cultural and topographic features is depicted on the Site Vicinity Map, Plate 1.

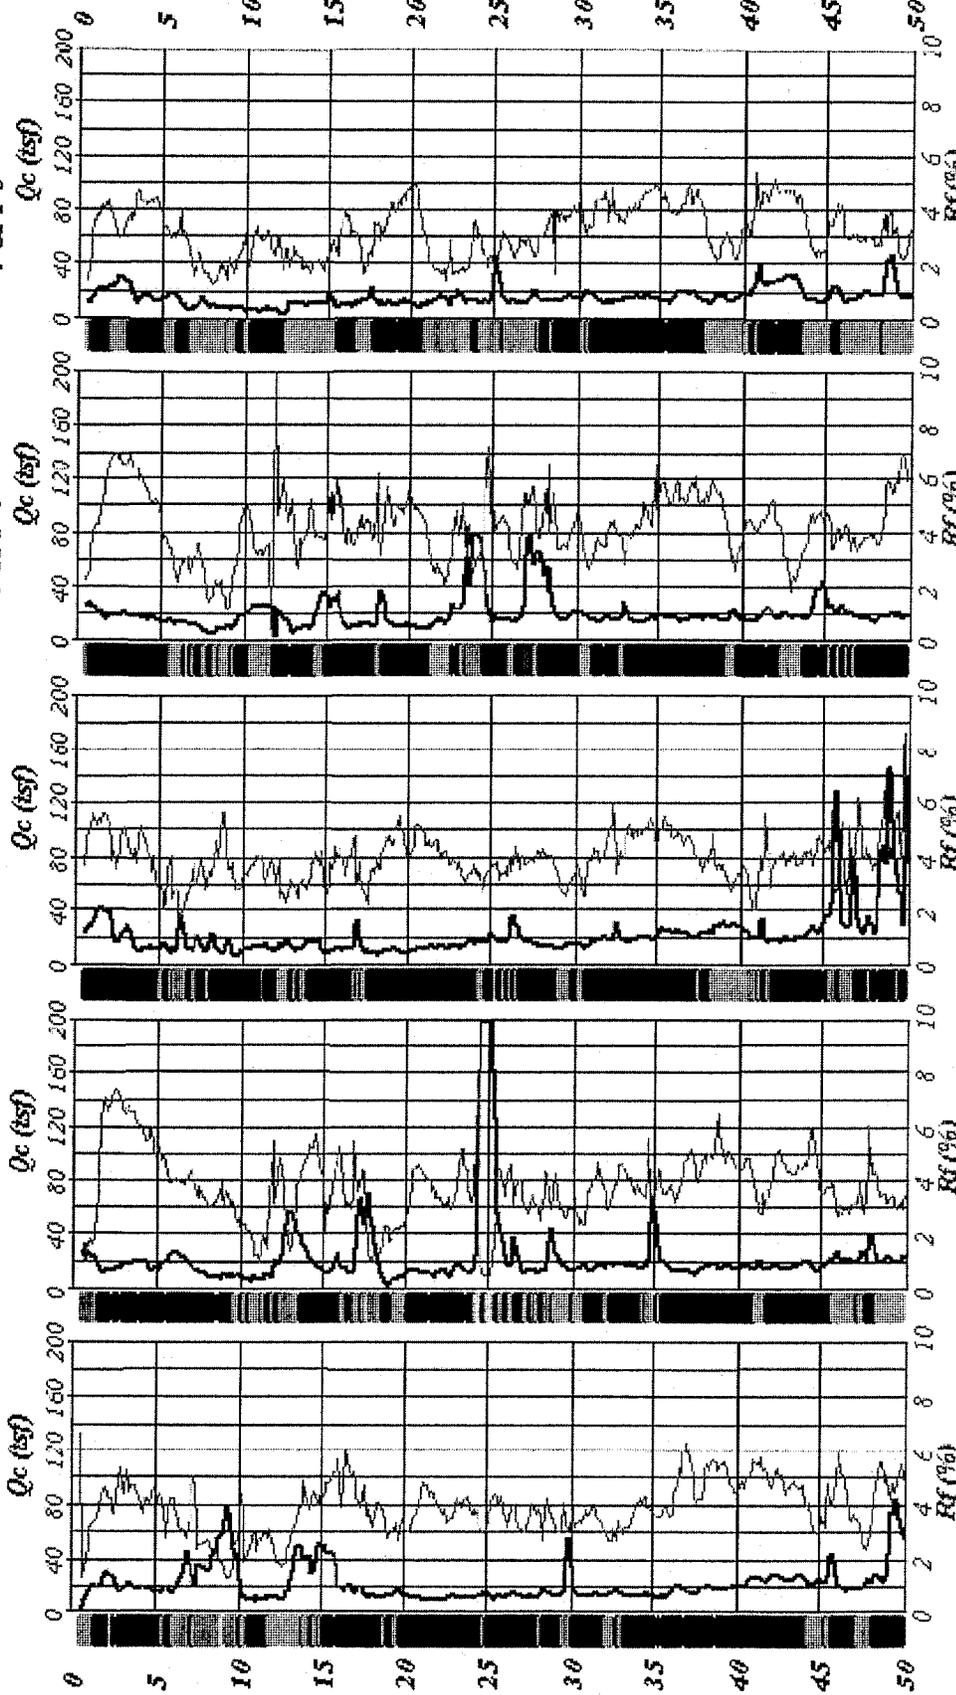
PROJECT: Arcadia - Quimby Rd./Capitol Ex : CPT-7 : LOCATION: San Jose CA
: CPT-6 : CPT-3

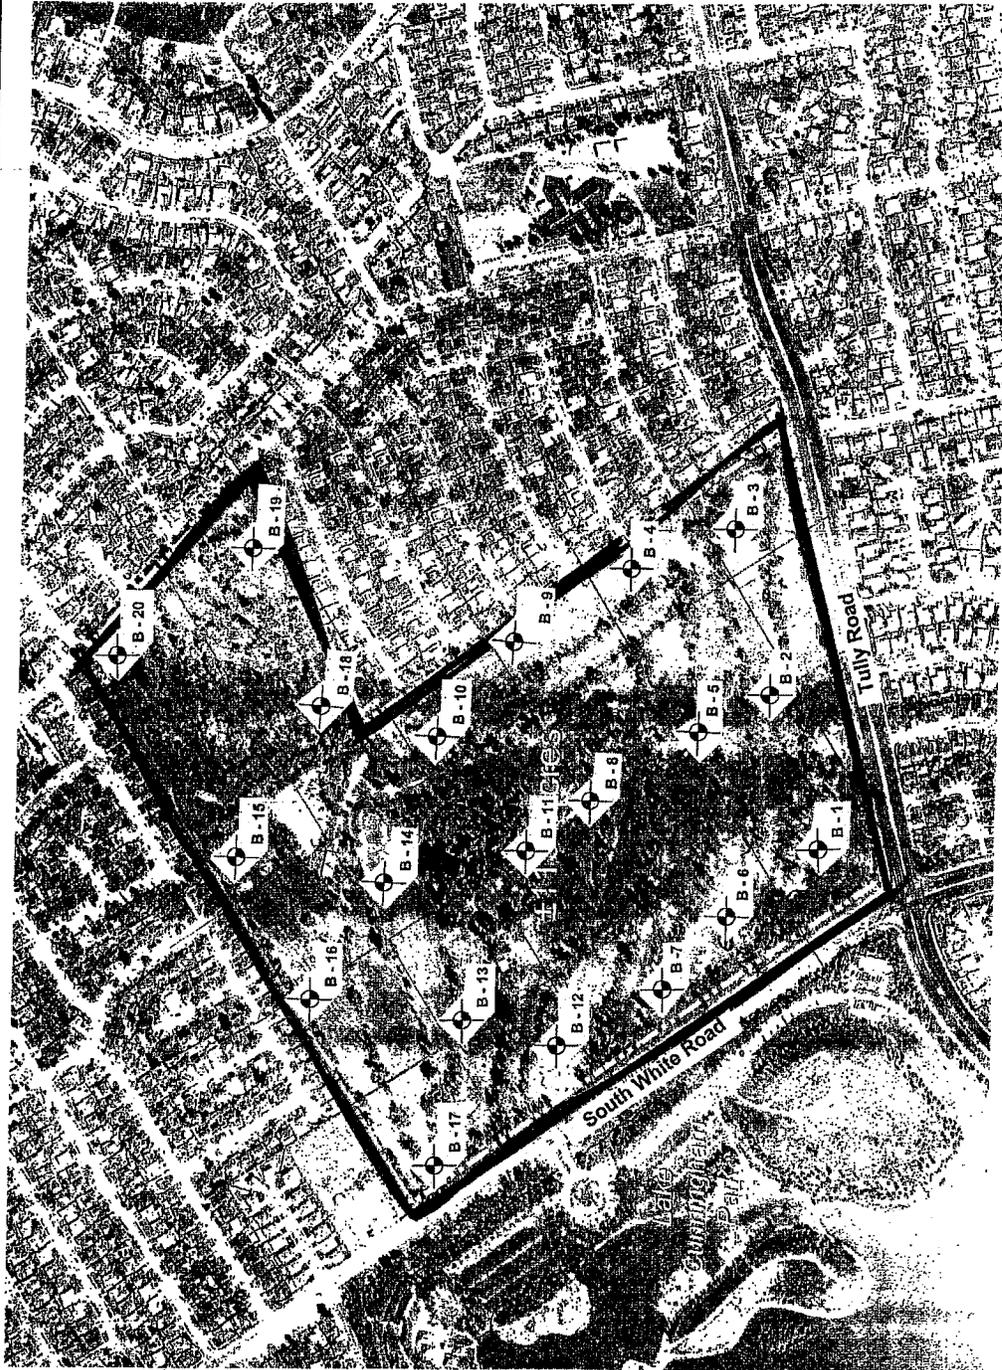
Boring Location (Typical 20)

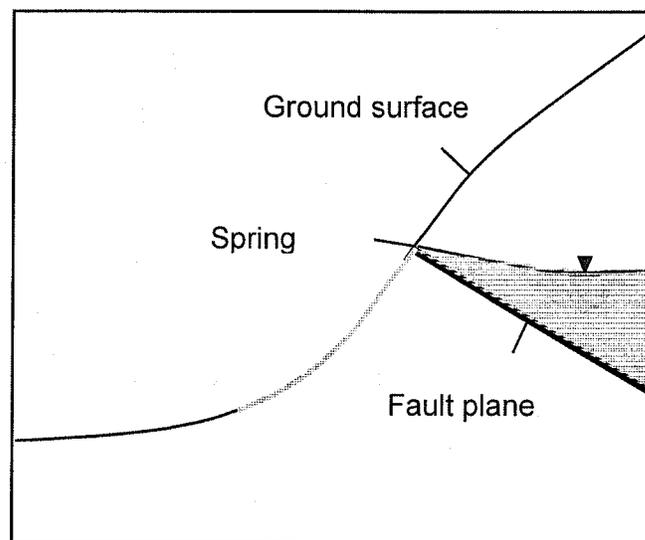
Diagrammatic cross section through a spring

Field mapping carried out during this investigation revealed springs on the slope east of Evergreen I. Springs can be associated with fault traces where the fault plane acts as a groundwater barrier and causes groundwater to flow to the surface as shown on the diagram below.

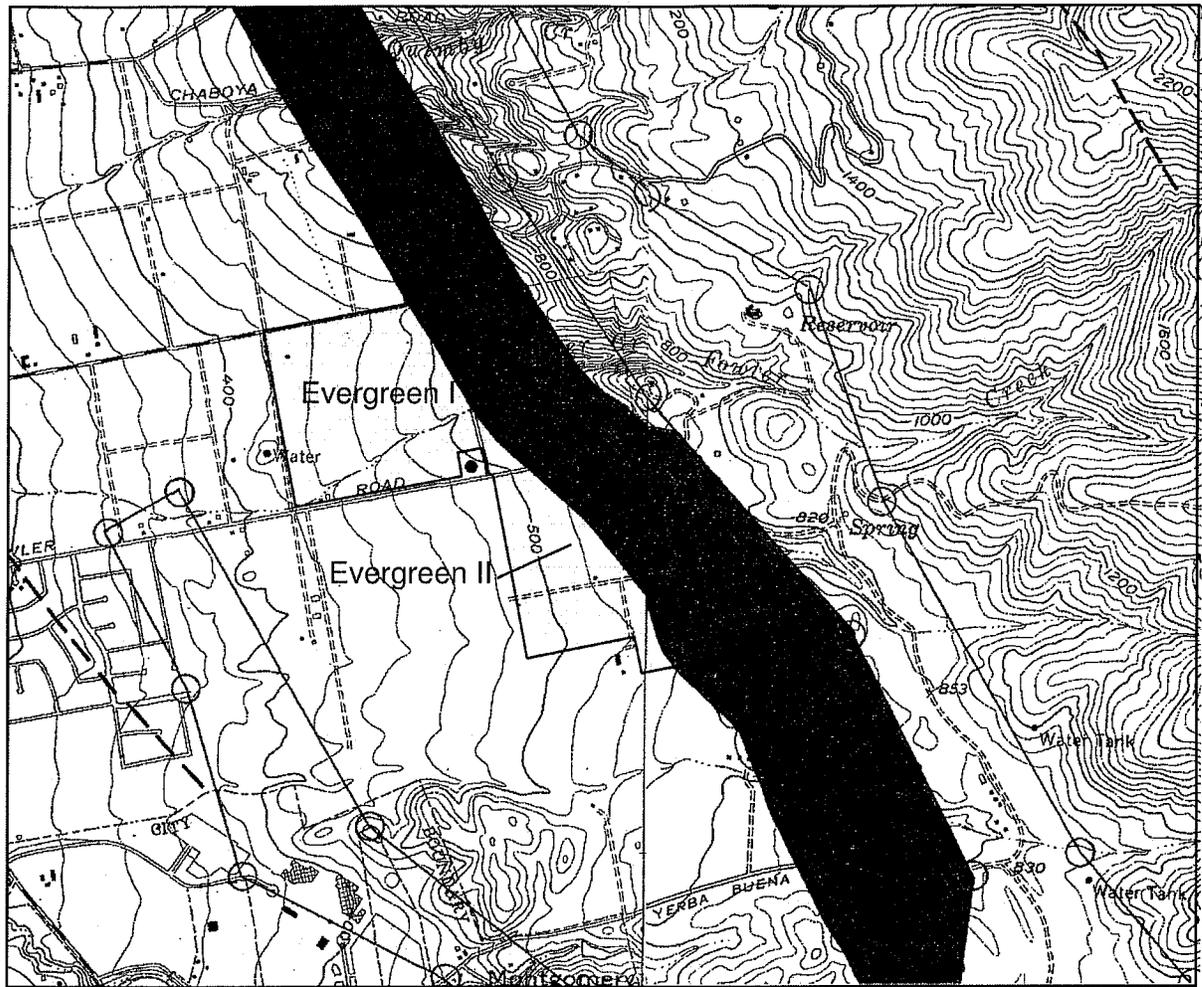
Evergreen fault zone

City of San Jose Special Studies Zone

KLEINFELDER 1362 Ridder Park Drive San José, California 95131 Ph. (408) 436-1155 Fax. (408) 436-1771		City of San Jose Special Studies Zone Evergreen I and II Fowler and Yerba Buena Roads San Jose, California	PLATE 5
Compiled by: P. Holland Reviewed by: M. Clark	Date: 10/18/04 Revision date:	PROJECT NO.: 49205/flt

As shown on Plate 5, the City of San Jose designates the eastern margin of the two properties to be in a Seismic Hazard Zone according to the City's Fault Hazard map (1983). The proposed scope and the results of our study were discussed with Mr. Michael Shimamoto, geologist for the Department of Public Works, City of San Jose. The City's letter dated February 8, 1996 to

the State of California to be an active source of ground rupture (California Earthquake Fault Zones, Plate 6) but not an active seismic shaking source by the UBC (2001) and is included on the City of San Jose Fault Hazard Map. A portion of the 1983 City of San Jose Special Study Zones Map is shown on Plate 5. The San Jose Special Study Zones Map indicates that the eastern portions of Evergreen I and II are within the City's "Special Studies Zones." With regard to the City's Fault Hazard Map, comprehensive geologic studies are required for sites within the Special Studies Zones (such as for the Quimby, Silver Creek, Calaveras, San Andreas faults).

The Evergreen area of the San Francisco bay area is a region of complex, interlacing faults along the western front of the Diablo Range near the south end of the Hayward fault. According to the 1983 City of San Jose Special Studies Zones Map (Plate 5), the eastern portions of the project sites are within a potential fault hazard zone. The City's zone is based on the possible presence of the Quimby fault located on the hillside to the east of the project sites. The Quimby fault is not within a State Earthquake Fault Zone (Plate 6), since it does not meet the California Division of Mines and Geology criteria of "sufficiently active" or "well-defined" (Hart and Bryant, 1999). However, the City's 1983 map shows the Quimby designated as a "special studies zone," and requires a fault investigation similar to that for development in a State mandated special studies zone. The Quimby fault shown on Dibblee's geologic map of the San Jose East Quadrangle (1972) indicates the fault lies at the base of the steep slope just east of the Evergreen I and II properties. This fault trend is included on the 1974 Regional Geologic Map by Cooper-Clark & Associates prepared for the City of San Jose as a planning document for San Jose's Sphere of Influence.

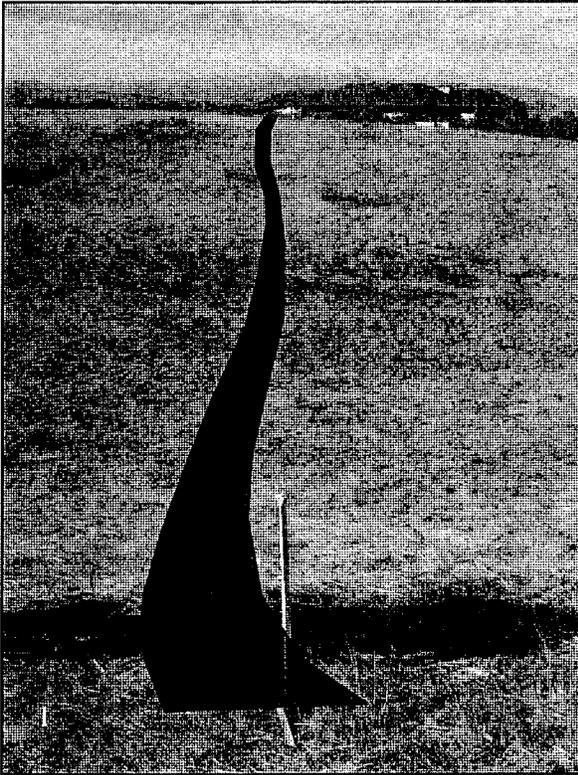
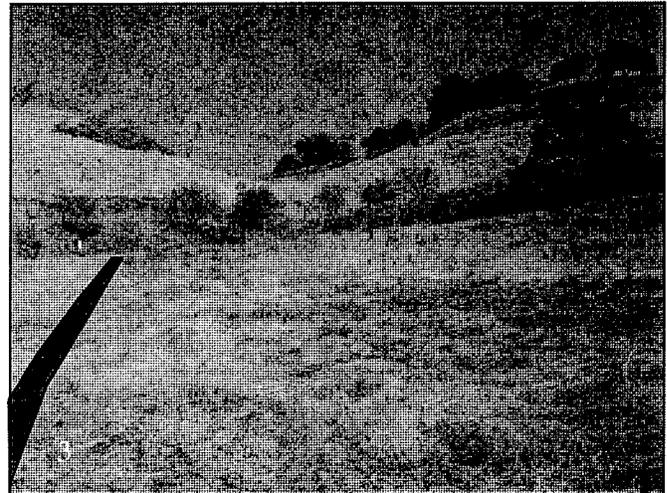
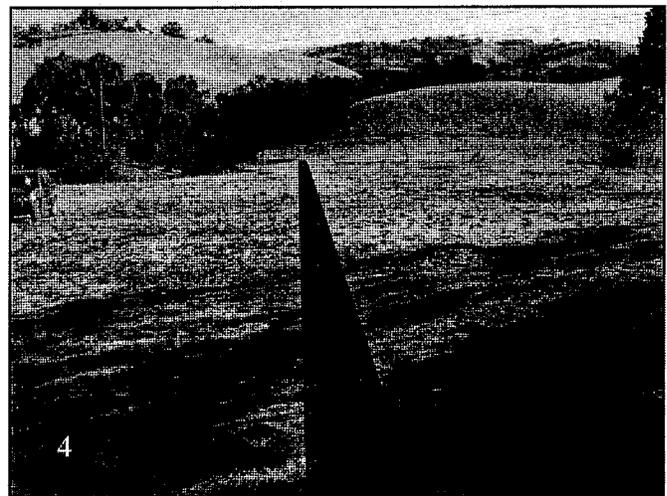
- 1 Evergreen II - Approximate location of Trench KA-T-1, looking southwest from east end of trench.
- 2 Evergreen II - Approximate location of Trench KA-T-2, looking southeast from above trench location.
- 3 Evergreen II - Approximate location of Trench KA-T-3, looking northeast from near west end of trench.
- 4 Evergreen I - Approximate location of Trench KA-T-4, looking northeast from near the west end of the trench.

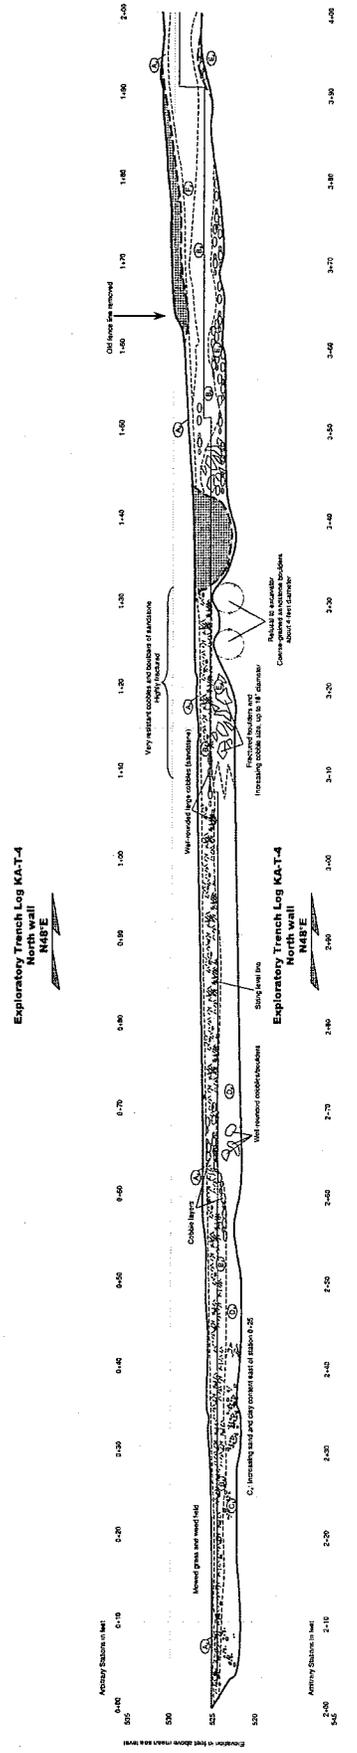
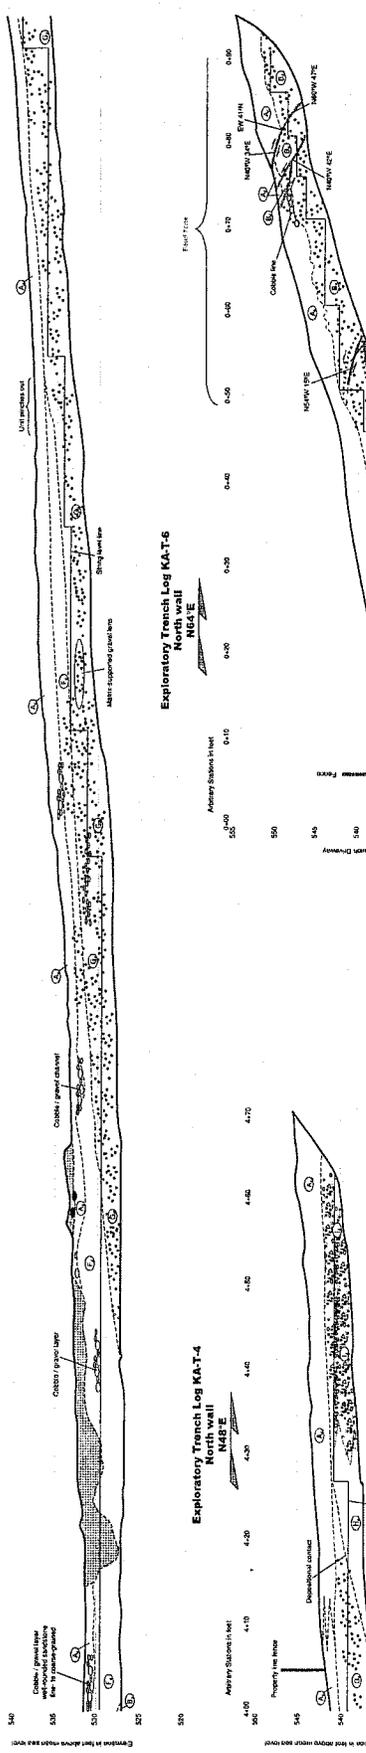
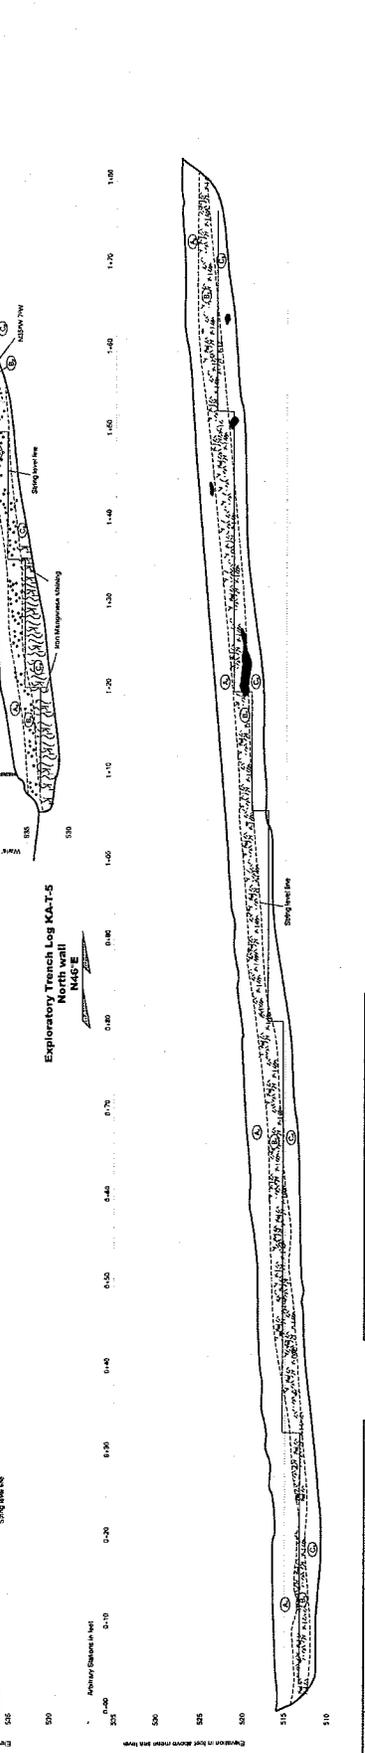
DATE: 11.04
SCALE: AS SHOWN
PLATE: 13 of 13

UNIT	DESCRIPTION TRENCH KA-T-5
(1)	Clayey silt (S1) clay brown, dry, hard, moderately compact (partial slip)
(2)	Claystone (S2) light brown, moderately weathered, weak, dry, clay part (1/2 to 2/3) claystone angular
(3)	Claystone (S3) wet brown, moderately weathered, no clay part, moderately strong to weak, contains rounded manganese fragments and shelling

UNIT	DESCRIPTION TRENCH KA-T-4 and KA-T-6
(1)	Clayey silt (S1) clay brown, dry, hard, moderately compact (partial slip)
(2)	Claystone (S2) light brown, moderately weathered, weak, dry, clay part (1/2 to 2/3) claystone angular

Field exploration of the sites for the fault evaluation was performed from September 27, 2004 through October 6, 2004, and consisted of field geologic mapping and excavating and logging of six exploratory trenches totaling about 1,325 linear feet, the locations of which are shown on the Site Plans and Geologic Maps, Plates 3 and 4. The trenches were excavated with a track-mounted excavator and were logged by our engineering geologist. Kleinfelder personnel shored the trenches where they were deeper than five feet for safe entry. One trench wall was hand picked to allow for geologic mapping and observation. The other trench wall was picked clean where needed to verify localized geologic features. Logs of the trenches are presented on Plates 13 and 14.

Graphic illustrations of the trench logs and faults identified in the Kleinfelder trenches are depicted on the Exploratory Trench Logs, Plates 13 and 14. The trenches were laid out generally from northeast to southwest normal to regional faulting and folding to maximize exposure of faults. The trenches on the Berg & Berg Enterprises property were loosely backfilled by replacing the excavated soil with little or no compactive effort. During site grading, Kleinfelder's trenches as well as previous subsurface exploration points should be excavated and recompact.

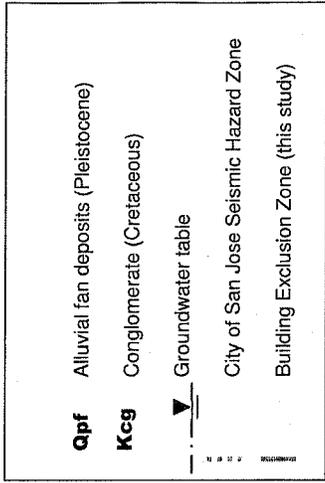
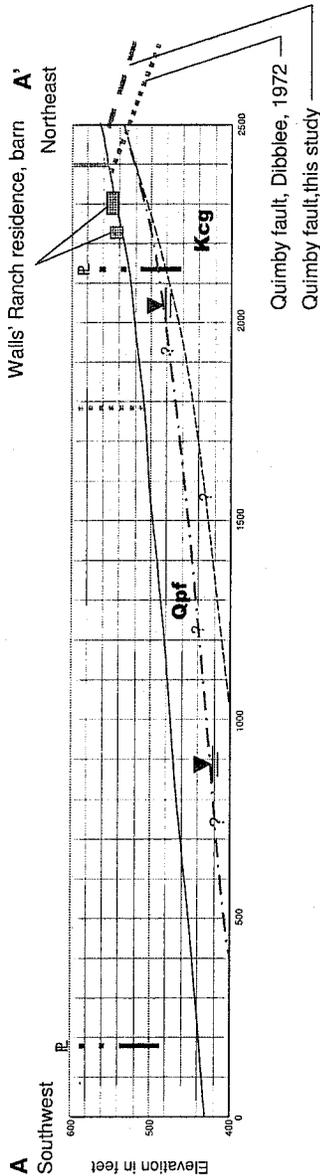
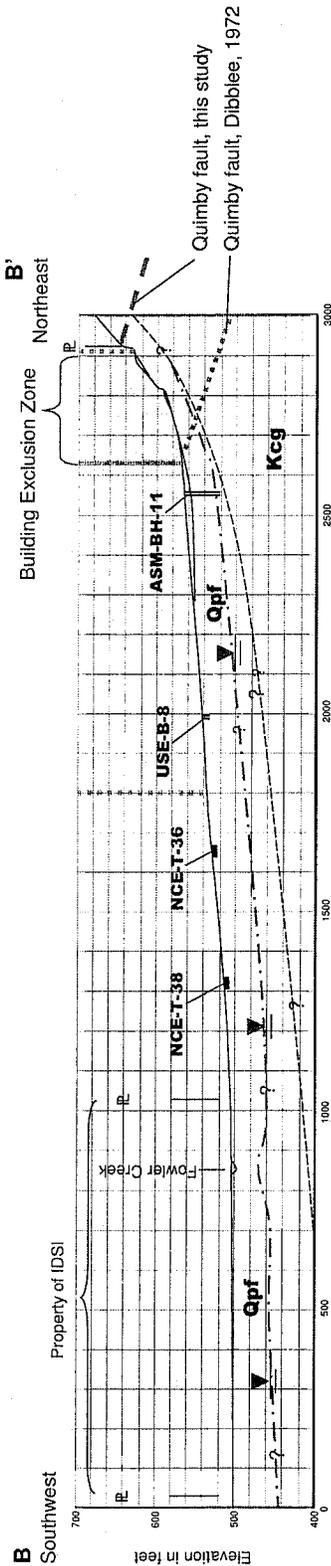
Geologic Cross Sections A - A' and B - B'

(9)	Clayey sandstone (S9) moderate to highly weathered, clay part (1/2 to 2/3) claystone angular
(10)	Clayey sandstone (S10) moderate to highly weathered, clay part (1/2 to 2/3) claystone angular

Vertical exaggeration = 2X horizontal
 Lines of sections are shown on Plates 3 and 4

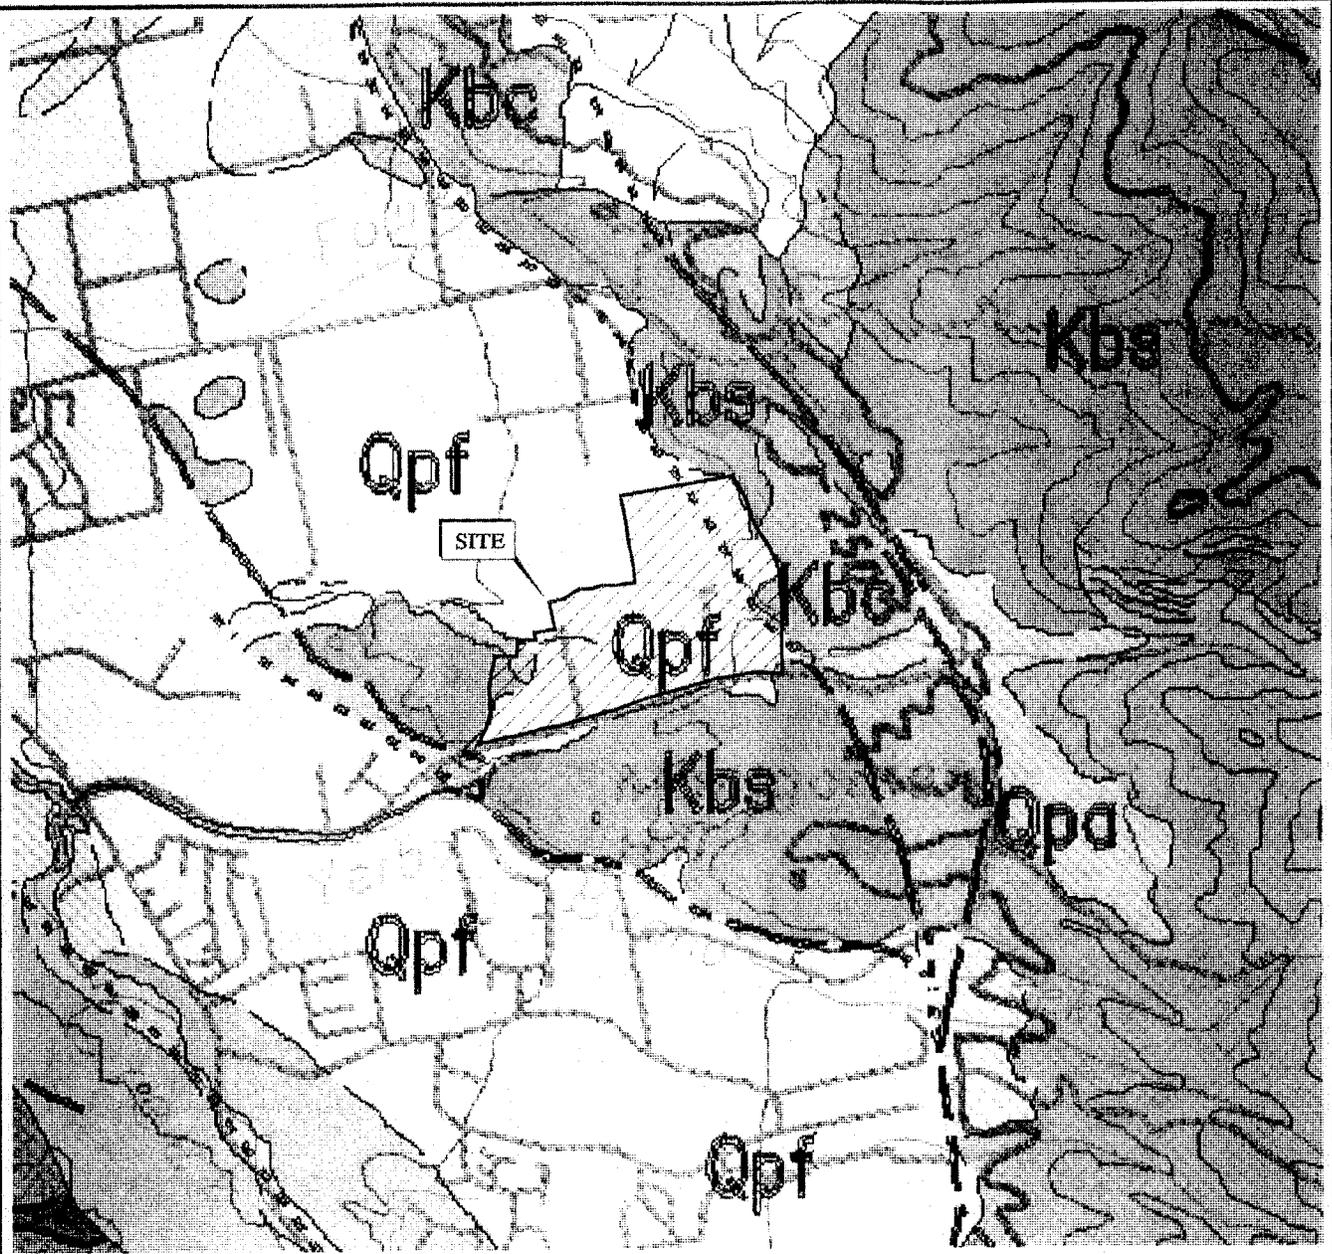
EXPLANATION

- Qpa** ALLUVIUM (UPPER PLEISTOCENE)
- Qpf** ALLUVIAL FAN DEPOSITS (UPPER PLEISTOCENE)
- Kbs** BARRYESSA FORMATION (CRETACEOUS)
SANDSTONE AND MUDSTONE
- Kbc** BARRYESSA FORMATION (CRETACEOUS)
CONGLOMERATE

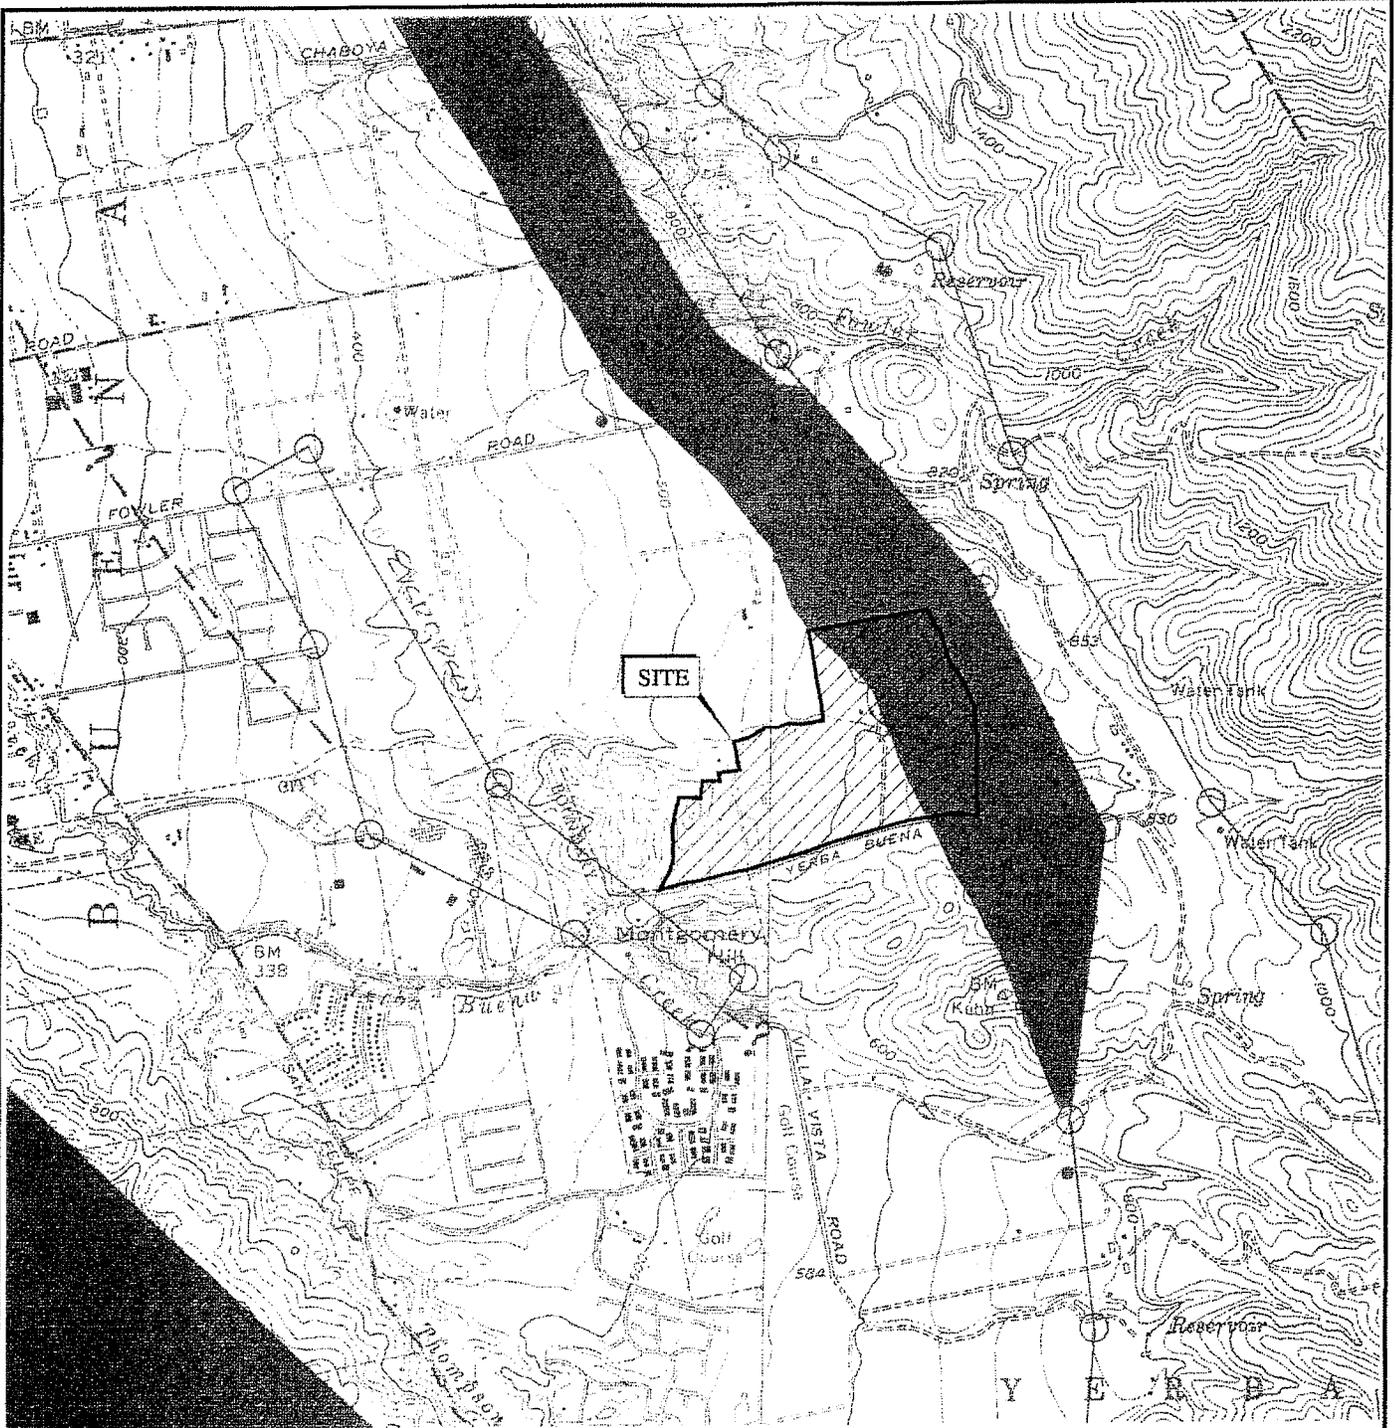
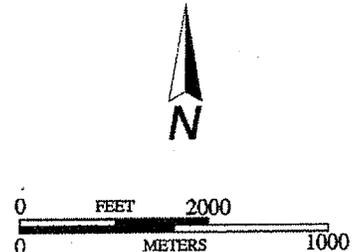
PROJECT NO.: 5056.3.500.01	FIGURE NO. 4
DATE: JULY 2004	
DRAWN BY: CLL CHECKED BY:

REPORTED FAULTS
QUERIED WHERE IN DOUBT

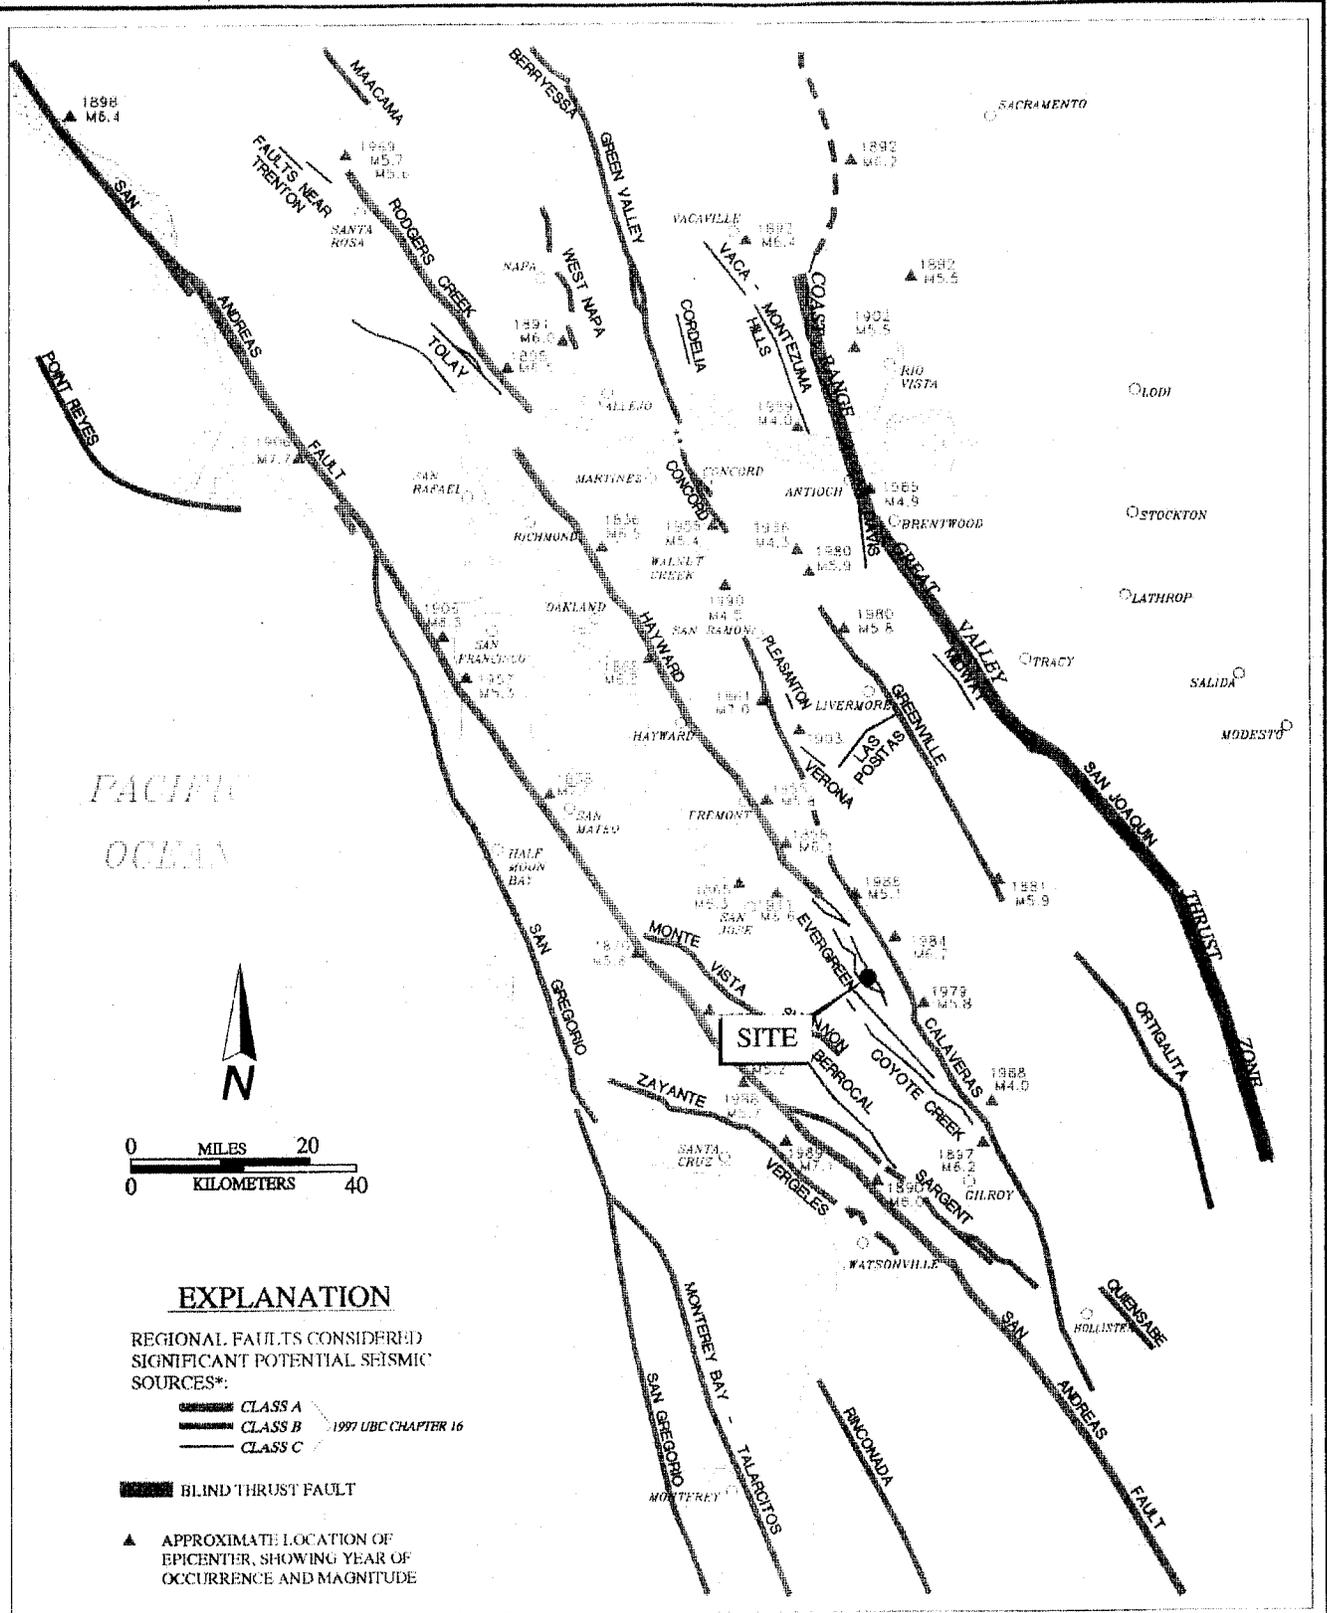
*BASED ON USGS OPEN FILE 96-706

The San Andreas Fault represents an active crustal plate boundary that is expected to produce the maximum probable earthquake for the region. Other active faults of coastal California are lesser-order features of the same stress-strain system. A Regional Faulting and Seismicity Map is presented on Figure 5 that shows the approximate location of major active faults and significant historic earthquakes with respect to the site.

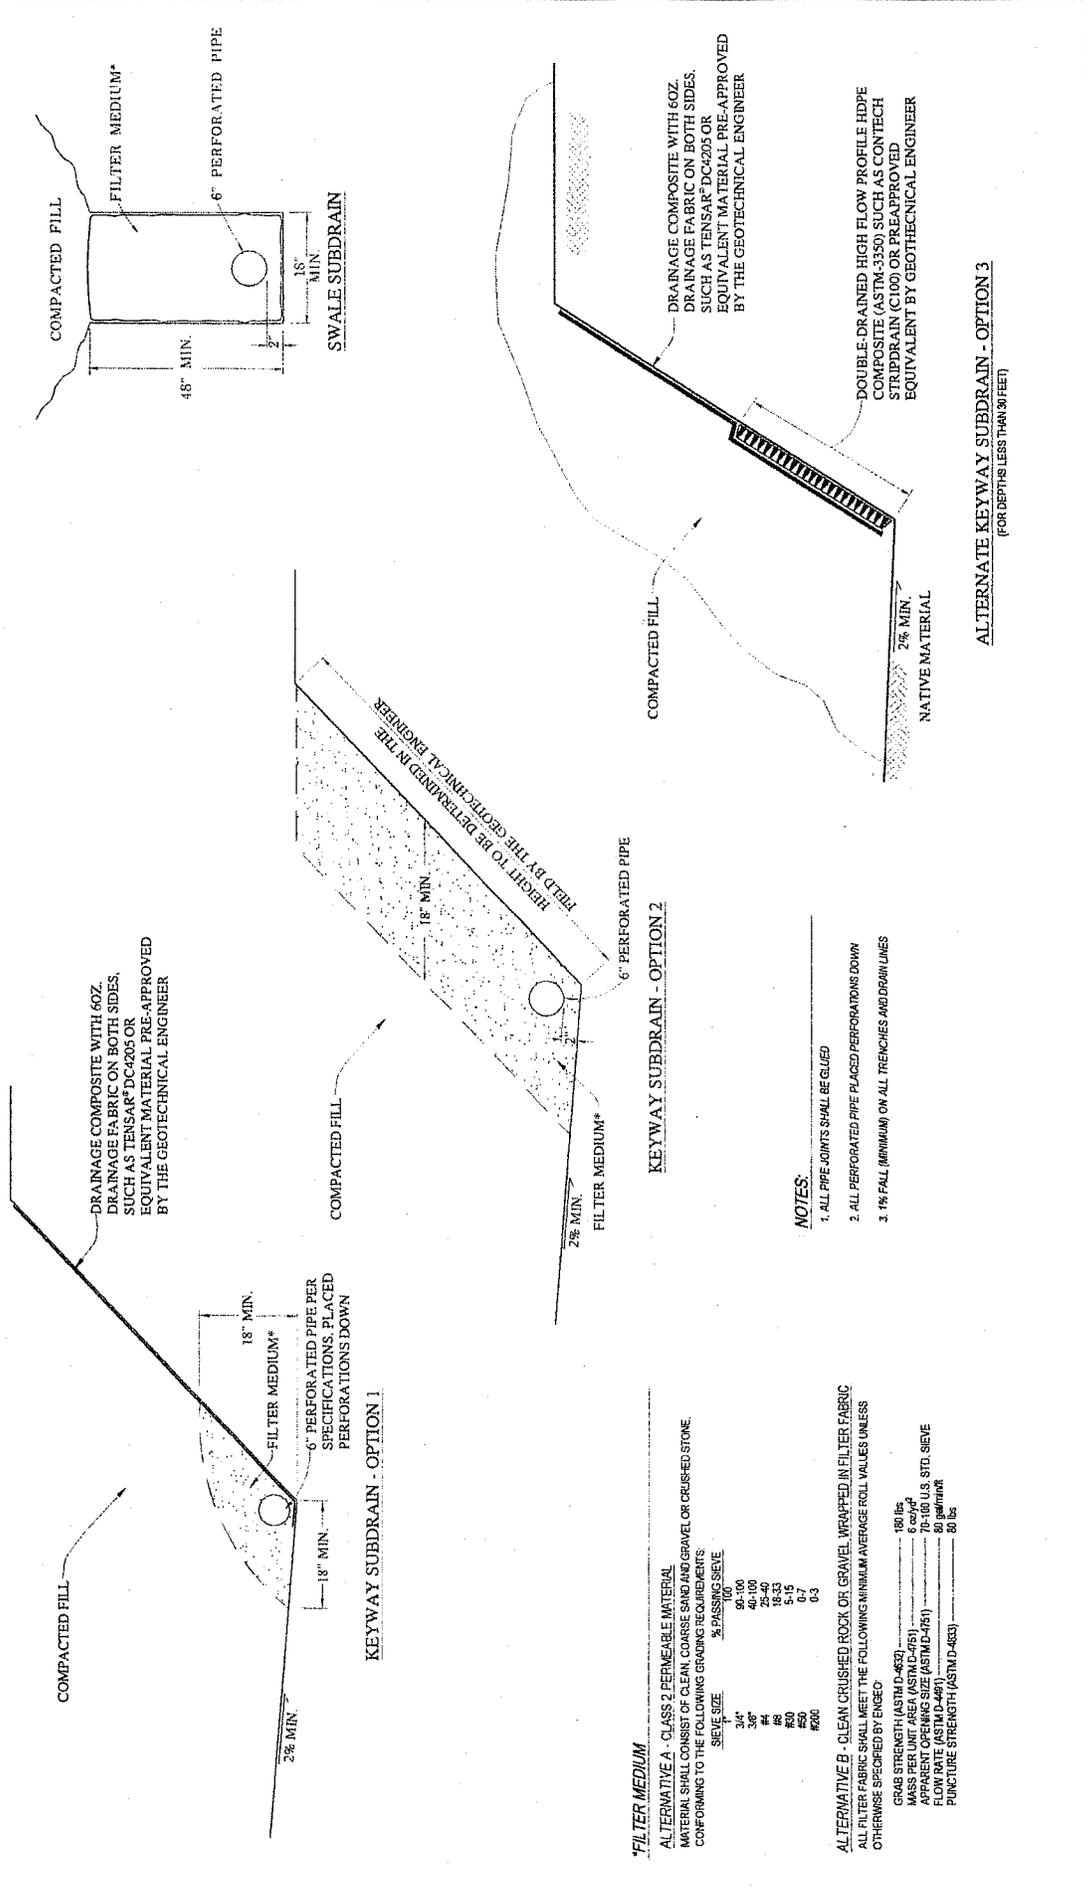
NO SCALE
FIGURE NO. **7**

***FILTER MEDIUM**

ALTERNATIVE A - CLASS 2 PERMEABLE MATERIAL
 ALL FILTER FABRIC SHALL CONSIST OF CLEAN, COARSE SAND AND GRAVEL OR CRUSHED STONE, CONFORMING TO THE FOLLOWING GRADING REQUIREMENTS:

Drainage courses which are to be filled should be provided with adequate subsurface drainage prior to placement of any fill. Swales should be cleaned of soft or compressible material to a firm soil or rock base. A subdrain should then be installed through the center of the subexcavation (Figure 7). Desiccated, cracked surface clays and slumping soils located along the swale areas should be removed, and the slopes should be benched prior to the placement of fill. Actual limits of subexcavation should be determined in the field at the time of grading by the Geotechnical Engineer.

requirements contained in Section 2.05, Part I of the Guide Contract Specifications with their general placement guidelines presented on Figure 7. As an alternative, prefabricated geocomposite subdrain systems are also available in lieu of round subdrain pipe encapsulated in a granular medium. Approved alternative subdrain system products may be provided at your request.

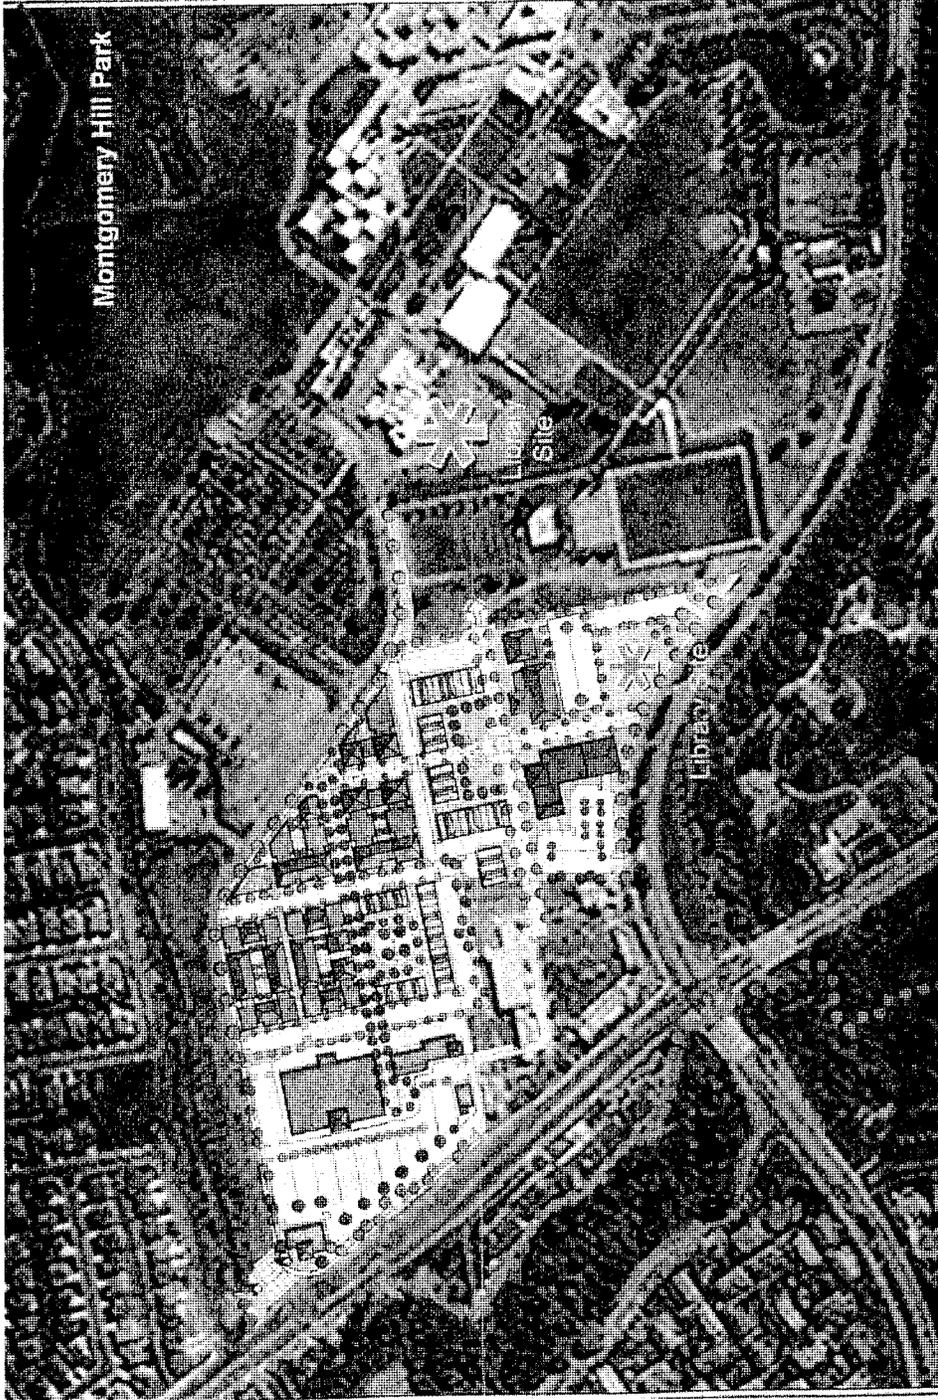
FIGURE 2
2100-1

SITE PLAN
EVERGREEN COMMUNITY COLLEGE
FEASIBILITY REVIEW
San Jose, California
