Geologic and Geotechnical Hazards Investigation

Type of Services	Geologic and Geotechnical Hazards Investigation
Project Name	Communications Hill – Phase 2
Location	Communications Hill Boulevard San Jose, California
Client	David J. Powers & Associates, Inc.
Client Address	1871 The Alameda, Suite 200 San Jose, CA 95126
Project Number	118-38-1
Date	April 21, 2014

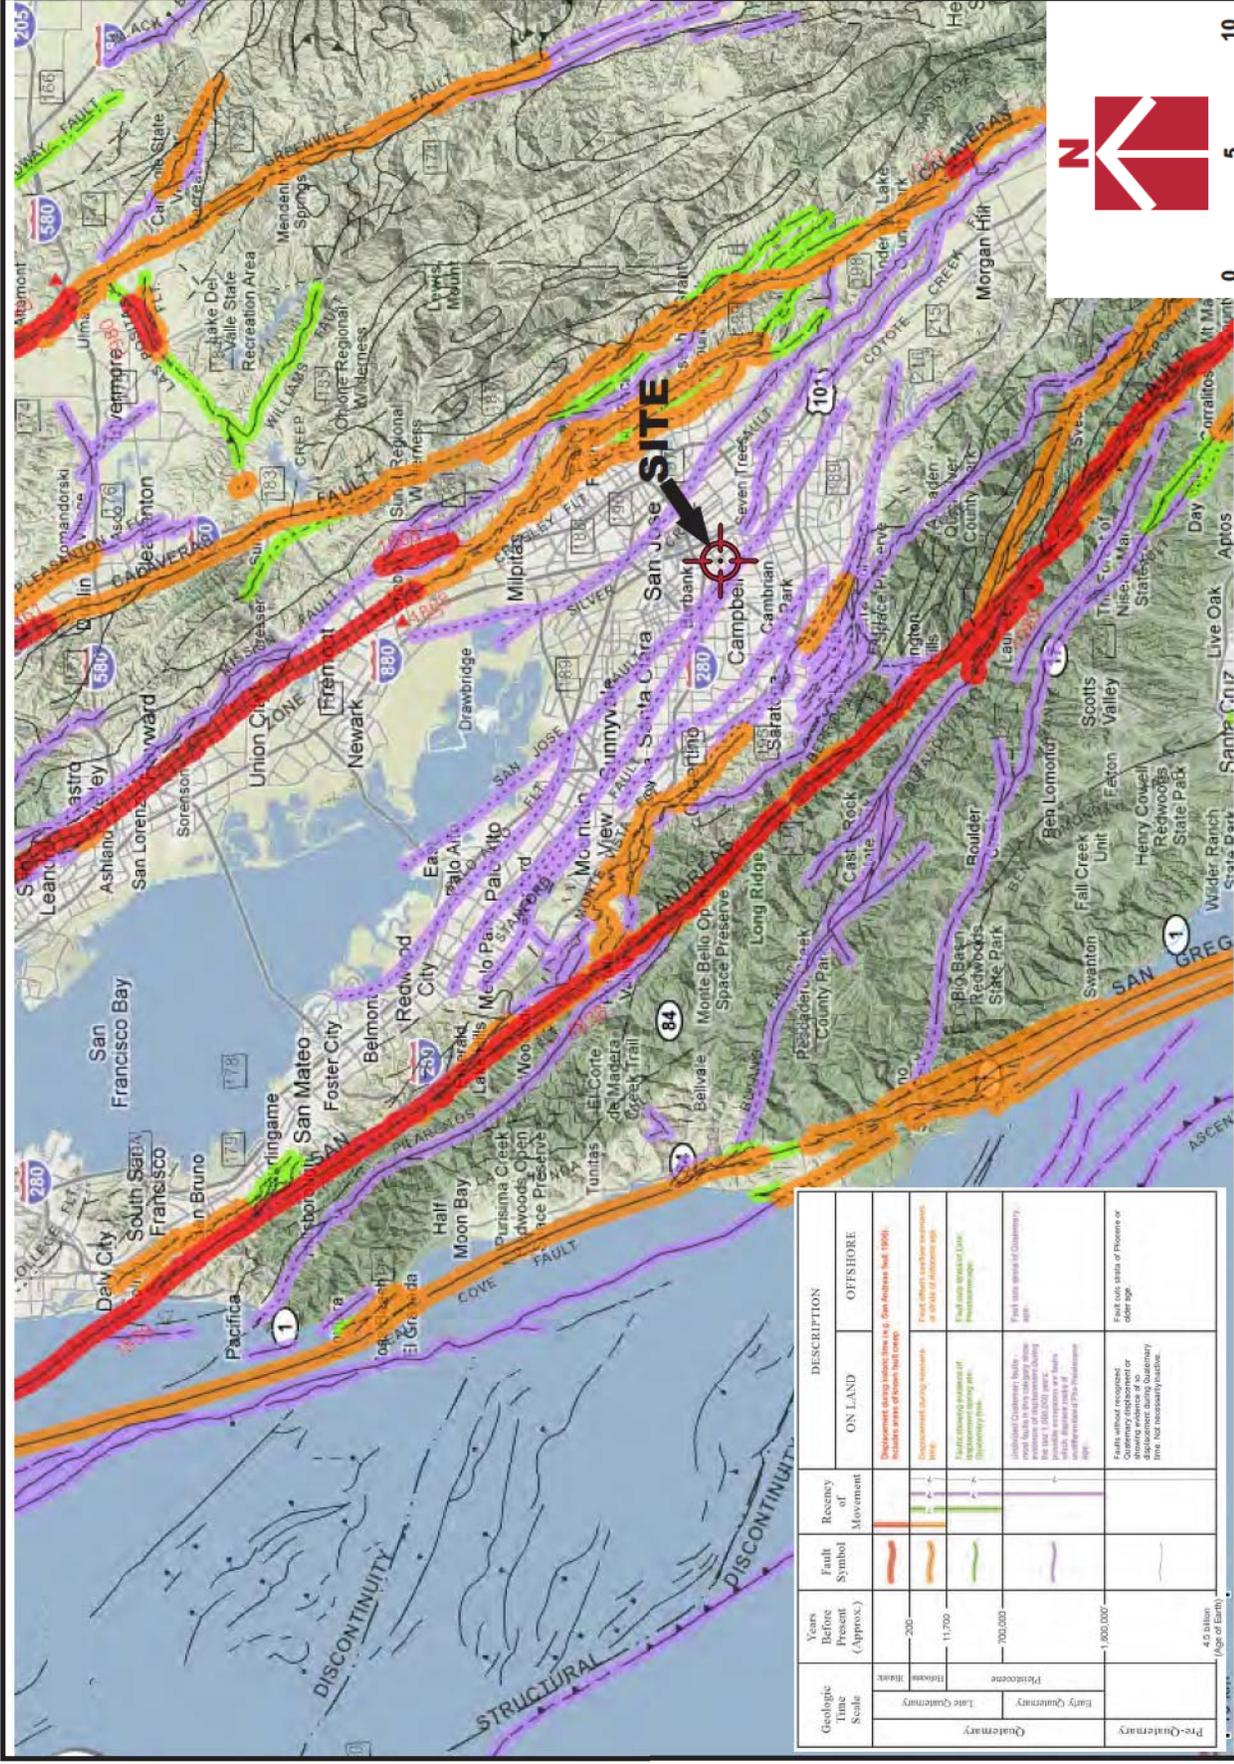
Geologic Time Scale	Years Before Present (Approx.)	Fault Symbol	Recentcy of Movement	DESCRIPTION	
				ON LAND	OFFSHORE
Quaternary	Recent	[Red line]	Active	Deposited during Holocene time (i.e. San Andreas fault, 1906). Includes areas of known fault creep.	Fault activity that has occurred or is likely to occur in the past 10,000 years.
	Late Quaternary	[Orange line]	Active	Deposited during Pleistocene time.	Fault along which evidence of recent faulting is present (including the last 100,000 years). Includes some exceptions for faults undisturbed by Pleistocene time.
Pre-Quaternary	Early Quaternary	[Green line]	Active	Deposited during Pleistocene time.	Fault with some evidence of Quaternary activity.
	1,000,000	[Purple line]	Active	Deposited during Pleistocene time.	Fault with some evidence of Quaternary activity.

Base by California Geological Survey - 2010 Fault Activity Map of California (Jennings and Bryant, 2010)

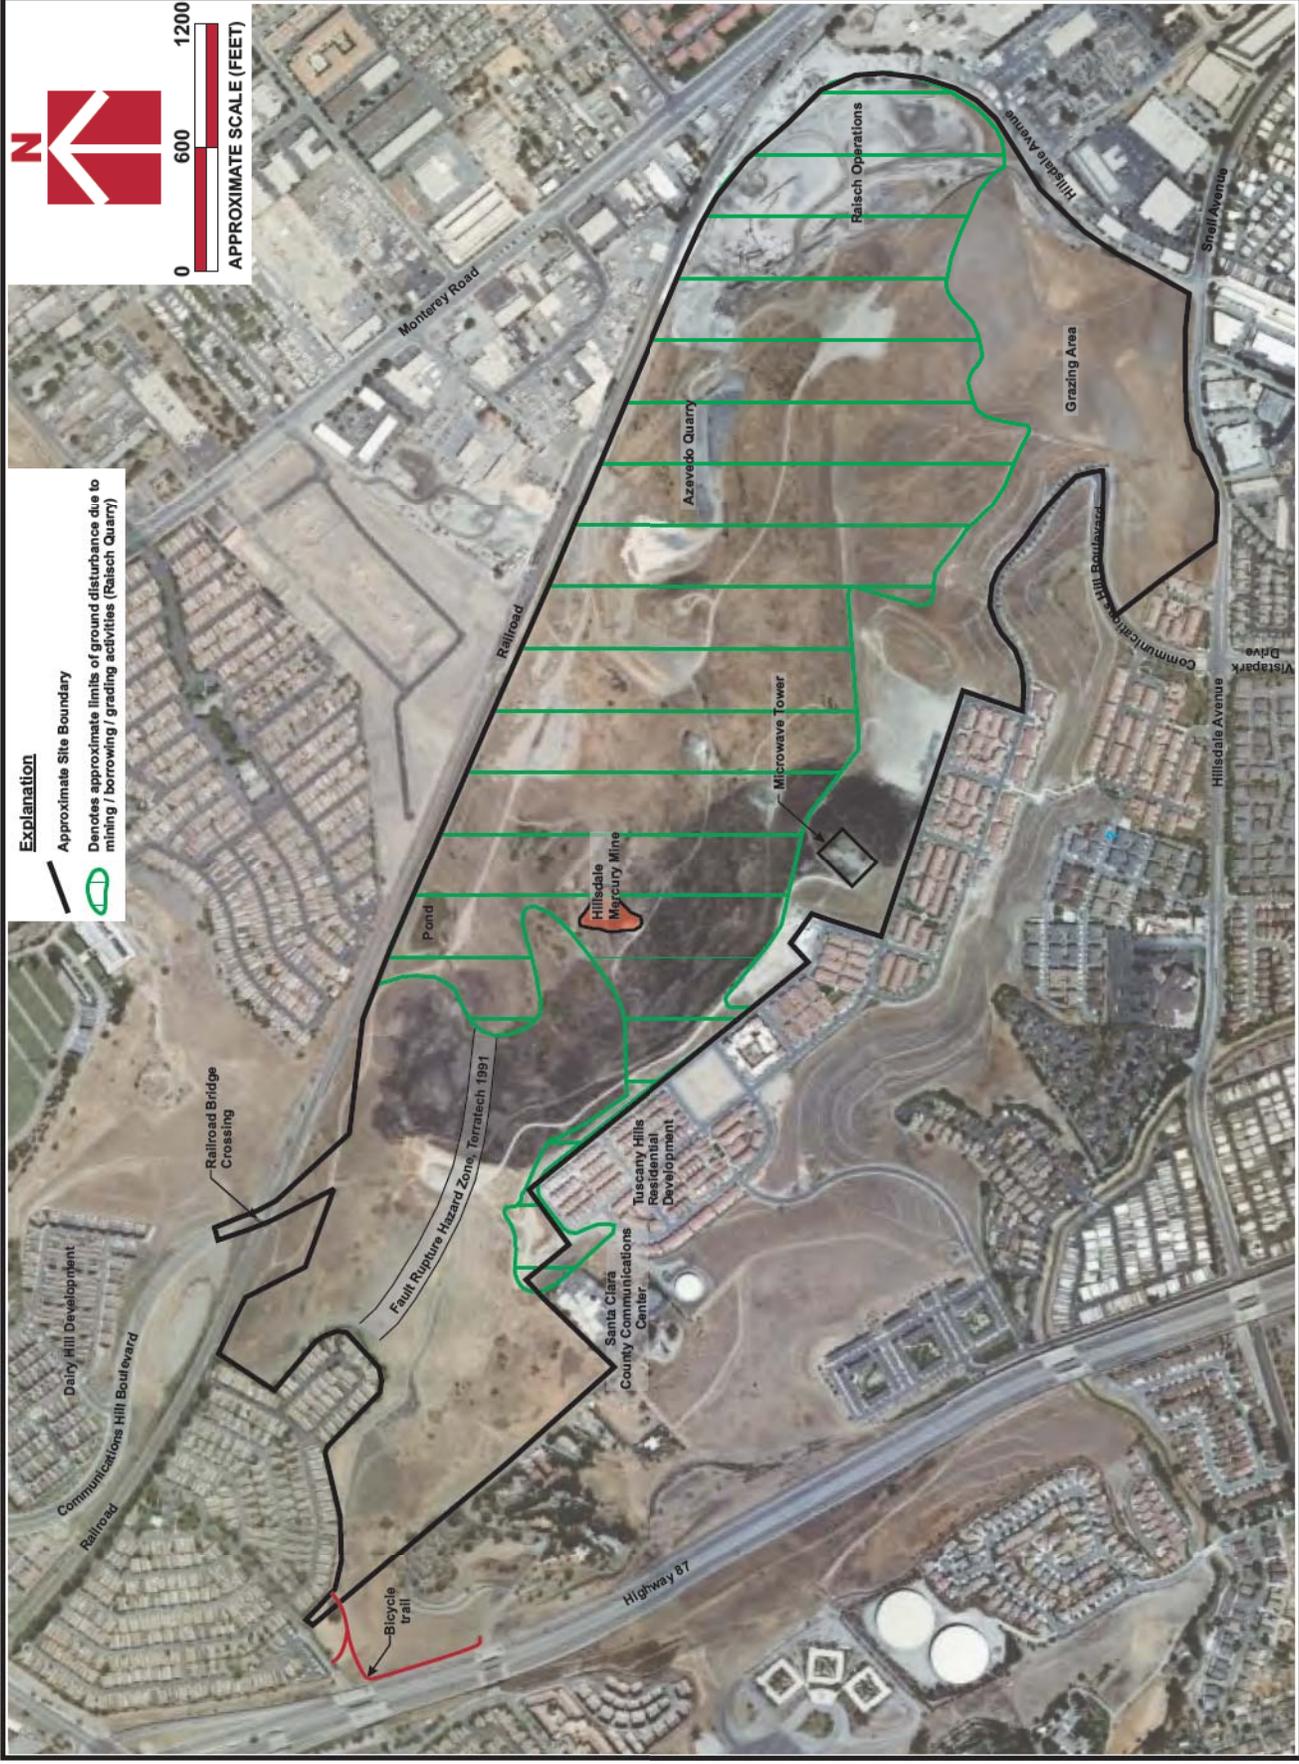
Aerial View of Site

- Approximate Site Boundary
- Denotes approximate limits of ground disturbance due to mining / borrowing / grading activities (Faisch Quarry)

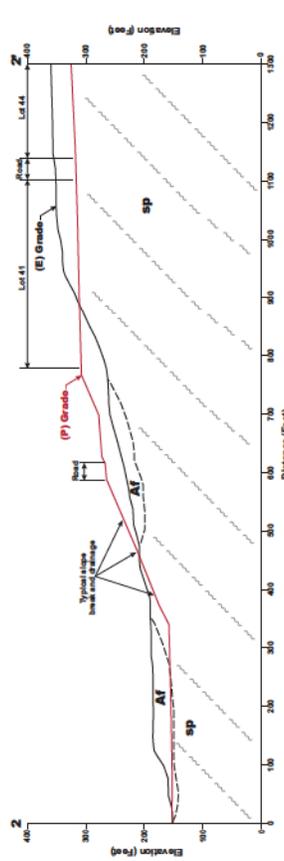
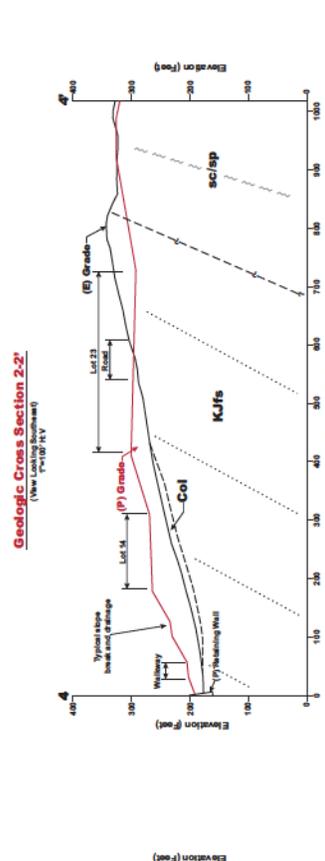
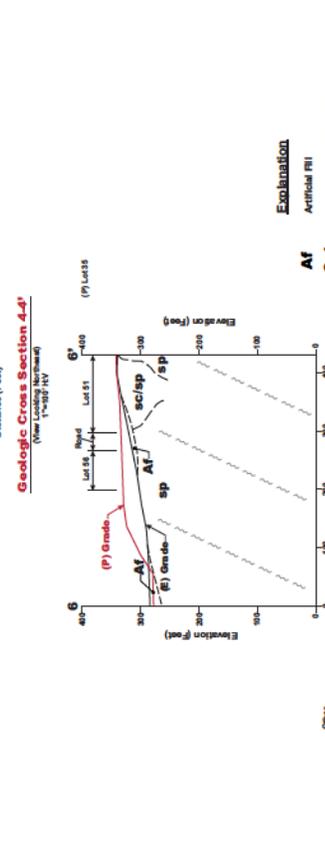
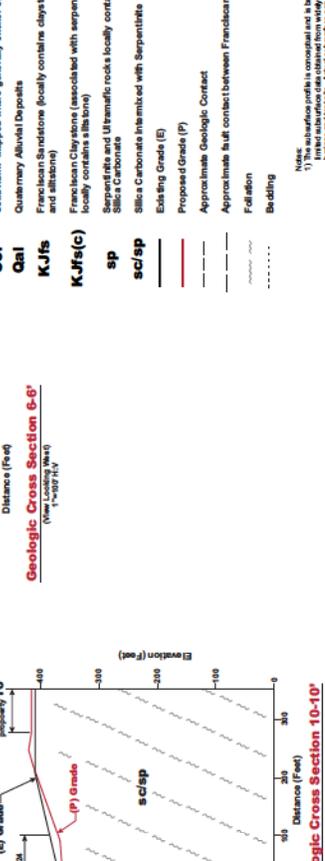
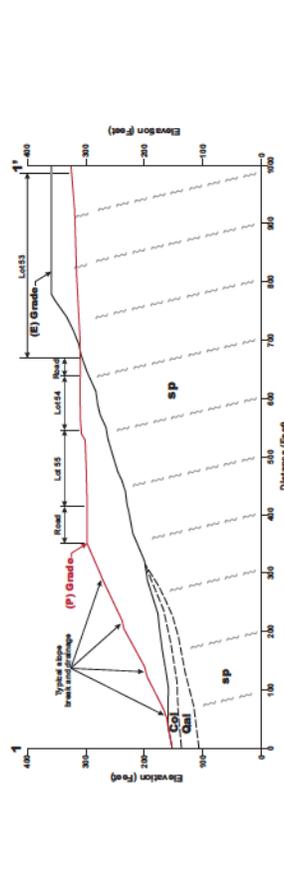
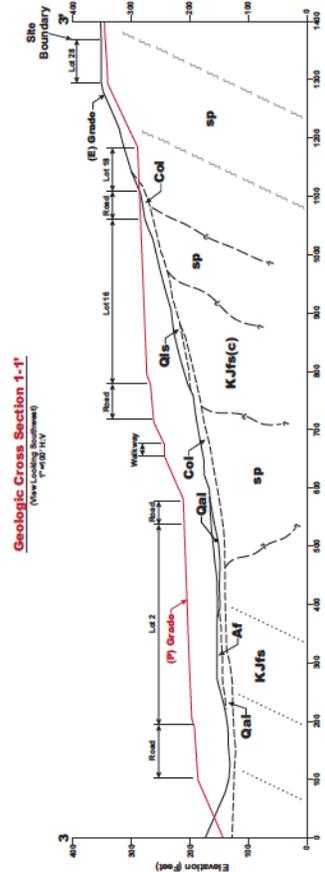
Geologic Cross Sections 1'-1' to 7'-7' and 10'-10'
 Communications Hill - Phase 2
 San Jose, CA

Artificial Fill	Colium: Mapped where generally thicker than 3'
Col	Quaternary Alluvial Deposits
Col	Franciscan Sandstone (locally contains claystone and siltstone)
KJfs	Franciscan Claystone (associated with serpentinite, locally contains siltstone)
KJfs(c)	Serpentinite and Ultramafic rocks locally contains Silica Carbonate
sp	Silica Carbonate interbedded with Serpentinite
sc/sp	Existing Grade (E)
sc/sp	Proposed Grade (P)
—	Approximate Geologic Contact
- - -	Approximate is alt contact between Franciscan units
.....	Fallition
.....	Bedding

Notes:
 1) The elevation profile is conceptual and is based on limited subsurface data obtained from nearby parcels.
 2) See Figure 2 for location of cross-sections.

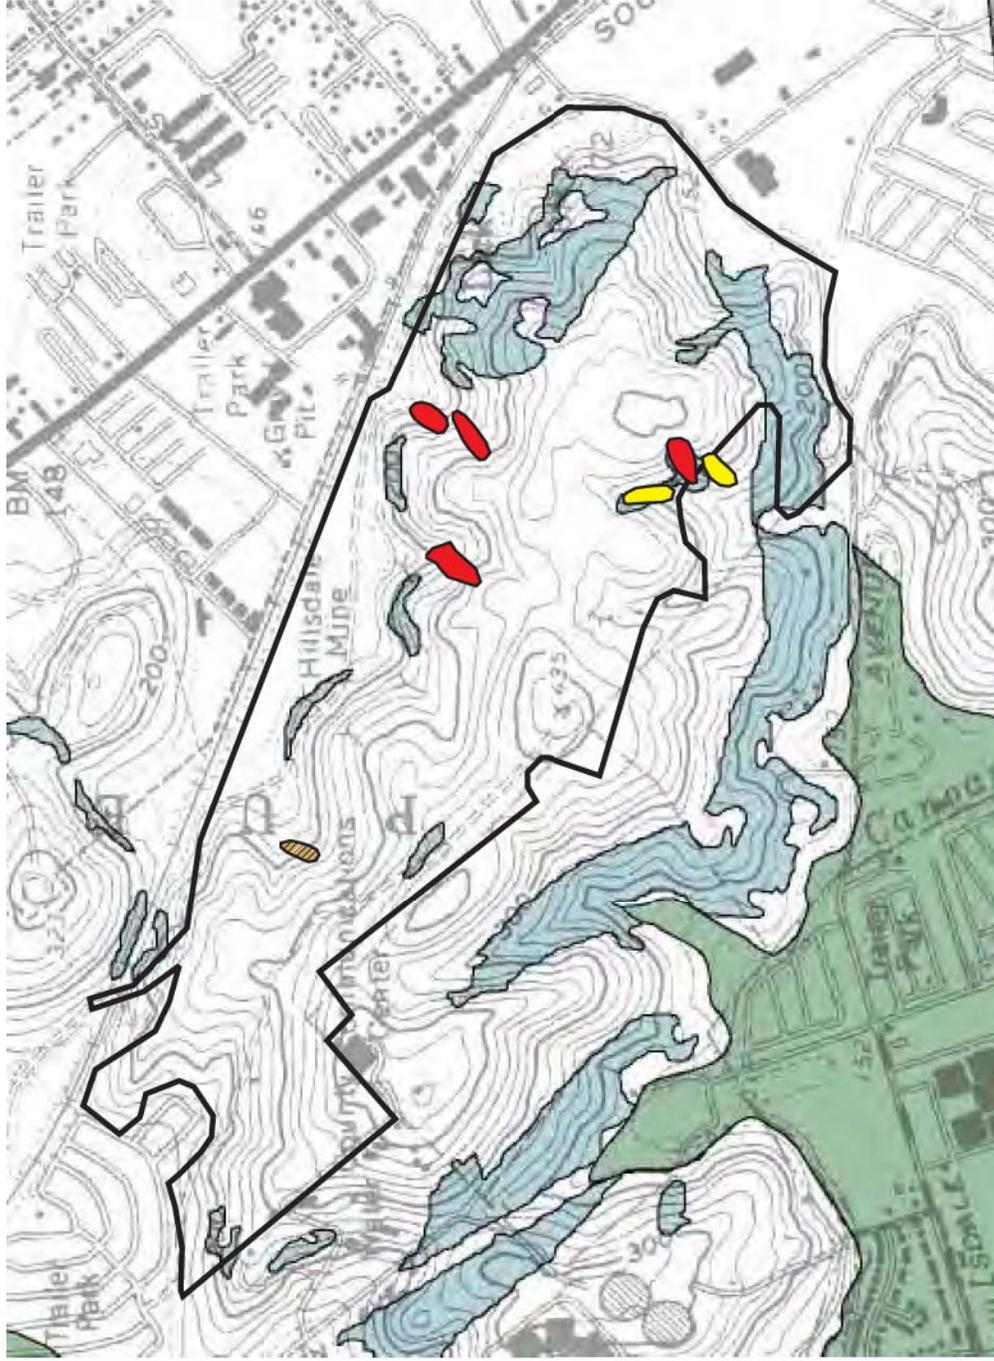
STATE OF CALIFORNIA
SEISMIC HAZARD ZONES
OFFICIAL MAP
Released: January 17, 2001

Areas where historic occurrence of liquefaction, or local geological, geotechnical and groundwater conditions indicate a potential for permanent ground displacements such that mitigation as defined in Public Resources Code Section 2693(c) would be required.

Areas where previous occurrence of landslide movement, or local topographic, geological, geotechnical and subsurface water conditions indicate a potential for permanent ground displacements such that mitigation as defined in Public Resources Code Section 2693(c) would be required.

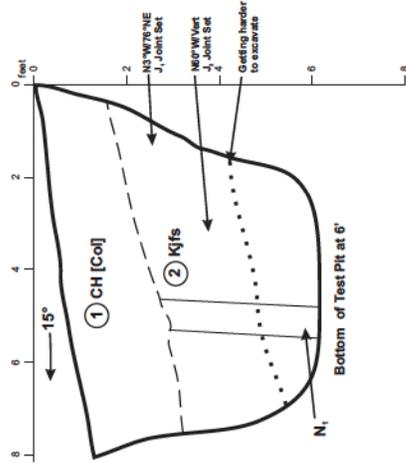
TP-1

- 1 Fat Clay (CH) [Colluvium]
moist, dark gray-brown; some gravel, blocky structure, expansion cracks to 1" wide, high plasticity
 - 2 Franciscan Sandstone [KJfs]
hard, moderately strong, moist, light olive brown to gray, moderate weathering, closely fractured; massive, contains interbedded shale
The N60°W joint set is very prominent.
- Notes:
J₁ is semicontinuous.
J₂ is discontinuous beyond 3 feet.
N₁ is a thin, siltstone bed with thin bedding (N76°W / 87°NE)

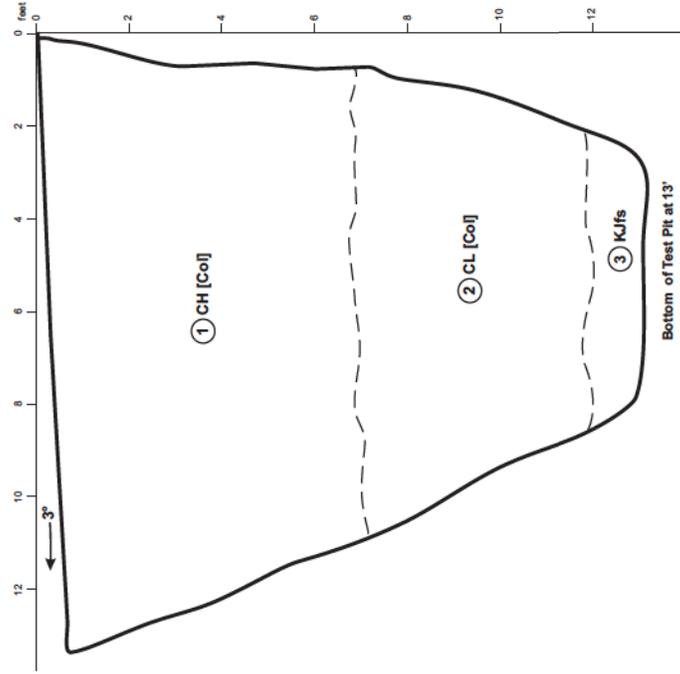
TP-2

- 1 Fat Clay (CH) [Colluvium]
moist, very dark gray-brown, some fine sand, trace fine subrounded gravel, moderate plasticity
- 2 Lean Clay with Sand (CL) [Colluvium]
moist, brown, fine sand, some fine to coarse gravel, some cobbles below 10', moderate plasticity
- 3 Franciscan Sandstone [KJfs]
moderately hard to hard (below 12'), weak to moderately strong, moist, olive, moderate weathering, moderate fracturing

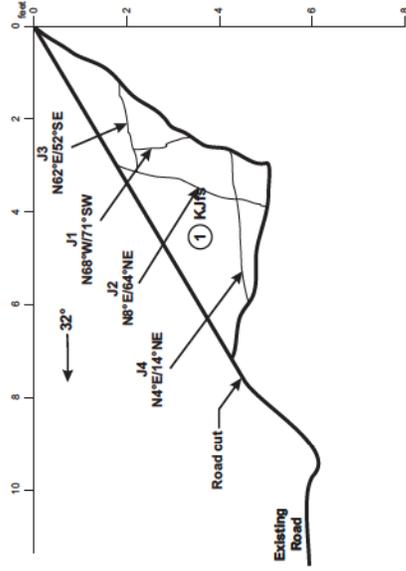
TP-3

- 1 Franciscan Sandstone [KJfs]
hard, moderately strong, moist, olive brown, moderate weathering, massive
- Notes:
J₁ = very prominent, continuous joint, rough surface
J₂ = semicontinuous joint
J₃ = semicontinuous joint
J₄ = semicontinuous joint

Notes: Test Pit was performed in existing road cut area.

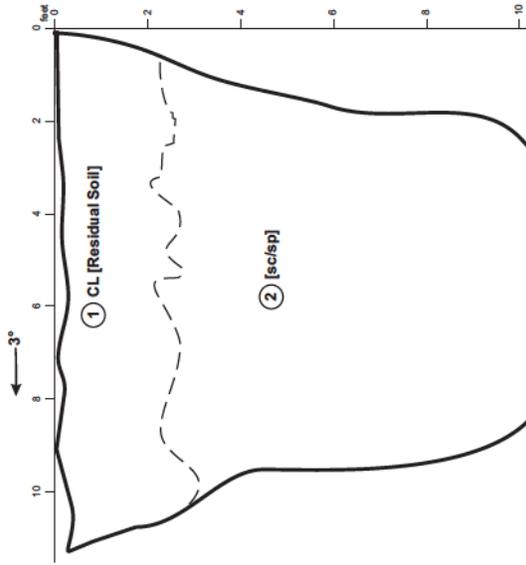
TP-4

Bottom of Test Pit at 10.25'

- ① Lean Clay with Sand (CL) [Residual Soil]
moist, medium brown, fine sand, some fine to coarse gravel, moderate plasticity

- ② Silica Carbonate intermixed with Serpentinite [sc/sp]
low to moderately hard, weak to moderately strong, moist, light gray to light orange to yellow brown with white veins, moderate weathering, intensely fractured

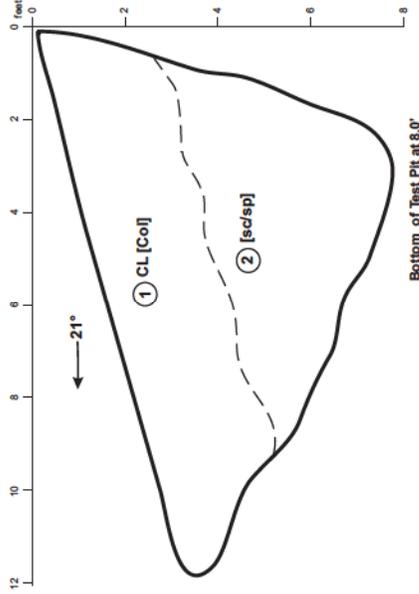
TP-5

Bottom of Test Pit at 8.0'

- ① Lean Clay (CL) [Colluvium]
moist, very dark gray-brown, some fine gravel, low to moderate plasticity

- ② Silica Carbonate intermixed with Serpentinite [sc/sp]
low hardness to moderate hardness below 5', weak, moist, light orange to light gray, moderate weathering, closely fractured, massive structure

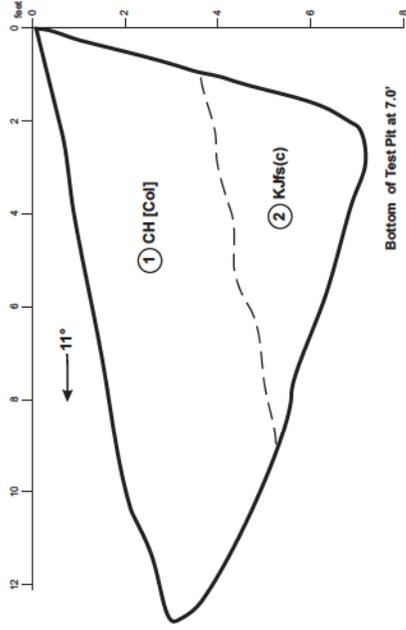
TP-6

Bottom of Test Pit at 7.0'

- ① Fat Clay (CH) [Colluvium]
moist, very dark gray-brown, trace sand, high plasticity

- ② Franciscan Claystone [K.Jfs(c)]
soft, plastic, moist, olive brown, moderate weathering, non fractured, sheared
Plasticity Index = 19, Liquid Limit = 40

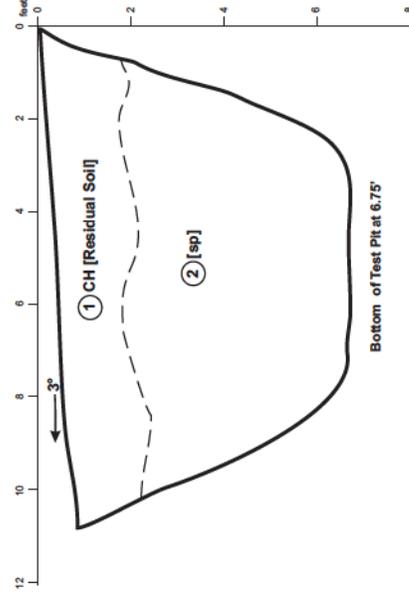
TP-7

- ① Fat Clay (CH) [Residual Soil]
moist, very dark gray-brown, trace sand, trace gravel, high plasticity
- ② Serpentineite [sp]
moderate hardness below 4.5'; weak, moist grayish brown with white veins, moderate weathering, moderately fractured

Notes:
N67°W/69°SW foliation at nearby outcrop.

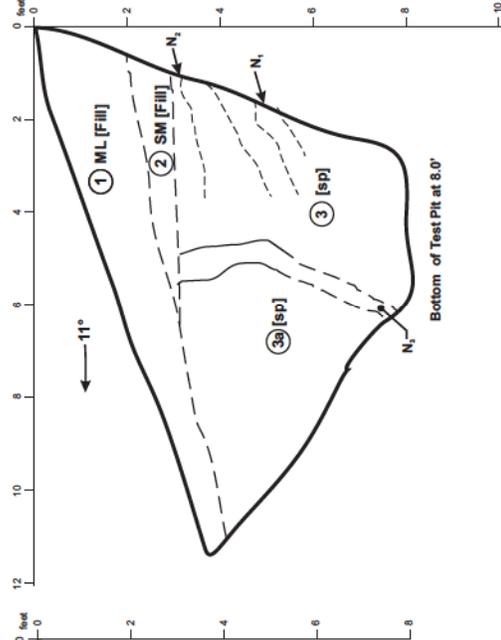
TP-8

- ① Sandy Silt with Gravel (ML) [Fill]
moist, very dark brown, fine to coarse gravel, low to moderate plasticity
- ② Silty Sand with Gravel (SM) [Fill]
moist, blue gray, fine to coarse gravel
- ③ Serpentineite [sp]
moderately hard, moderately strong, moist, very dark gray-brown, moderate weathering, closely fractured, some interbedded Diabase
- ③a Serpentineite [sp]
low hardness, weak to moderately strong, moist, greenish grey, moderate to deep weathering
Plasticity Index = 28, Liquid Limit = 51

Notes:
N1 = semicontinuous joint set dipping 47°NE
N2 = discontinuous joint set dipping 12°SW
N3 = semicontinuous shear (sandy silt, strike 68°NE)

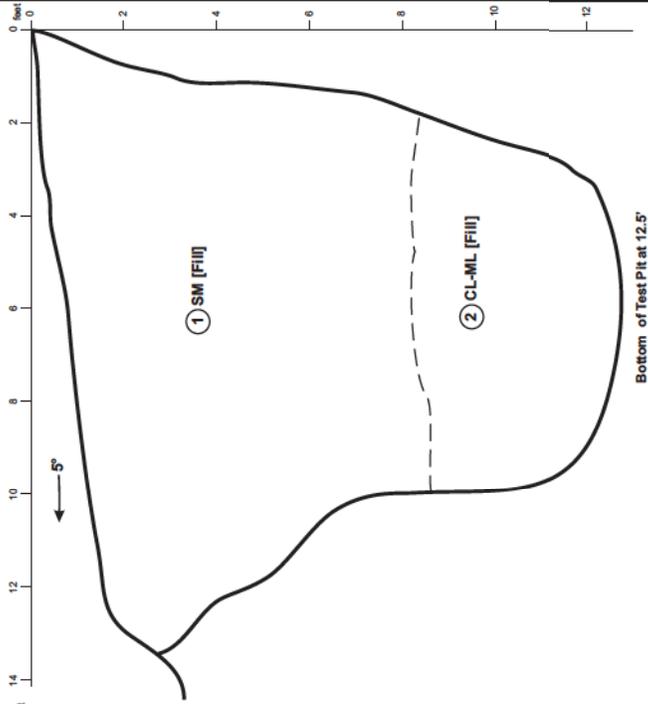
TP-9

- ① Silty Sand with Gravel (SM) [Fill]
moist, reddish brown, fine to coarse subrounded and rounded to subangular gravel, getting harder to excavate at 5'
- ② Silty Clay (CL-ML) [Fill]
very dark gray-brown, some sand, some fine to coarse subangular gravel, low plasticity

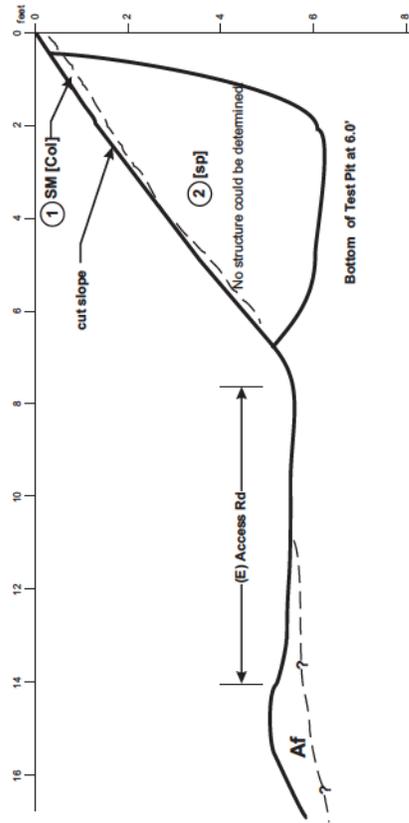
TP-10

① Silty Sand (SM) [Colluvium]
moist, dark brown

② Serpentinite (sp)
moderately hard, moderately strong, moist, greenish gray,
moderate weathering, variable subhorizontal foliation

Notes: Af is not laterally extensive.

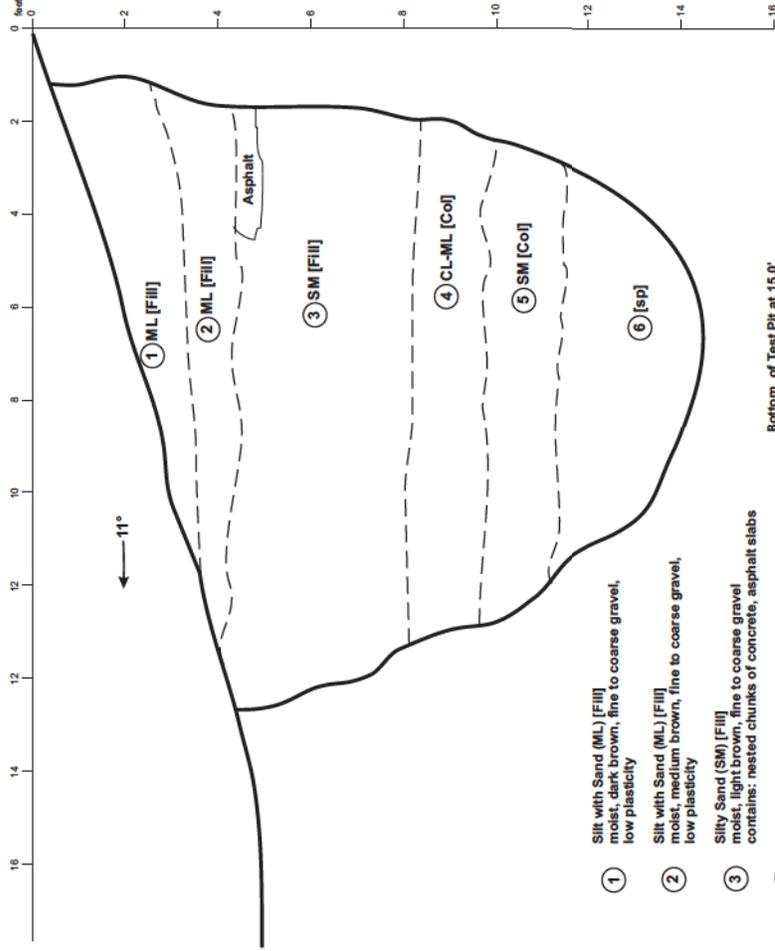
TP-11

① Silty Sand (ML) [Fill]
moist, dark brown, fine to coarse gravel,
low plasticity

② Silty Sand (ML) [Fill]
moist, medium brown, fine to coarse gravel,
low plasticity

③ Silty Sand (SM) [Fill]
moist, light brown, fine to coarse gravel
contains: nested chunks of concrete, asphalt slabs

④ Silty Clay (CL-ML) [Colluvium]
moist, dark brown, low plasticity

⑤ Silty Sand (SM) [Colluvium]
moist, light yellow brown, some fine gravel

⑥ Serpentinite (sp)
moderately hard, weak, moist, light gray and yellow brown,
deeply weathered, closely fractured and sheared. Intermixed
with Diabase

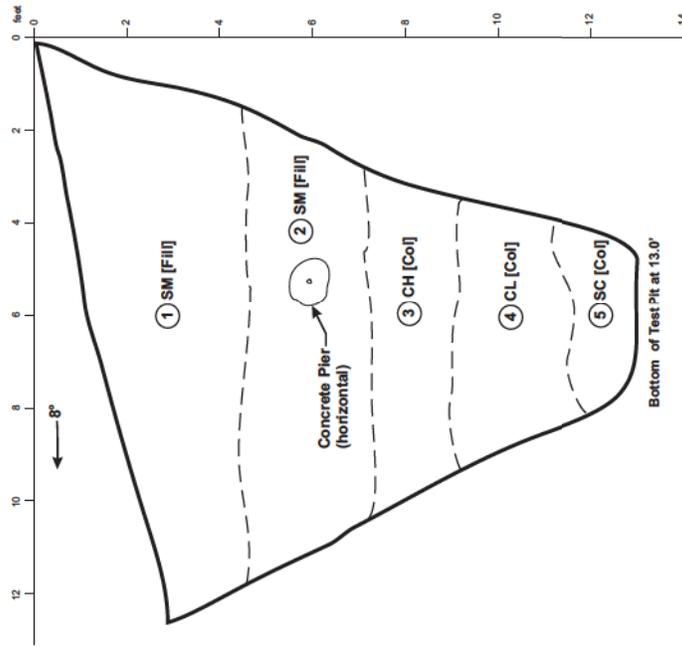
TP-12

- ① Silty Sand with Gravel (SM) [FIII]
moist, dark brown, fine subangular to subrounded and rounded gravel, contains man-made debris (plastic pipe, asphalt chunks)
- ② Silty Sand with Gravel (SM) [FIII]
moist, dark brown, fine to coarse gravel, contains man-made debris (concrete pier)
- ③ Fat Clay (CH) [Colluvium]
moist, very dark grayish brown to black, high plasticity
- ④ Lean Clay (CL) [Colluvium]
moist, dark gray and light gray mottled, moderate plasticity
- ⑤ Clayey Sand with Gravel (SC) [Colluvium]
moist to wet, dark gray, fine to coarse angular gravel

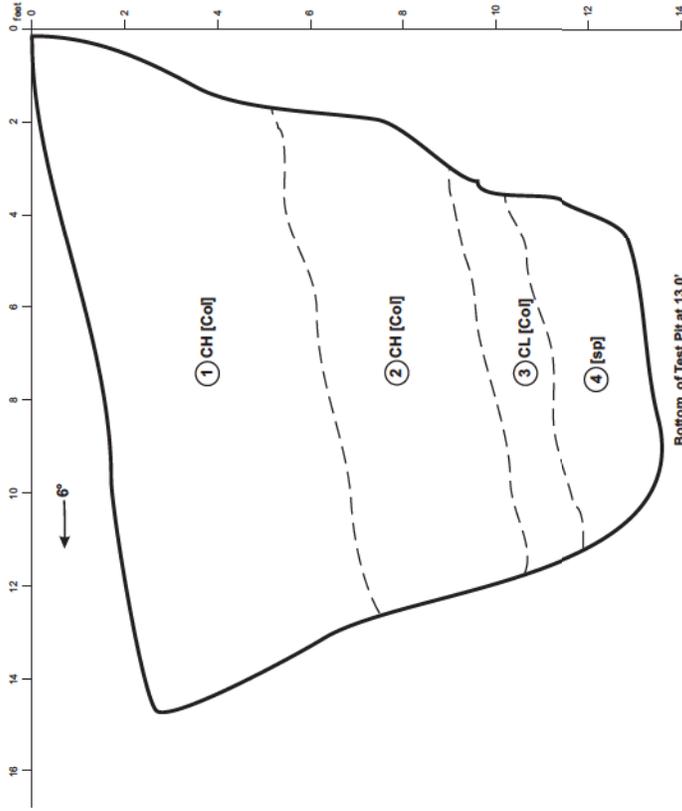
TP-13

- ① Fat Clay (CH) [Colluvium]
moist, very dark grayish brown, some fine to coarse subangular gravel, high plasticity, expansion cracks to 2.5' deep
- ② Fat Clay (CH) [Colluvium]
moist, dark brown, some fine to coarse subangular gravel, high plasticity
- ③ Lean Clay with Sand (CL) [Colluvium]
moist, reddish brown, trace fine gravel, moderate plasticity
- ④ Serpentinite (sp)
low hardness, friable to moderately strong below 12'; moist, olive to light brown, moderately weathered, closely fractured and sheared

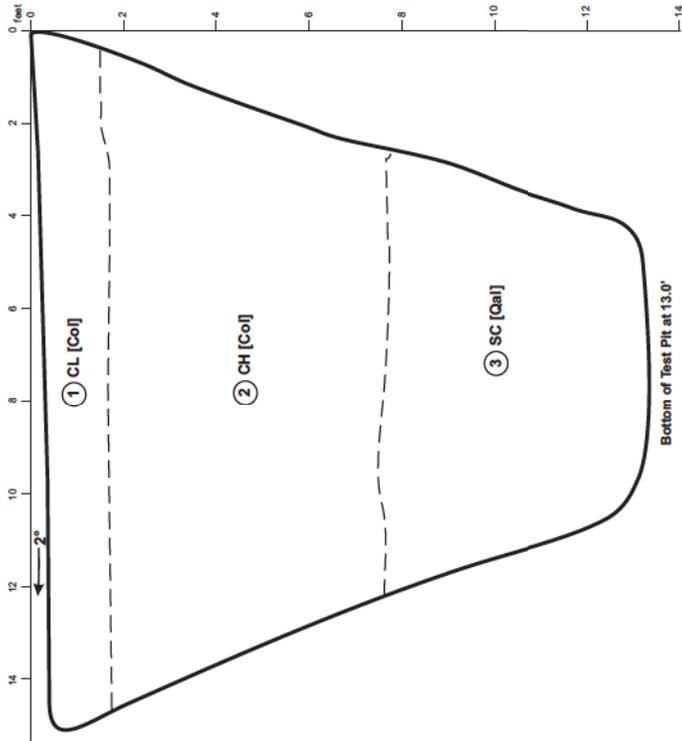
TP-14

- ① Sandy Lean Clay (CL) [Colluvium]
moist, very dark gray brown, some fine to coarse gravel, moderate plasticity
- ② Fat Clay (CH) [Colluvium]
moist, dark brown, fine to coarse gravel, some fine sand, some gravel, high plasticity
- ③ Clayey Sand with Gravel (SC) [Alluvium]
moist, medium brown, fine sand, fine subangular to subrounded gravel

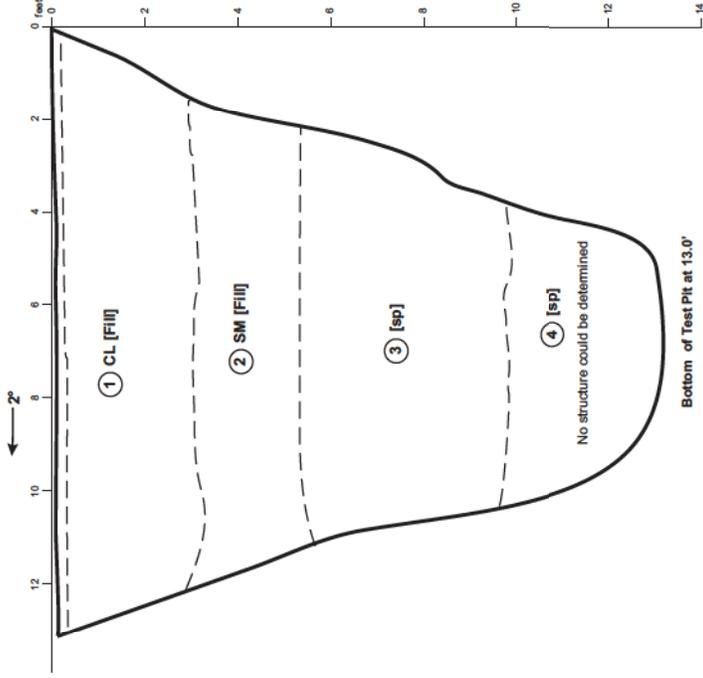
TP-15

- ① Sandy Lean Clay with Gravel (CL) [Fill]
moist, light yellowish brown and grayish brown
- ② Silty Sand with Gravel (SM) [Fill]
moist, light yellow brown, fine to coarse angular gravel (serpentine)
- ③ Serpentine (sp)
moderately hard, moderately strong, moist, light yellow brown, moderate weathering, closely fractured
- ④ Serpentine (sp)
hard, moderately strong, moist, olive to blue gray, moderate weathering, closely fractured

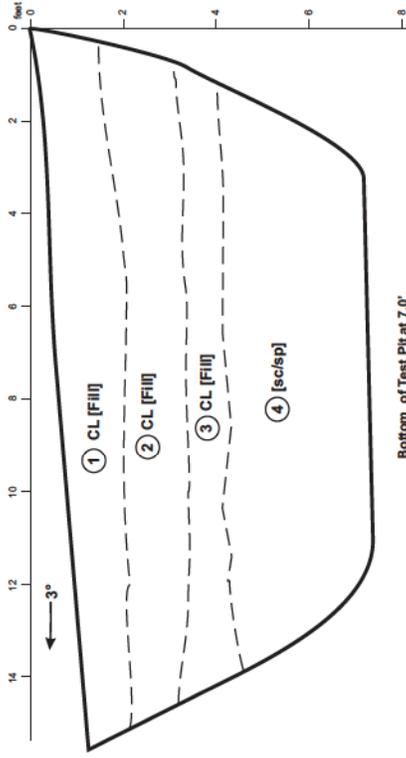
TP-16

- ① Sandy Lean Clay (CL) [FIll]
moist, medium brown, trace gravel, moderate plasticity
- ② Sandy Lean Clay with Gravel (CL) [FIll]
moist, light olive brown, coarse gravel, moderate plasticity
- ③ Sandy Lean Clay with Gravel (CL) [FIll]
moist, dark brown, moderate plasticity, contains man-made materials
- ④ Silica Carbonate intermixed with Serpentine [sc/sp]
moderately hard to hard below 6', moderately strong, moist, orange brown, deeply weathered

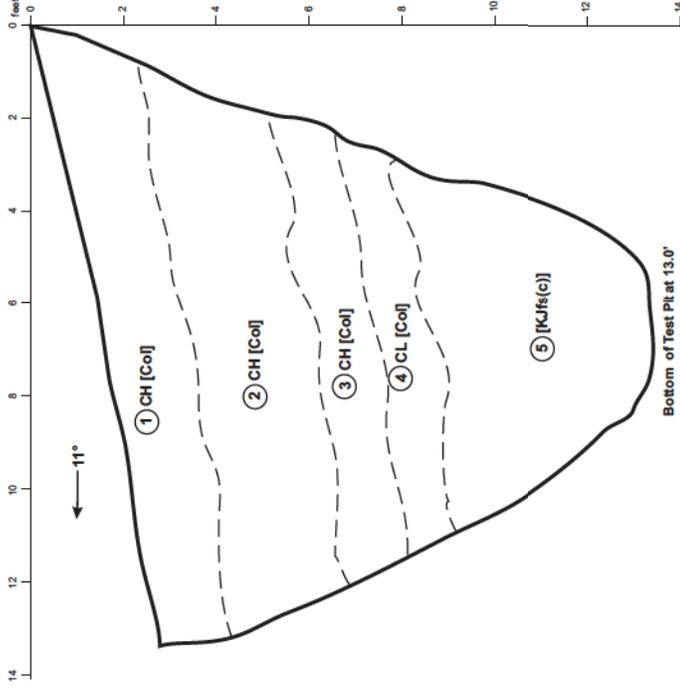
TP-17

- ① Fat Clay (CH) [Colluvium]
moist, black, trace sand, trace gravel, high plasticity
- ② Fat Clay (CH) [Colluvium]
moist, very dark greyish brown, trace sand, high plasticity
- ③ Sandy Fat Clay with Gravel (CH) [Colluvium]
moist, very dark grey, fine to coarse gravel and cobbles of silica carbonate and serpentine, high plasticity
- ④ Lean Clay with Sand (CL) [Colluvium]
moist, medium gray to olive with white mottles, some gravel, moderate plasticity
- ⑤ Franciscan Claystone [Kfs(c)]
low hardness, weak, moist, olive gray with white mottles, moderate weathering, closely fractured and sheared, massive

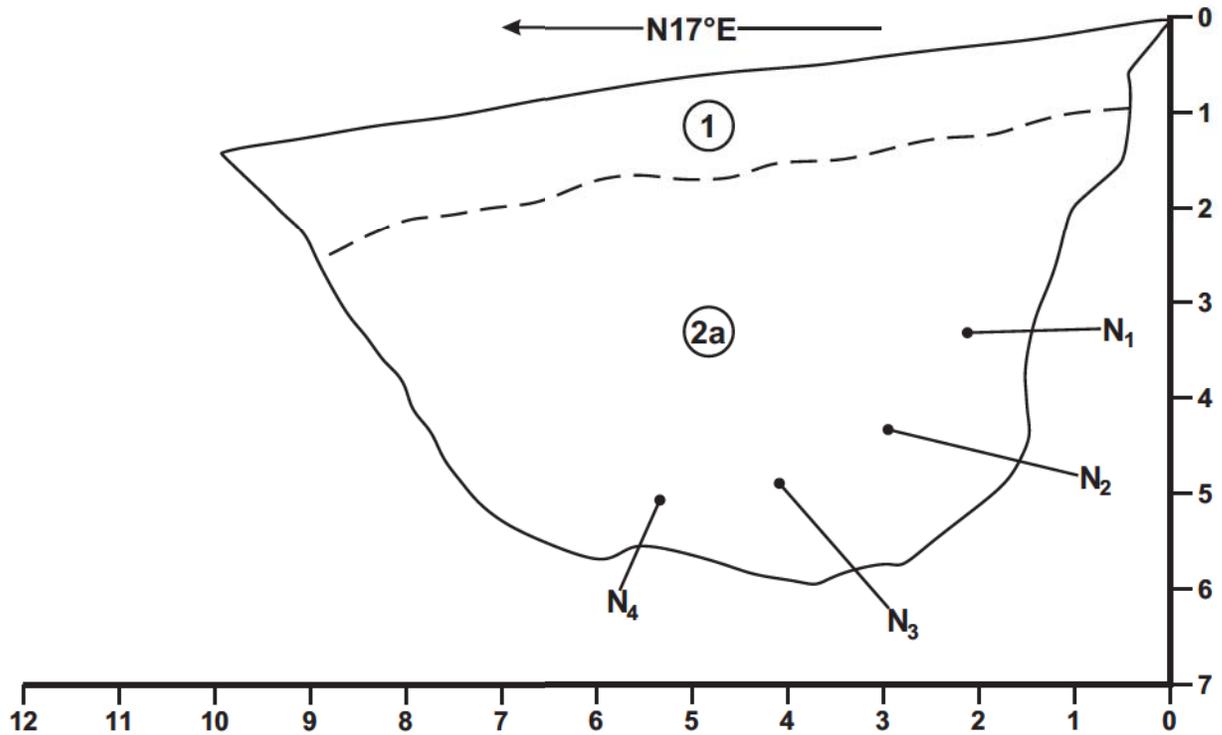
TP-1A

① Sandy silt: Very dark gray-brown, damp, firm, some clay [residual soil]

②a Silica carbonate: Light yellow, brown and orange, hard, fractured, severely weathered, rough surfaces, vined with SiO₂

N₁ = Prominent fracture = N80°E/87°SE

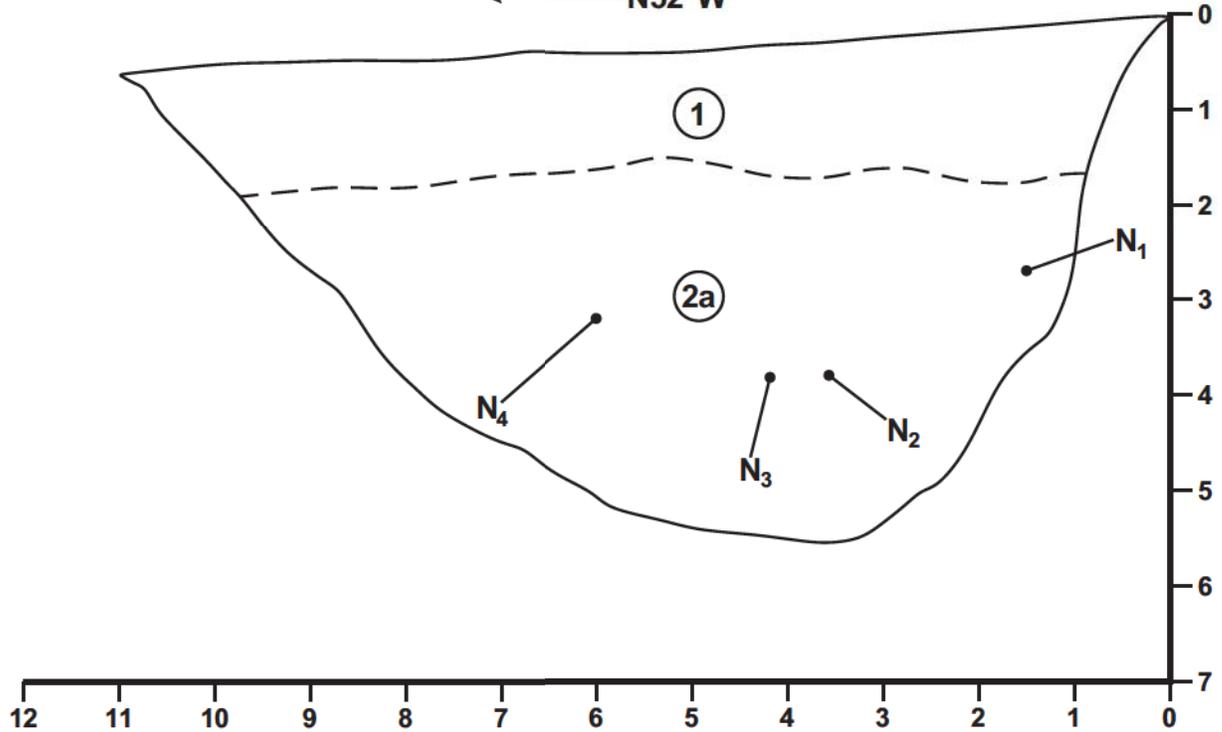
TP-2A

① Sandy silt: Gray-brown, damp, firm, [residual soil]

②a Silica carbonate: Orange and light yellow-brown, damp, hard, severely weathered, jointed and fractured, cemented locally

N₁ = Shear = N5°E/75°SE
N₂ = Joint = 0°N/60°E - Failed
N₃ = Joint = N62°E/88°SE
N₄ = Joint = N58°W/54°SW

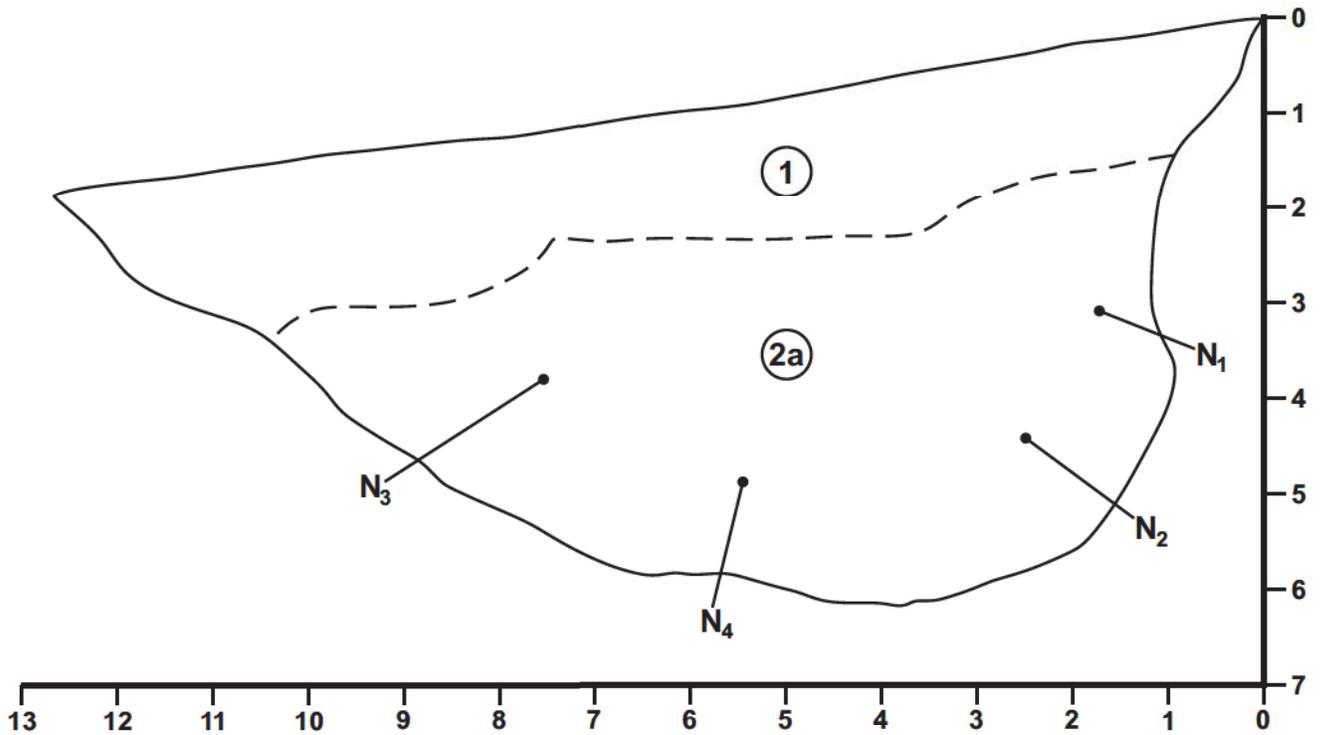
TP-4A

- ① Silty sand with gravel: Dark brown, damp, loose [residual soil]
- ②a Silica carbonate: Orange and light yellow-brown, damp, weak to moderately strong, severely to very severely weathered, jointed and sheared

N₁ = Joint set = N30°W/81°NE
N₂ = Shear = N69°W/48°SW
N₃ = Foliation = N85°W/50°NE
N₄ = Fractures = N21°W/70°NE

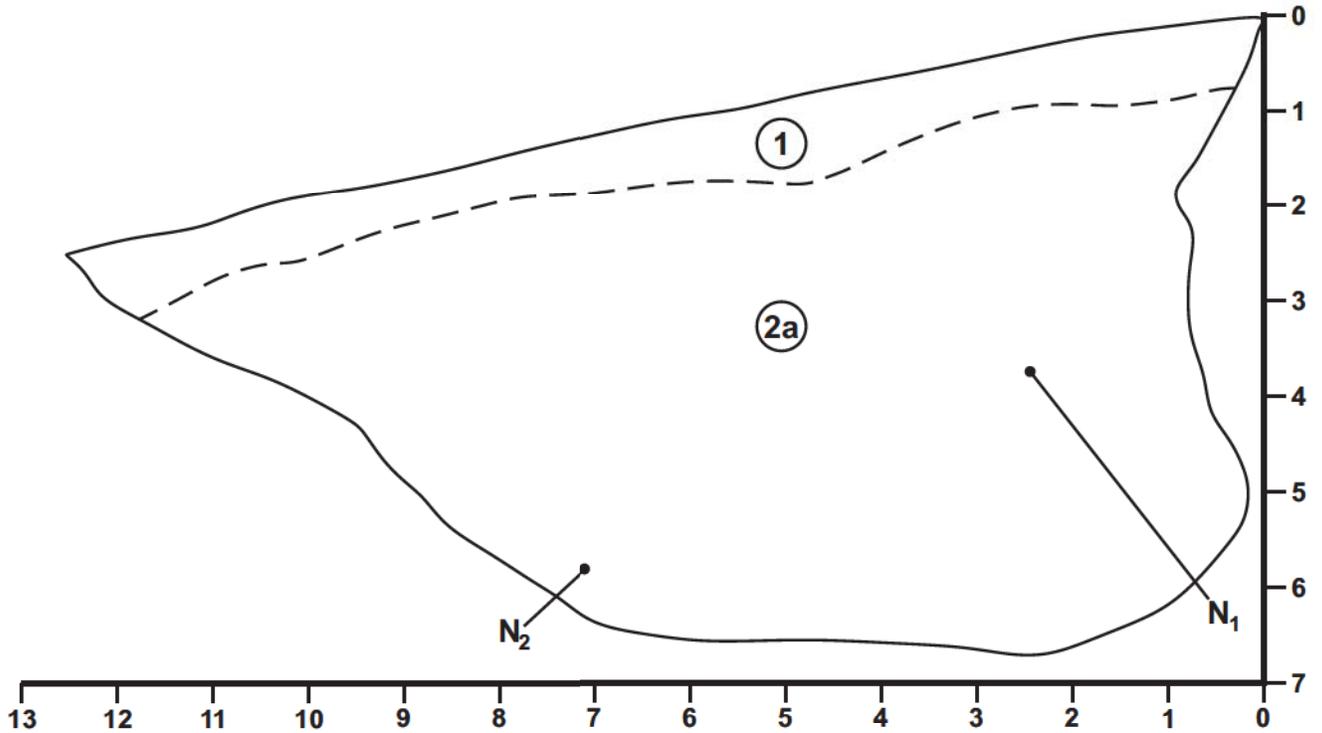
TP-5A

- ① Silty sand with gravel: Dark brown, damp, loose [residual soil]
- ②a Intermixed ultramafic rocks and serpentinite: Dark green and black, discontinuous fractures throughout, severely weathered, moderately strong

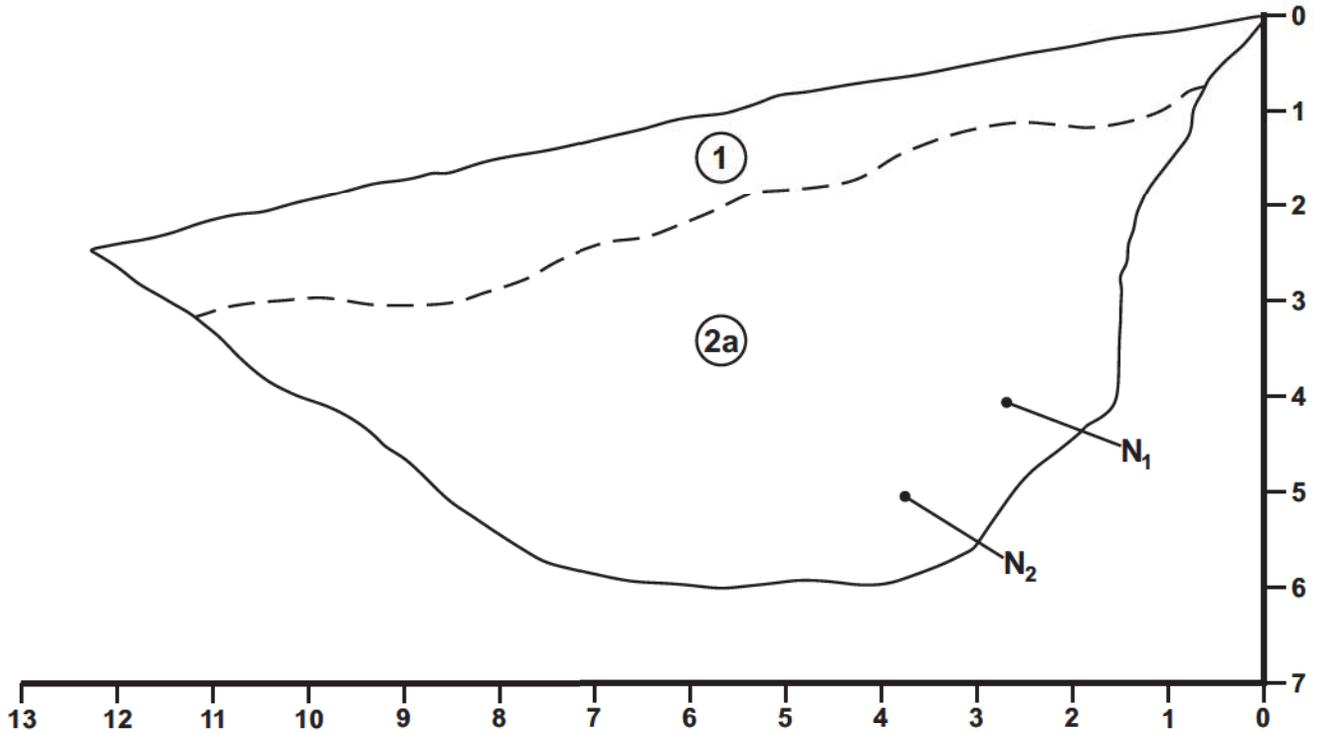
TP-6A

① Silty sand with gravel: Dark brown, damp, loose [residual soil]

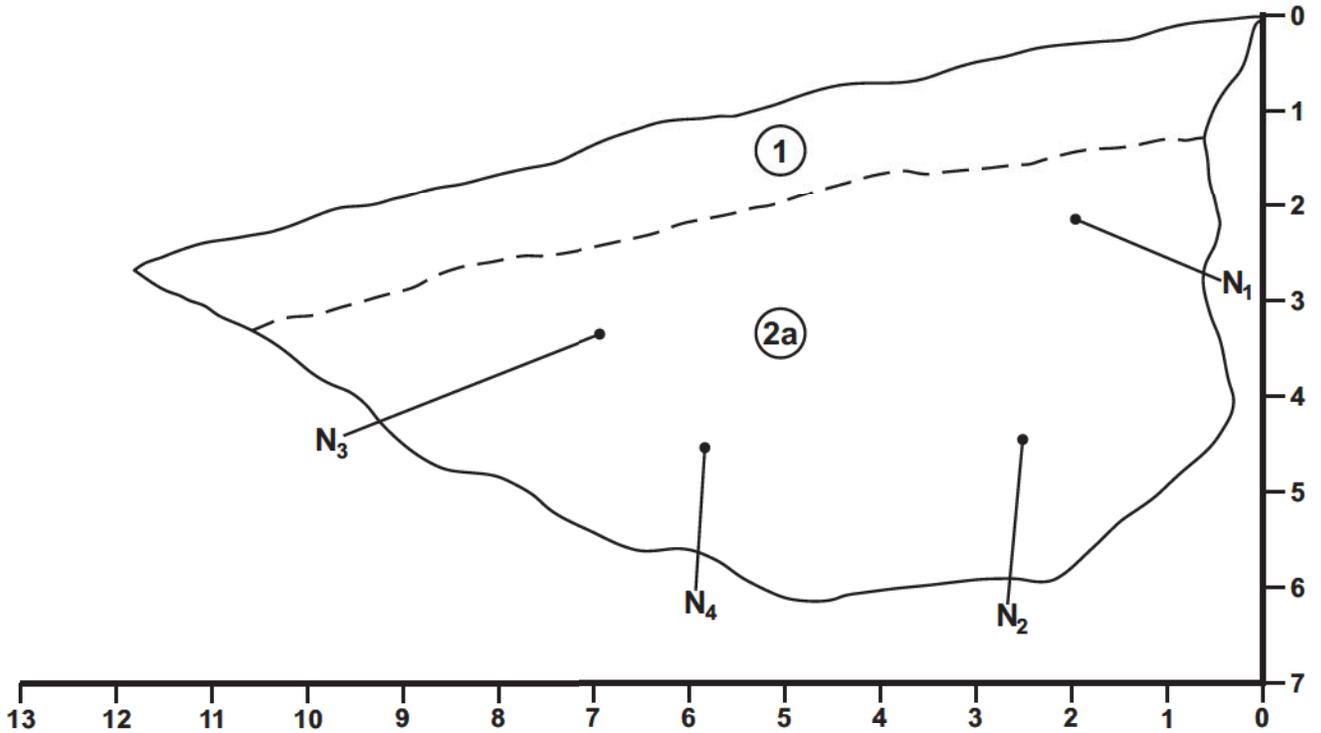
TP-7A

① Silty sand with gravel: Very dark grey-brown, damp, firm [residual soil]
