Geologic and Geotechnical Hazards Investigation

Type of Services	Geologic and Geotechnical Hazards Investigation
Project Name	Communications Hill – Phase 2
Location	Communications Hill Boulevard San Jose, California
Client	David J. Powers & Associates, Inc.
Client Address	1871 The Alameda, Suite 200 San Jose, CA 95126
Project Number	118-38-1
Date	April 21, 2014

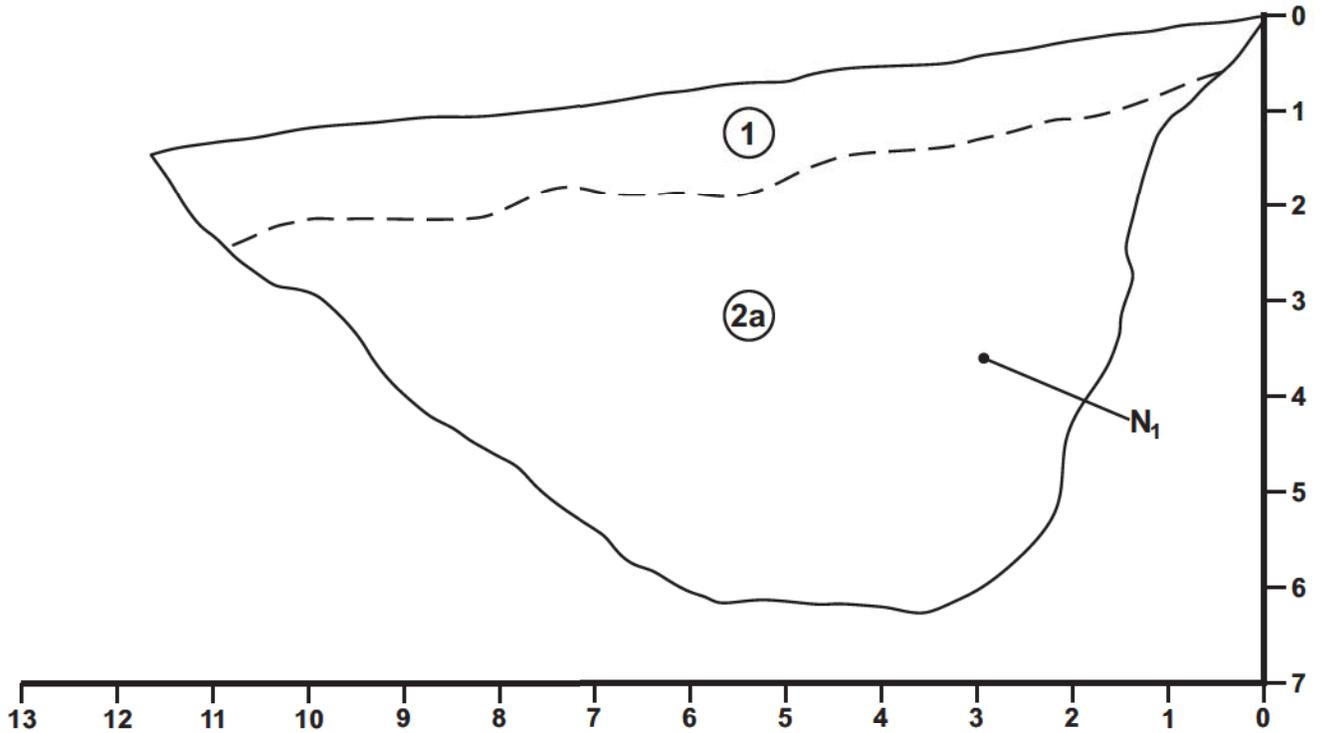
TP-8A

① Sandy silt with gravel: Dark gray -brown, damp, loose [residual soil]

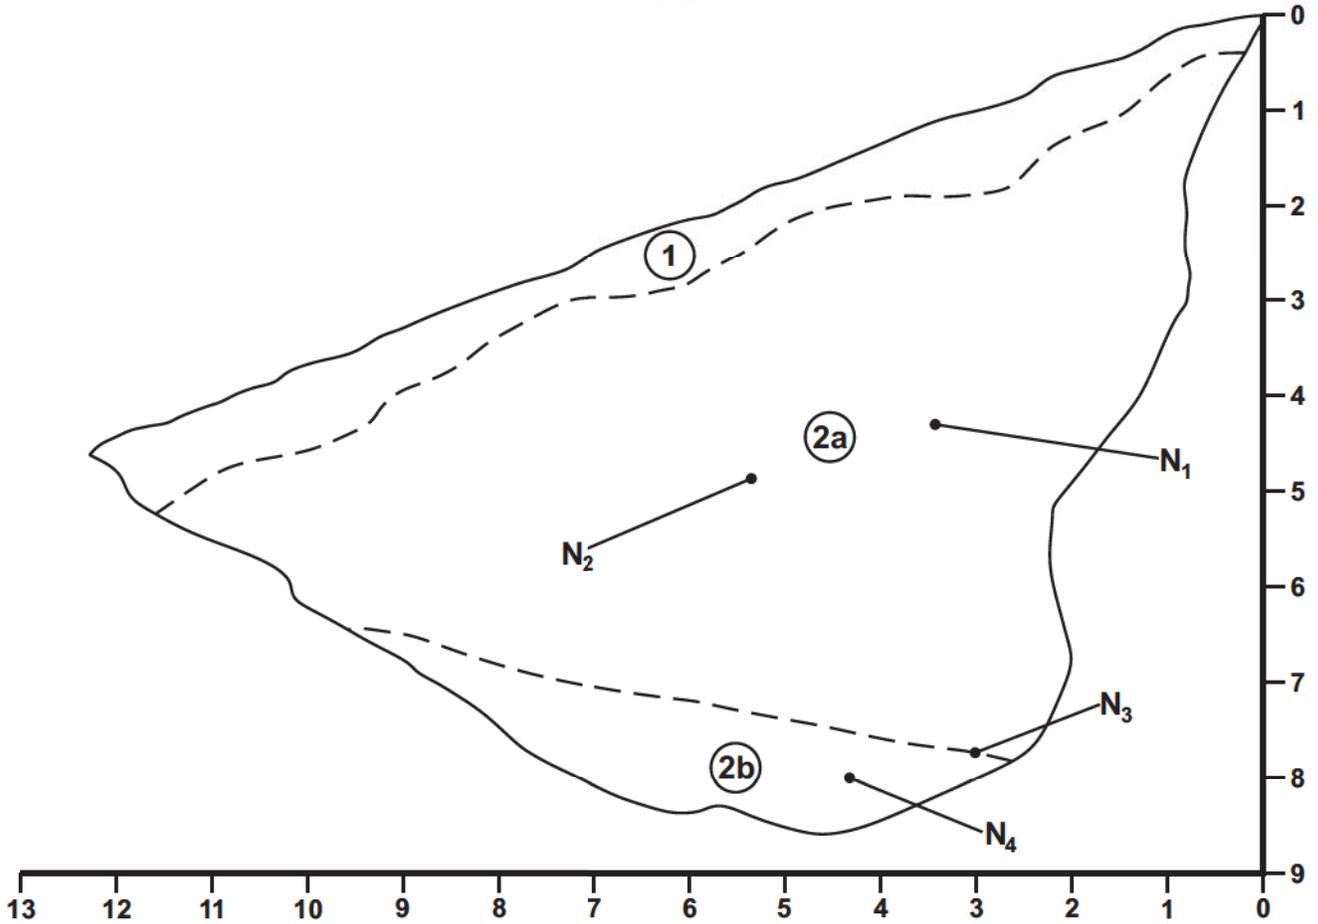
TP-9A

- ① Sandy silt with gravel: Very dark gray -brown, damp, firm [residual soil]
- ②a Sandy shale: Very dark gray-brown, damp, weak, moderately-severely weathered, thin bedded, fissile, pervasively fractured, jointed
- ②b Sandstone: Medium gray-brown, damp, moderately hard, slightly cemented, moderately-severely weathered

- N₁ = Joint Set = N81°W/31°NE
- N₂ = Spalling on bedding plane
- N₃ = Contact = N30°E/41°NW
- N₄ = Bedding = N30°W/36°SW

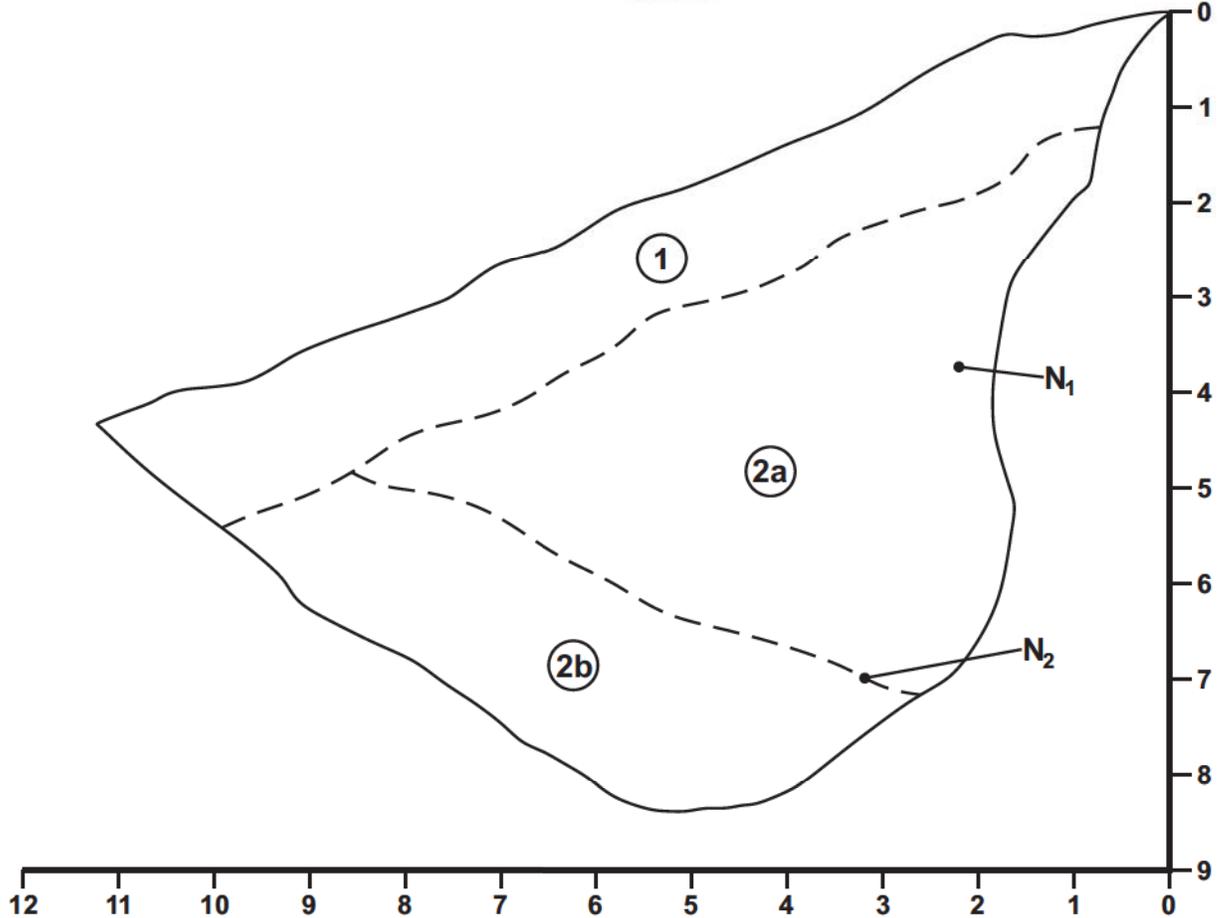
TP-10A

- ① **Sandy silt with gravel:** Very dark gray -brown, damp, firm [residual soil]
- ②a **Sandy shale:** Very dark gray-brown, damp, moderately hard, thin bedded, fissile, sheared and fractured
- ②b **Sandy claystone:** Olive brown and light yellow-brown, damp, weak, laminated and thin bedded, sheared and fractured, contains thin interbeds of fine sandstone

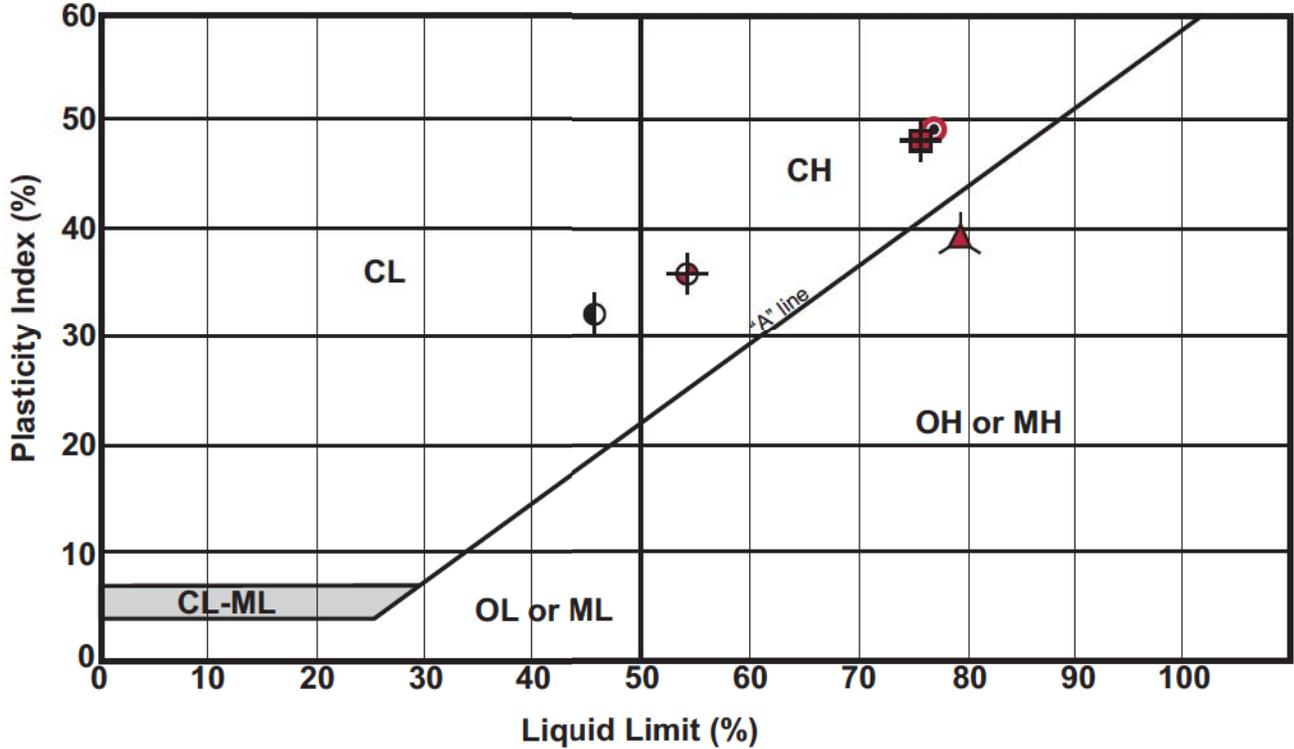
Plasticity Index (ASTM D4318) Testing Summary

Symbol	Boring No.	Depth (ft)	Natural Water Content (%)	Liquid Limit (%)	Plastic Limit (%)	Plasticity Index	Passing No. 200 (%)	Group Name (USCS - ASTM D2487)
⊗	EB-2	1.5	18	54	18	36	—	Fat Clay (CH) [Colluvium]
⊠	EB-3	1.5	40	76	28	48	—	Fat Clay (CH) [Colluvium]
⊗	EB-3	3.5	25	77	28	49	—	Sandy Fat Clay (CH) [Colluvium]
▲	EB-4	12.5	37	79	40	39	—	Sandy Elastic Silt (MH) [Colluvium]
⊙	EB-5	14.0	23	46	14	32	—	Lean Clay (CL) [Alluvium]

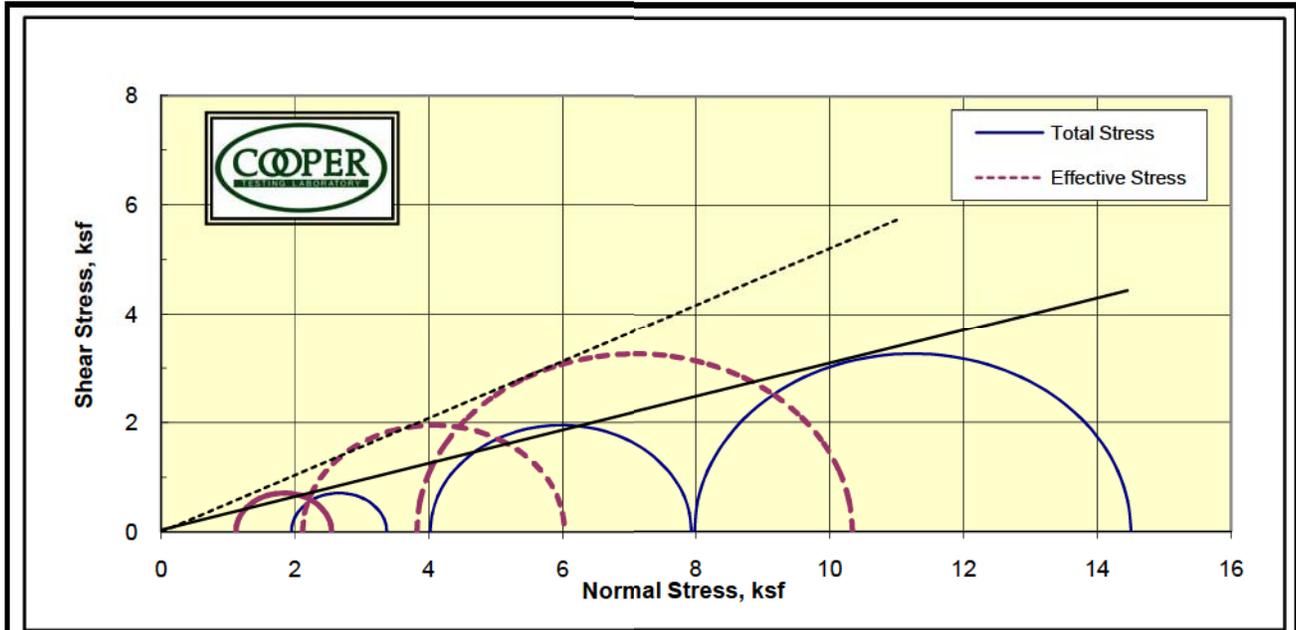
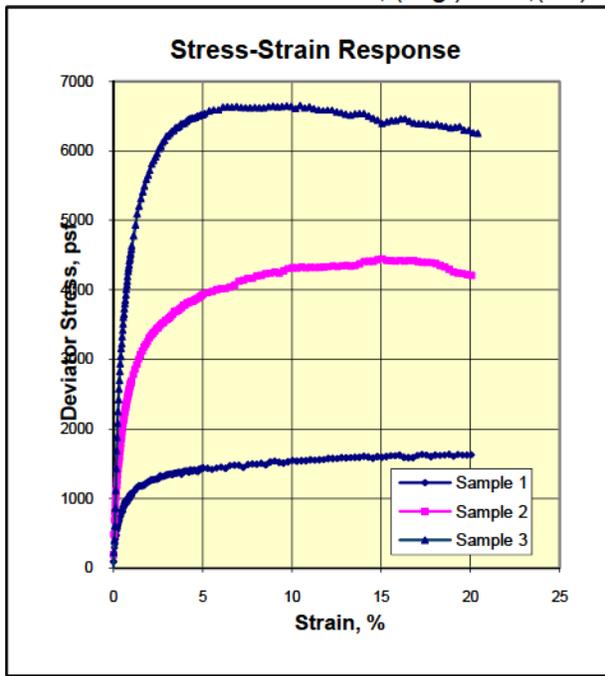
Triaxial Consolidated Undrained with Pore Pressure
ASTM D4767

Total : 17Phi, (deg.) OC,(ksf) Effective: 27.6Phi, (deg.) OC,(ksf)

Sample:	1	2	3	4
MC, %	23.6	23.4	24.2	
DD, pcf	101.7	103.2	100.6	
Sat. %	96.9	99.8	96.8	
Void Ratio	0.656	0.632	0.675	
Diameter in	2.40	2.40	2.42	
Height, in	4.99	5.02	5.02	
Final				
MC, %	26.2	25.1	24.3	
DD, pcf	98.7	100.4	101.7	
Sat. %	100.0	100.0	100.0	
Void Ratio	0.707	0.678	0.656	
Diameter, in	2.44	2.44	2.43	
Height, in	4.98	4.99	4.92	
Cell, psi	62.4	76.3	104.1	
BP, psi	48.9	48.4	48.7	
Effective Stresses At:				
Strain, %	5.0	5.0	5.0	
Deviator ksf	1.428	3.915	6.525	
Excess PP	0.826	1.909	4.163	
Sigma 1	2.542	6.023	10.340	
Sigma 3	1.114	2.108	3.815	
P, ksf	1.828	4.066	7.077	
Q, ksf	0.714	1.958	3.262	
Stress Ratio	2.281	2.857	2.710	
Rate in/min	0.001	0.001	0.001

Job No.: 640-132	Date: 2/20/2009
Client: Cornerstone Earth Group	BY: DC
Project: Comm Hill II - P955	
Sample 1) EB-5;10 @ 9.5'	Dark Gray CLAY
Sample 2) EB-5;12 @ 14.0'	Grayish Brown CLAY w/ Sand
Sample 3) EB-5;13 @ 14.5'	Grayish Brown CLAY

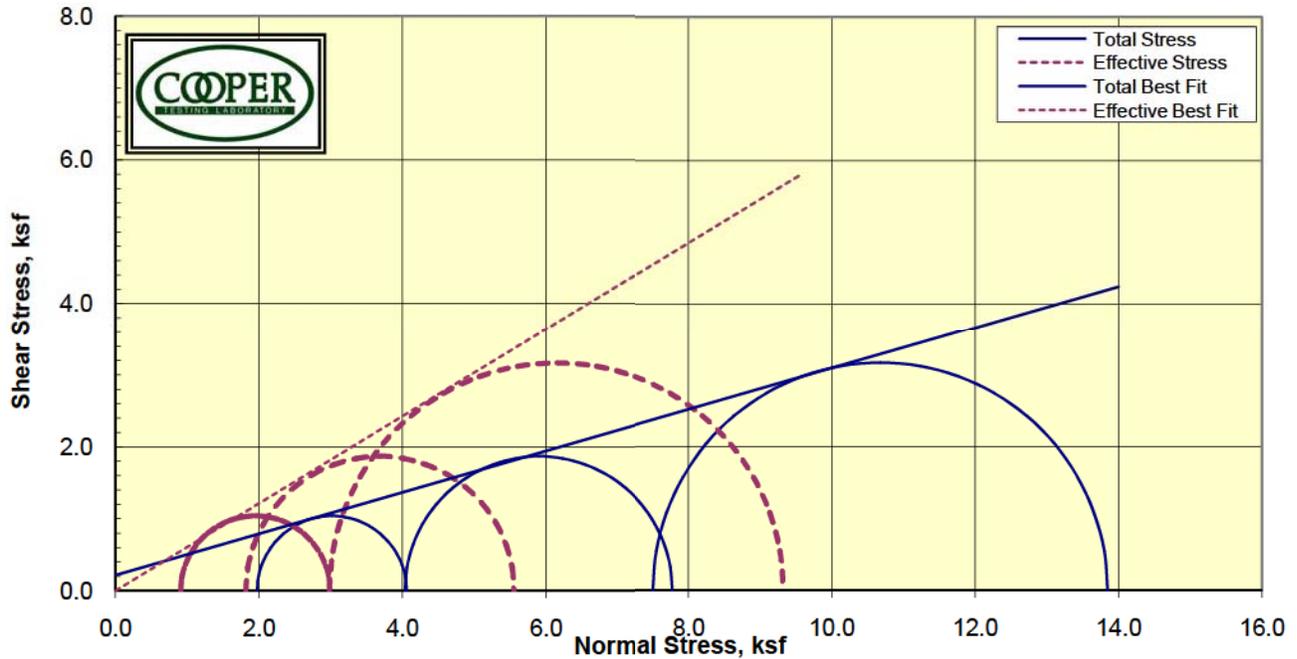
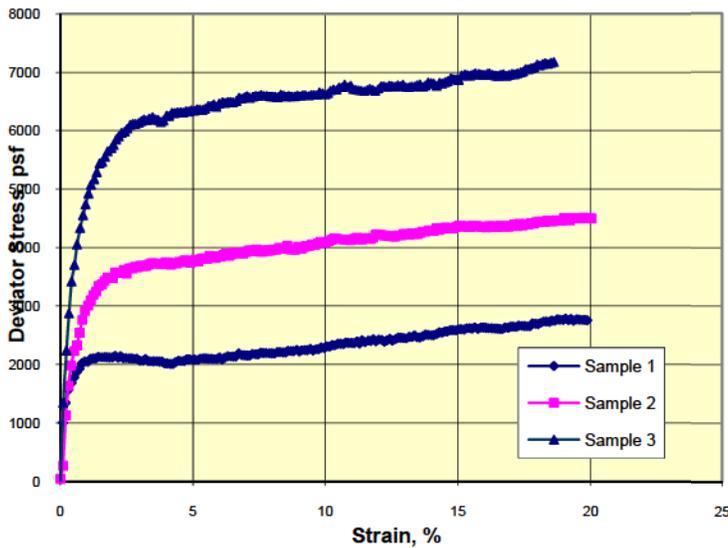
Triaxial Consolidated Undrained

Stress-Strain Response

Sample:	1	2	3	4
MC, %	16.1	15.9	15.5	
Dry Dens, pcf	104.7	104.9	105.2	
Sat. %	71.4	71.1	69.5	
Void Ratio	0.609	0.606	0.601	
Diameter, in	2.38	2.38	2.38	
Height, in	5.00	5.00	5.00	
Final				
MC, %	25.2	23.4	22.3	
Dry Dens, pcf	100.2	103.2	105.2	
Sat. %	100.0	100.0	100.0	
Void Ratio	0.681	0.632	0.602	
Diameter, in	2.42	2.40	2.39	
Height, in	5.02	4.98	4.94	
Cell, psi	61.9	75.8	100.0	
BP, psi	48.2	47.8	47.9	
Effective Stresses At:				
Strain, %	5.0	5.0	5.0	
Deviator ksf	2.083	3.741	6.342	
Excess PP	1.066	2.218	4.522	
Sigma 1	2.991	5.555	9.323	
Sigma 3	0.907	1.814	2.981	
P, ksf	1.949	3.685	6.152	
Q, ksf	1.042	1.870	3.171	
Stress Ratio	3.296	3.062	3.128	
Rate in/min	0.001	0.001	0.001	
Total C	0.2	ksf		
Total Phi	16.1	Degrees		
Eff. C	0.0	ksf		
Eff. Phi	31.3	Degrees

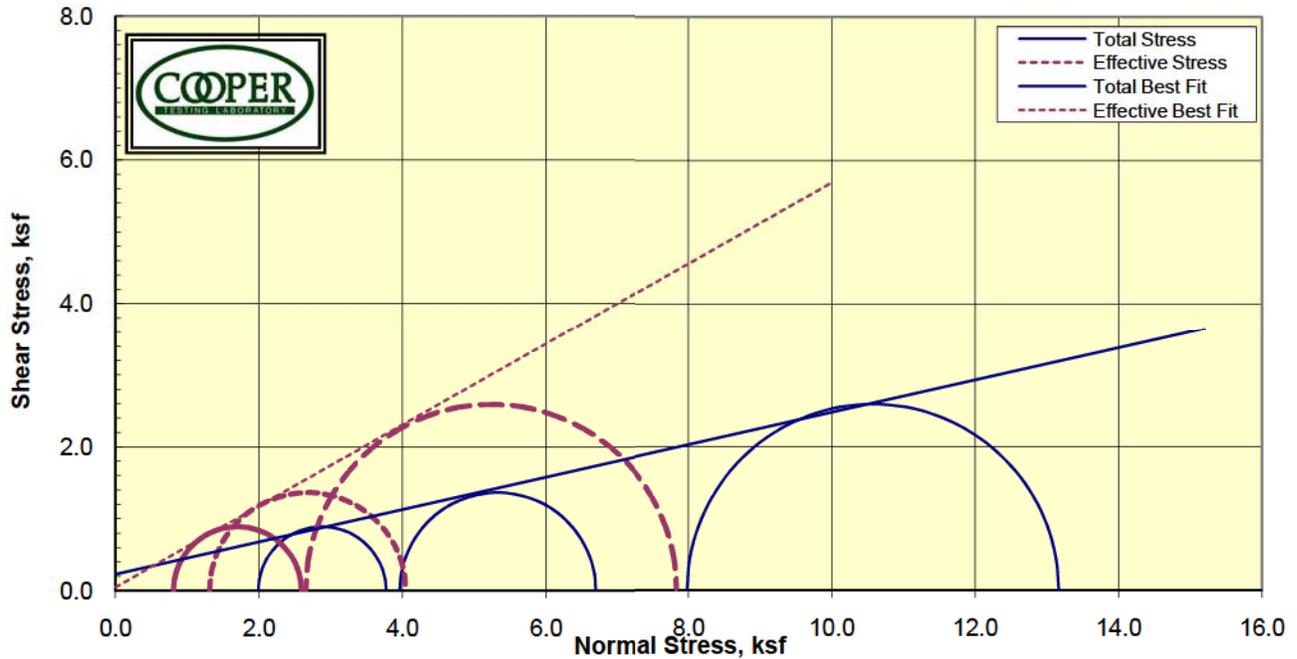
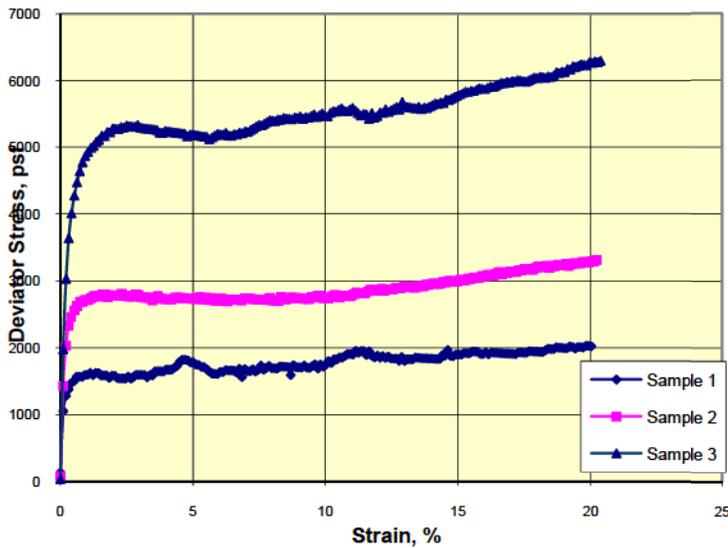
Triaxial Consolidated Undrained

Stress-Strain Response

Sample:	1	2	3	4
MC, %	18.4	18.4	18.3	
Dry Dens, pcf	99.9	99.9	99.9	
Sat. %	72.2	72.2	72.2	
Void Ratio	0.687	0.687	0.686	
Diameter, in	2.38	2.38	2.38	
Height, in	5.00	5.00	5.00	
Final				
MC, %	24.3	22.4	21.0	
Dry Dens, pcf	101.7	105.0	107.5	
Sat. %	100.0	100.0	100.0	
Void Ratio	0.656	0.605	0.567	
Diameter, in	2.36	2.33	2.32	
Height, in	4.96	4.93	4.88	
Cell, psi	52.4	66.3	94.1	
BP, psi	38.6	38.8	38.7	
Effective Stresses At:

Strain, %	5.0	5.0	5.0
Deviator ksf	1.785	2.733	5.184
Excess PP	1.181	2.650	5.328
Sigma 1	2.591	4.043	7.834
Sigma 3	0.806	1.310	2.650
P, ksf	1.699	2.677	5.242
Q, ksf	0.892	1.367	2.592
Stress Ratio	3.213	3.086	2.957
Rate in/min	0.001	0.001	0.001
Total C	0.2	ksf	
Total Phi	12.7	Degrees	
Eff. C	0.1	ksf	
Eff. Phi	29.5	Degrees

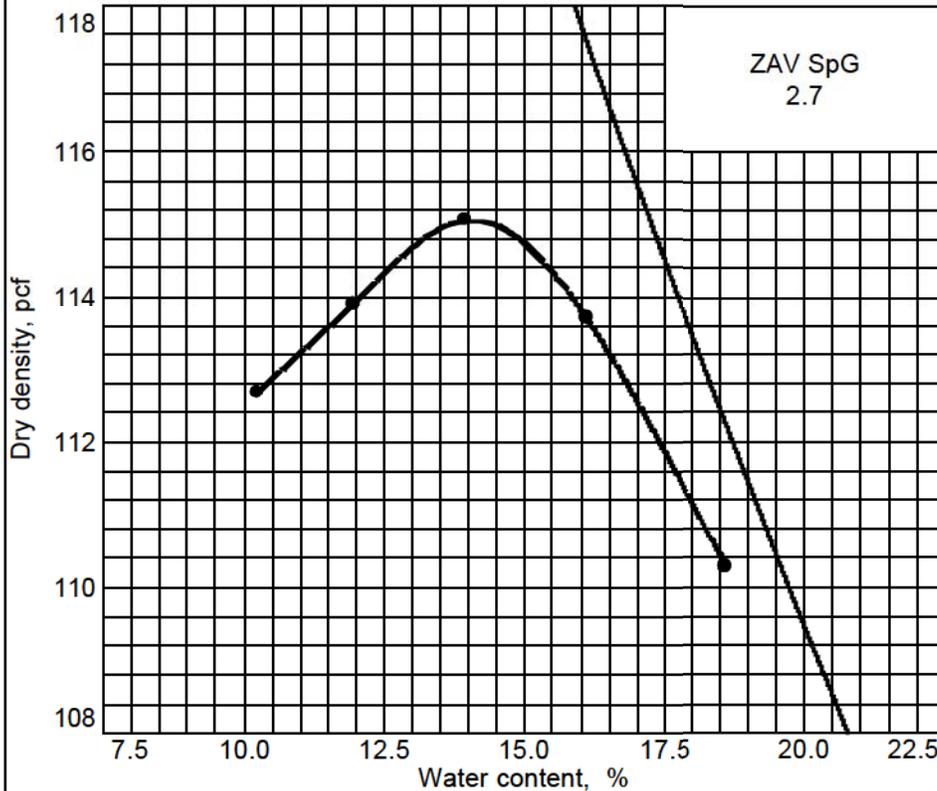
TESTING DATA

1	2	3	4	5	6
WM + WS	8.79	8.82	8.67	8.78	8.56	
WM	4.42	4.42	4.42	4.42	4.42	
WW + T #1	632.40	589.20	669.10	613.40	657.30	
WD + T #1	579.30	535.50	619.10	548.70	615.30	
TARE #1	198.50	201.90	200.60	200.80	204.70	
WW + T #2						
WD + T #2						
TARE #2						
MOISTURE	13.9	16.1	11.9	18.6	10.2	
DRY DENSITY	115.1	113.7	113.9	110.3	112.7

Maximum Density: Two (2) maximum density tests (ASTM D1557) were performed on samples of the subsurface soils to measure the relative maximum density and optimum moisture content.

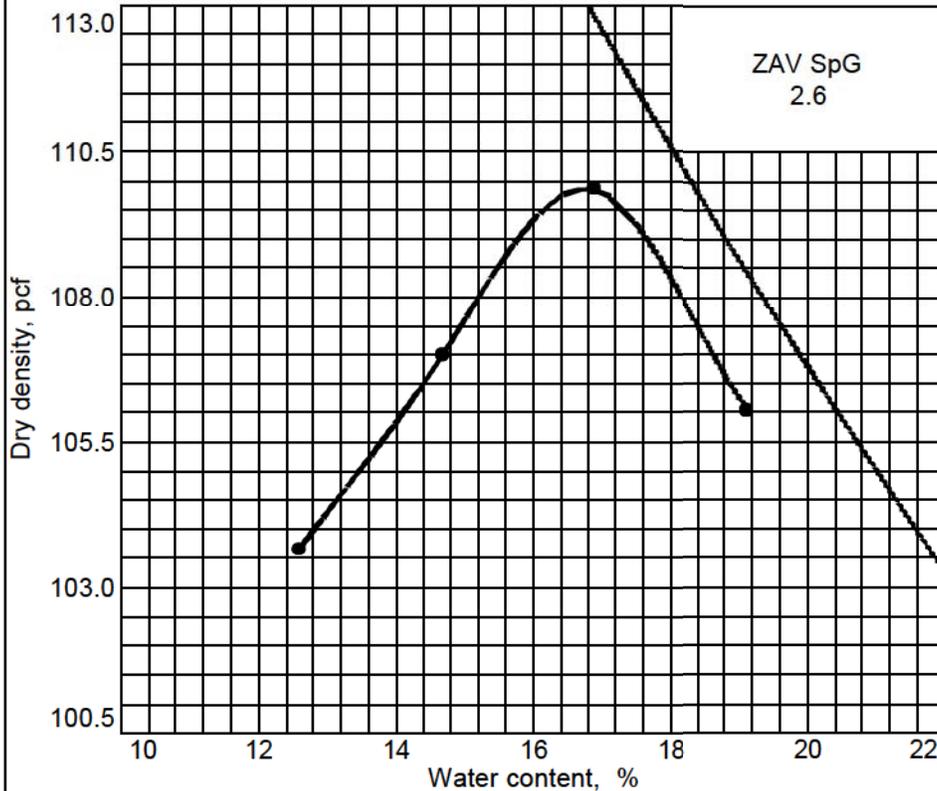
COMPACTION TEST REPORT

Test Specification:

ASTM D 1557-00 Method A Modified

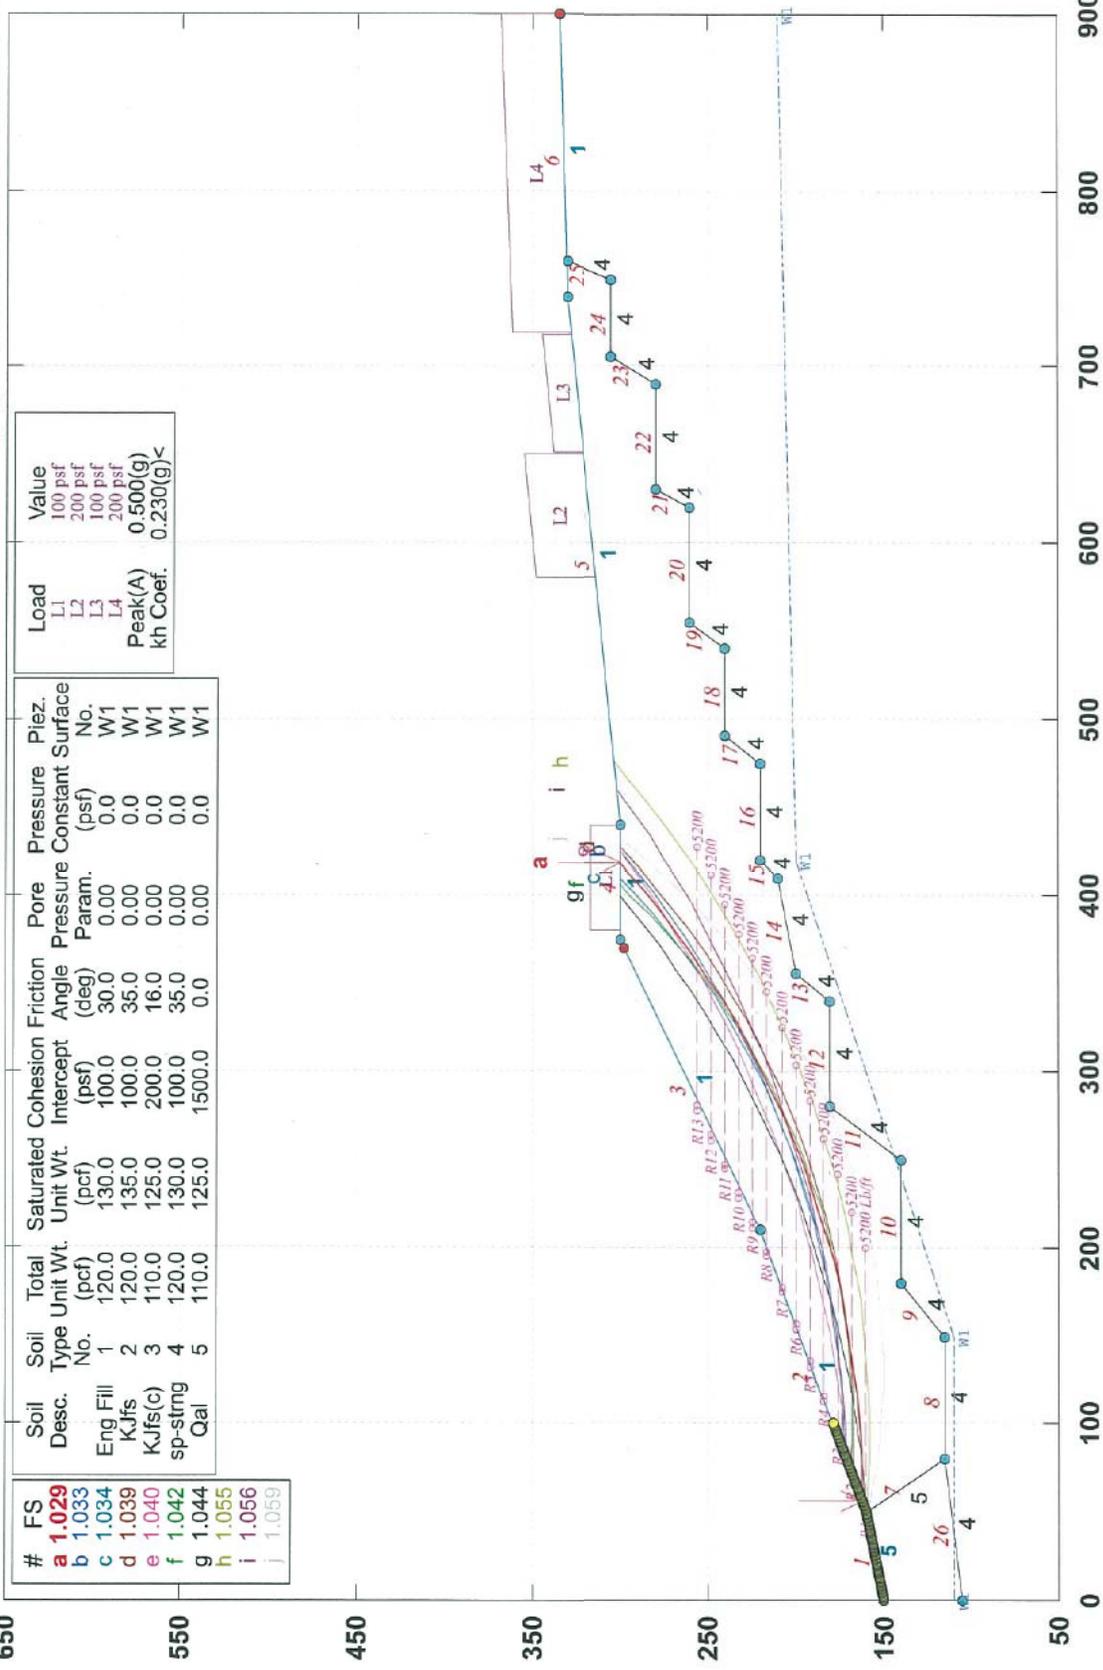
118-38-1 Comm Hill II- Section 1-1' seismic (8' geogrid spacing @ 150'L)

Load	Value
L1	100 psf
L2	200 psf
L3	100 psf
L4	200 psf
Peak(A)	0.500(g)
kh Coef.	0.230(g)<

#	FS	Soil Desc.	Soil Type No.	Total Unit Wt. (pcf)	Saturated Unit Wt. (pcf)	Cohesion (psf)	Friction Angle (deg)	Pore Pressure Param. (psf)	Pressure Constant (psf)	Piez. Constant Surface No.
a	1.029	Eng Fill	1	120.0	130.0	100.0	30.0	0.00	0.0	W1
b	1.033	KJfs	2	120.0	135.0	100.0	35.0	0.00	0.0	W1
c	1.034	KJfs(c)	3	110.0	125.0	200.0	16.0	0.00	0.0	W1
d	1.039	sp-string	4	120.0	130.0	100.0	35.0	0.00	0.0	W1
e	1.040	Qal	5	110.0	125.0	1500.0	0.0	0.00	0.0	W1
f	1.042									
g	1.044									
h	1.055									
i	1.056									
j	1.059

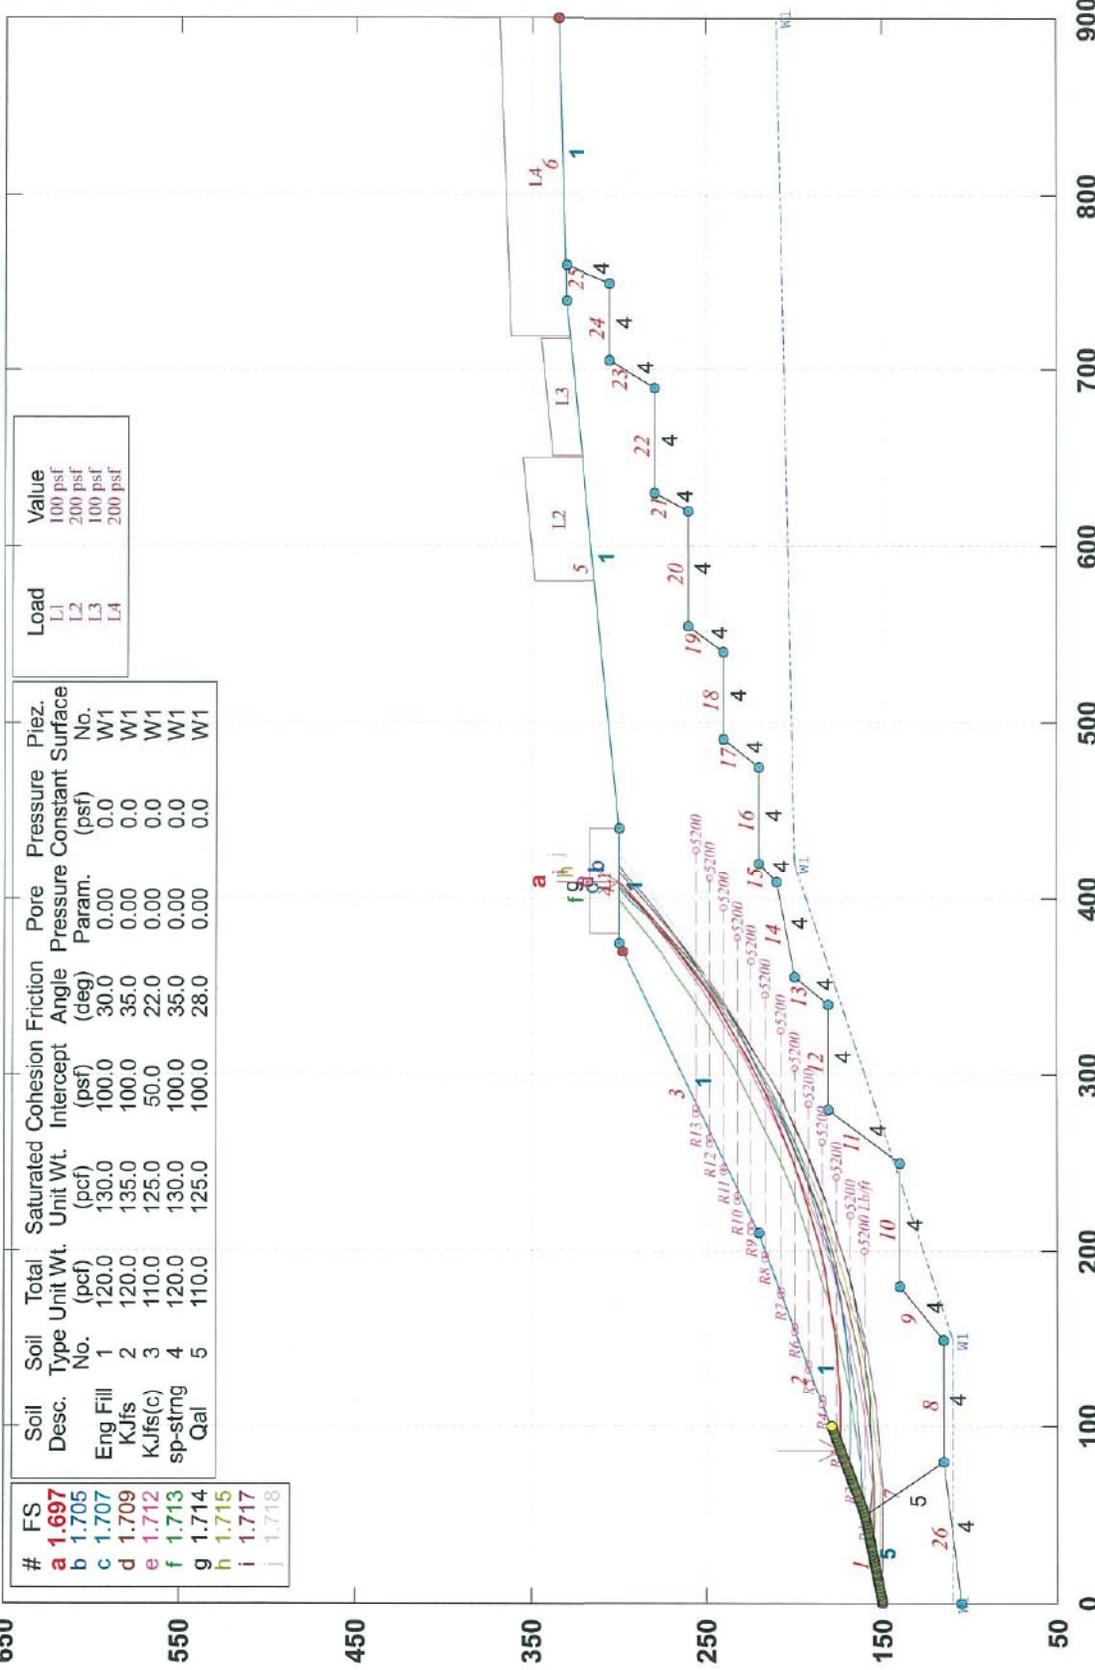
118-38-1 Comm Hill II- Section 1-1' static (8' geogrid spacing @ 150'L)

Load	Value
L1	100 psf
L2	200 psf
L3	100 psf
L4	200 psf

#	FS	Soil Desc.	Soil Type No.	Total Unit Wt. (pcf)	Saturated Unit Wt. (pcf)	Cohesion (psf)	Friction Angle (deg)	Pore Pressure Param. (psf)	Pressure Constant	Piez. No.
a	1.697	Eng Fill	1	120.0	130.0	100.0	30.0	0.00	0.0	W1
b	1.705	KJfs	2	120.0	135.0	100.0	35.0	0.00	0.0	W1
c	1.707	KJfs(c)	3	110.0	125.0	50.0	22.0	0.00	0.0	W1
d	1.709	sp-strng	4	120.0	130.0	100.0	35.0	0.00	0.0	W1
e	1.712	Qal	5	110.0	125.0	100.0	28.0	0.00	0.0	W1
f	1.713									
g	1.714									
h	1.715									
i	1.717									
j	1.718

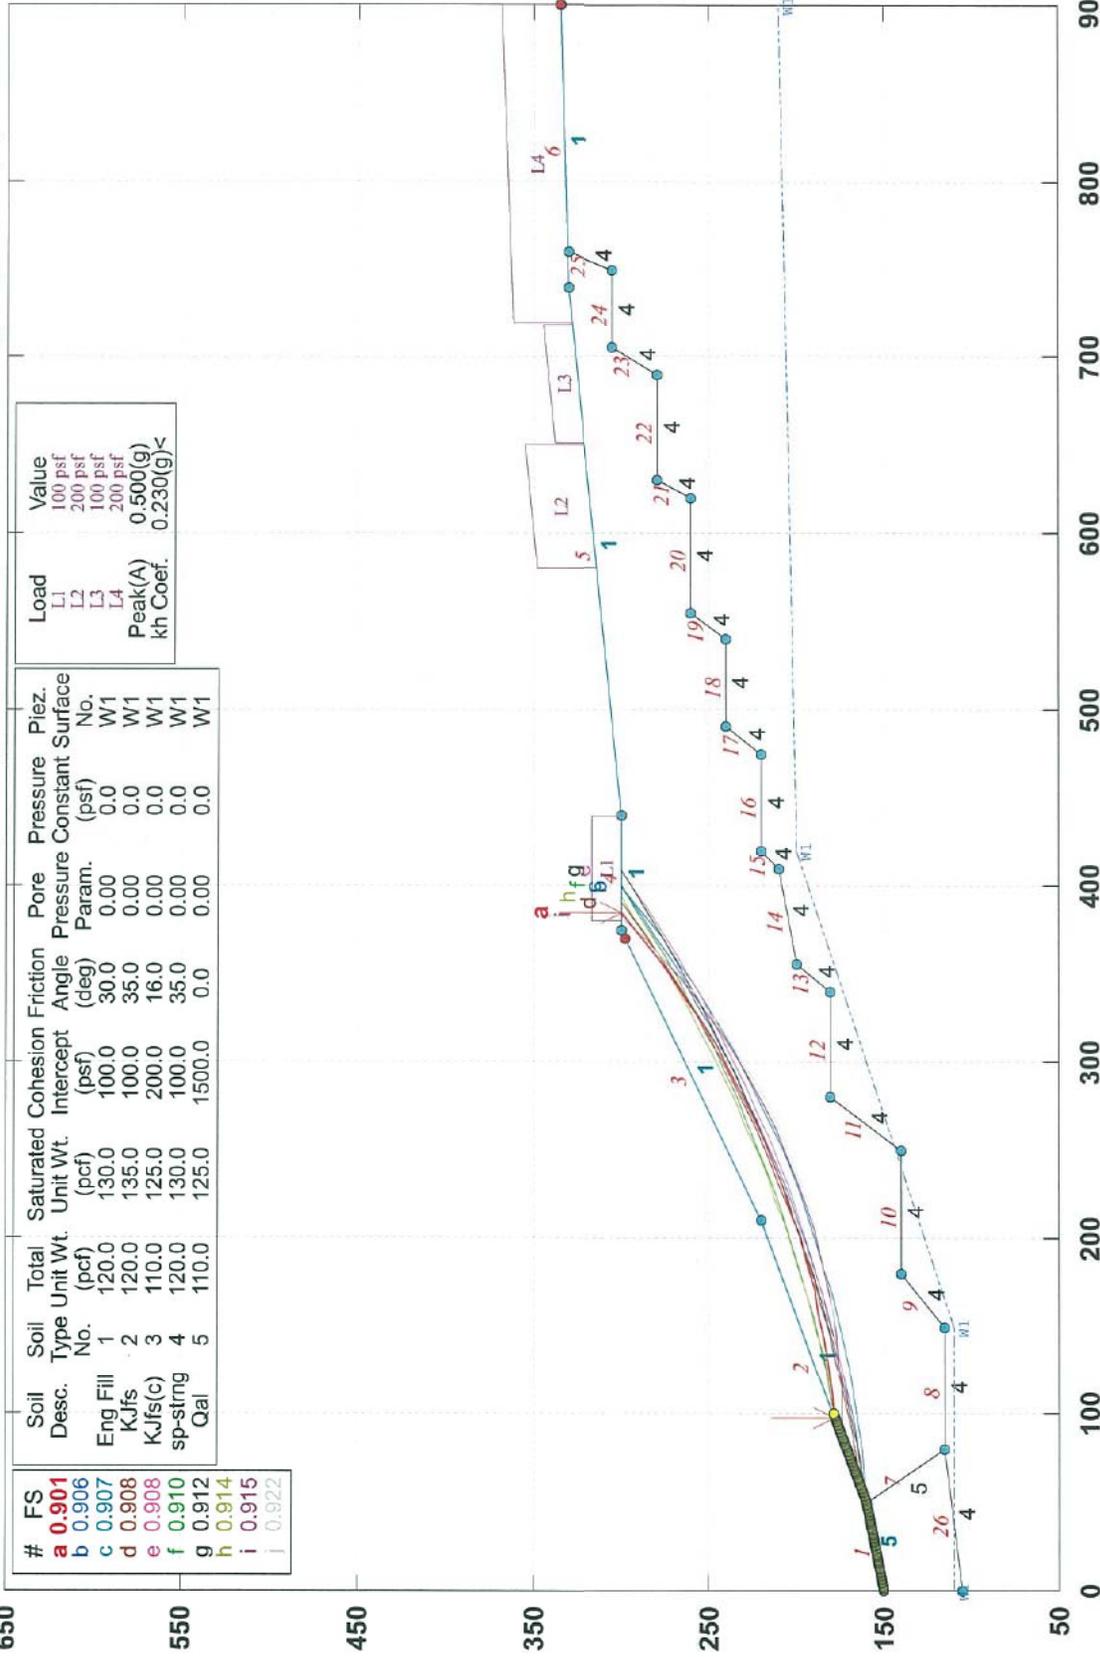
118-38-1 Comm Hill II- Section 1-1' seismic no mitigation

GSTABL7 v.2 FSmin=0.901
Safety Factors Are Calculated By The Modified Bishop Method

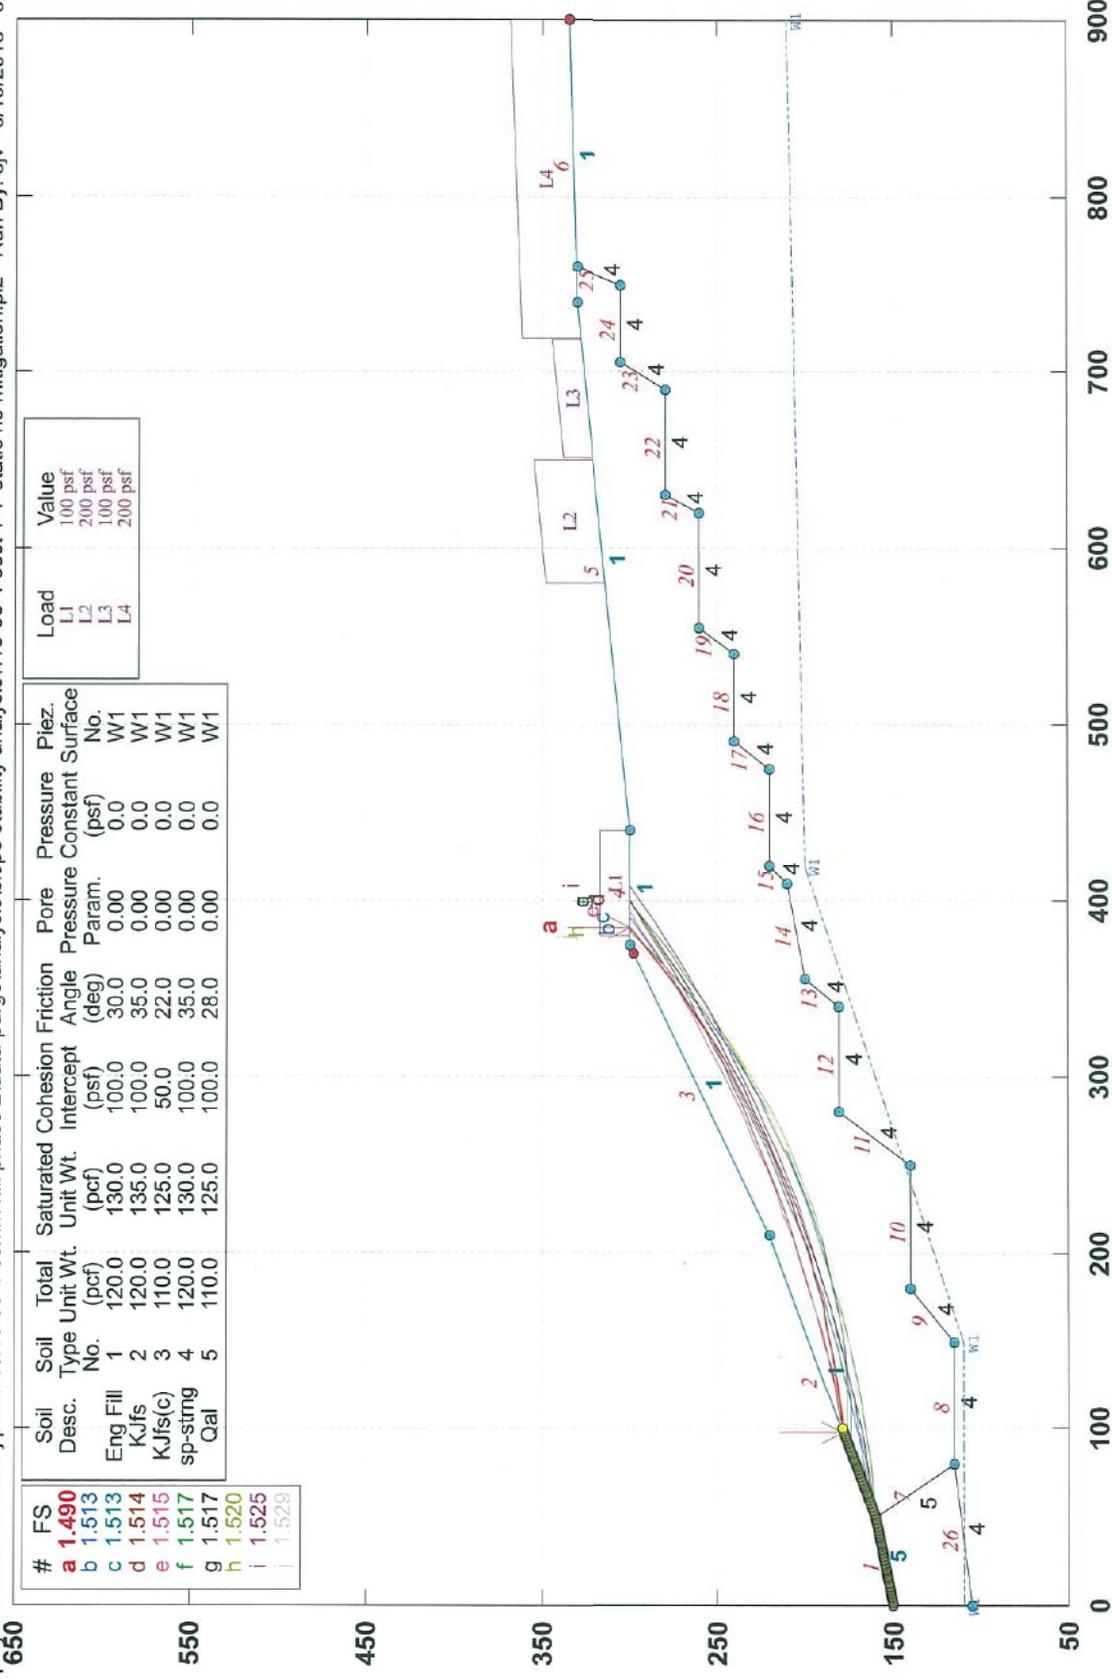
118-38-1 Comm Hill II- Section 1-1' static no mitigation

GSTABL7 v.2 FSmin=1.490
Safety Factors Are Calculated By The Modified Bishop Method

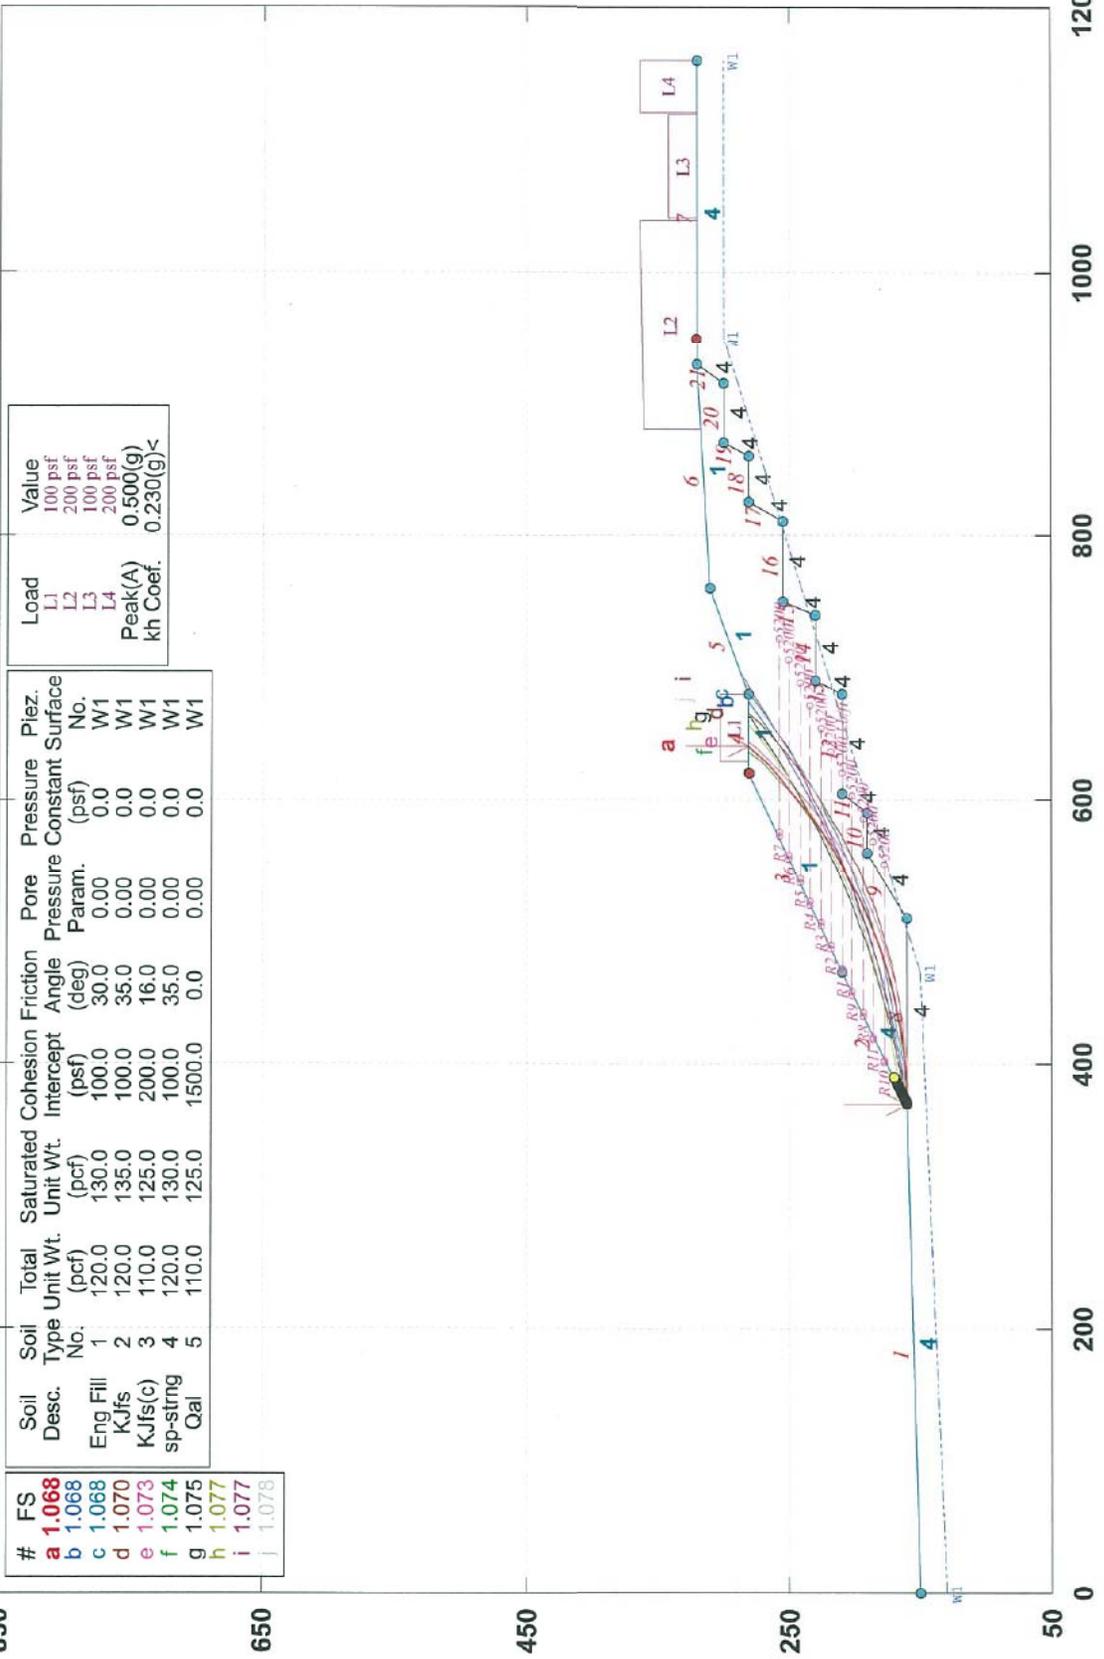
118-38-1 Comm Hill II- Section 2-2' seismic (8' grid spacing @ 150'L)

Load	Value
L1	100 psf
L2	200 psf
L3	100 psf
L4	200 psf
Peak(A)	0.500(g)
kh Coef.	0.230(g)<

#	FS	Soil Desc.	Soil Type No.	Total Unit Wt. (pcf)	Saturated Unit Wt. (pcf)	Intercept (psf)	Friction Angle (deg)	Pore Pressure Param.	Pressure Constant (psf)	Piez. No.
a	1.068	Eng Fill	1	120.0	130.0	100.0	30.0	0.00	0.0	W1
b	1.068	KJfs	2	120.0	135.0	100.0	35.0	0.00	0.0	W1
d	1.070	KJfs(c)	3	110.0	125.0	200.0	16.0	0.00	0.0	W1
f	1.074	sp-strng	4	120.0	130.0	100.0	35.0	0.00	0.0	W1
g	1.075	Qal	5	110.0	125.0	1500.0	0.0	0.00	0.0	W1

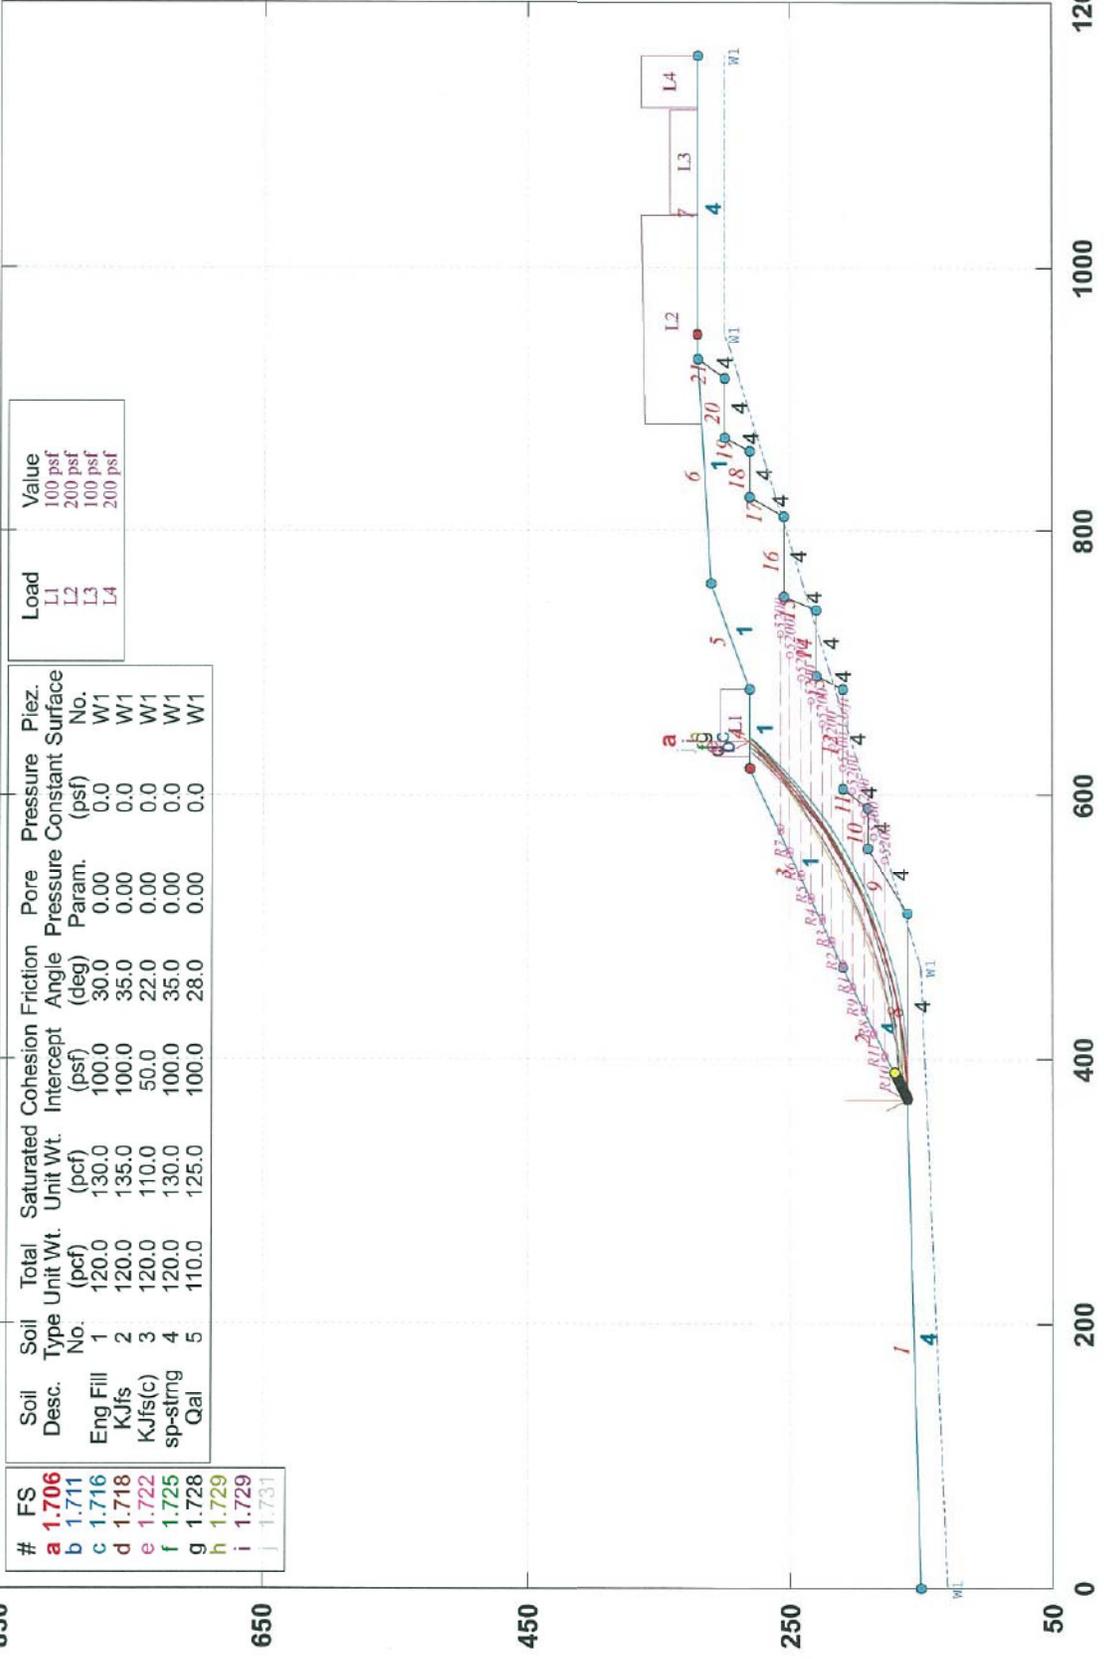
118-38-1 Comm Hill II- Section 2-2' static (8' grid spacing @ 150'L)

GSTABL7 v.2 FSmin=1.706
Safety Factors Are Calculated By The Modified Bishop Method
