Geologic and Geotechnical Hazards Investigation

Type of Services	Geologic and Geotechnical Hazards Investigation
Project Name	Communications Hill – Phase 2
Location	Communications Hill Boulevard San Jose, California
Client	David J. Powers & Associates, Inc.
Client Address	1871 The Alameda, Suite 200 San Jose, CA 95126
Project Number	118-38-1
Date	April 21, 2014

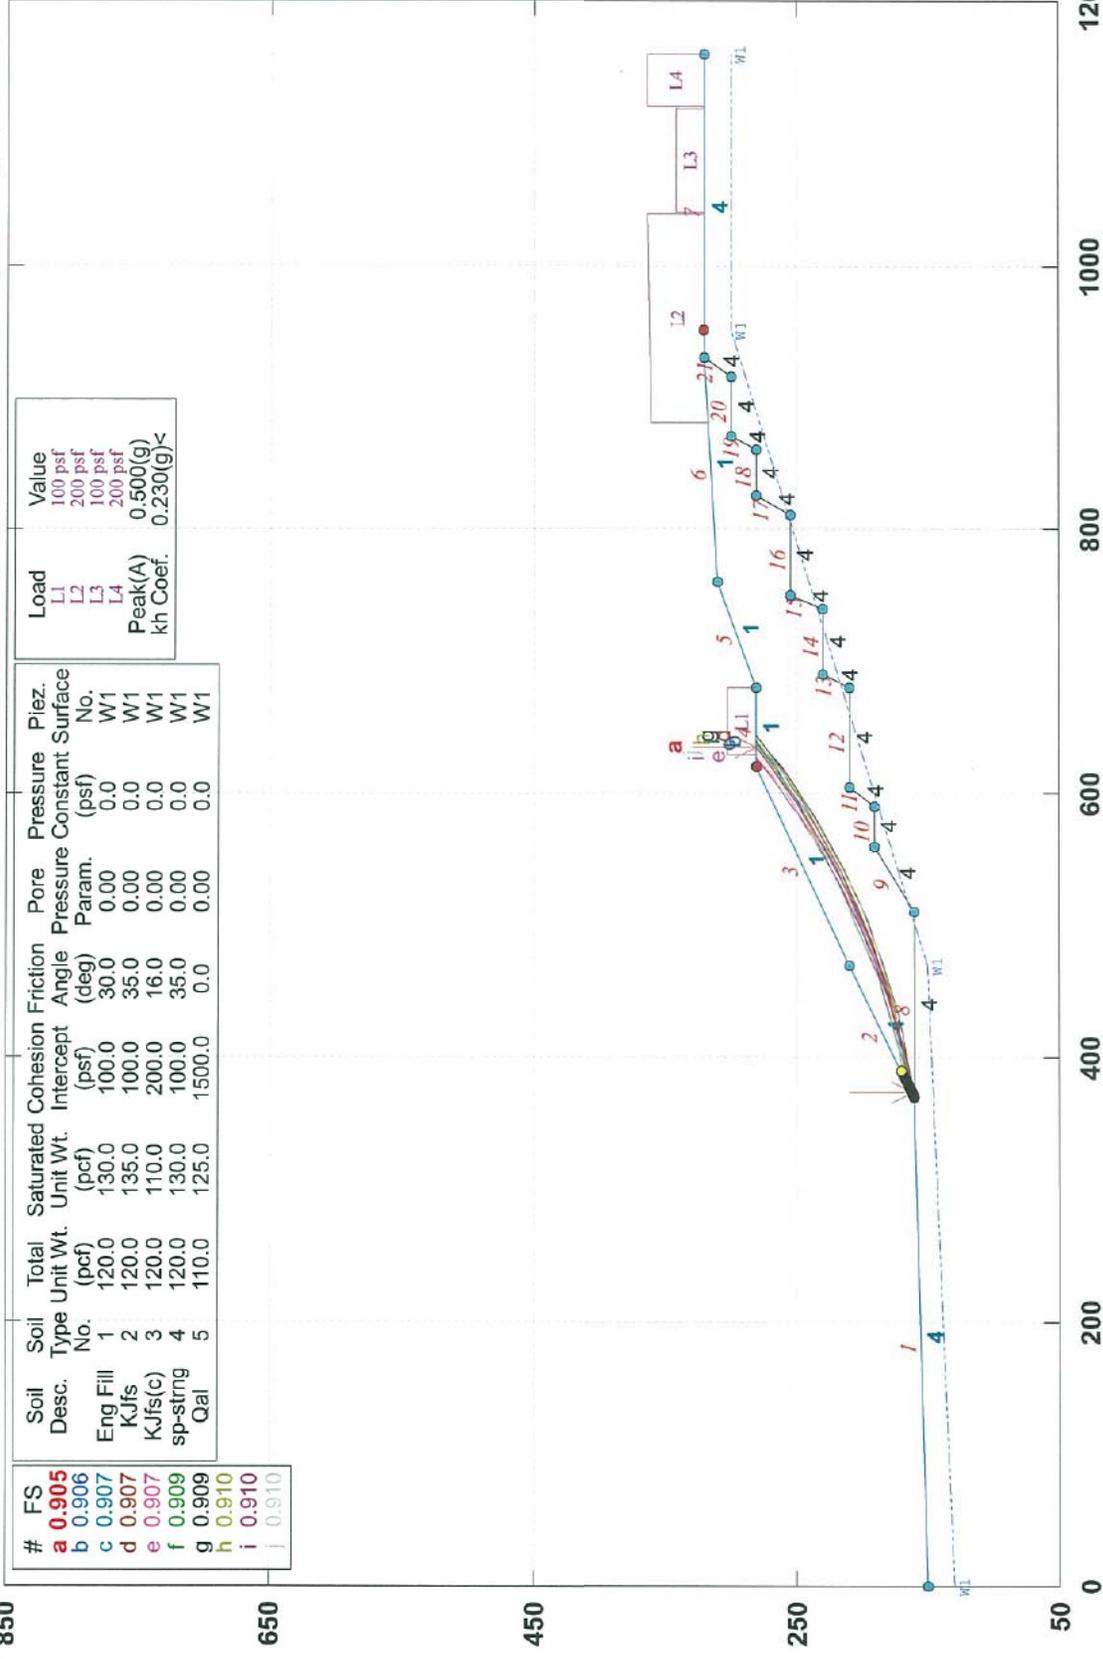
118-38-1 Comm Hill II- Section 2-2' seismic no mitigation

GSTABL7 v.2 FSmin=0.905
Safety Factors Are Calculated By The Modified Bishop Method

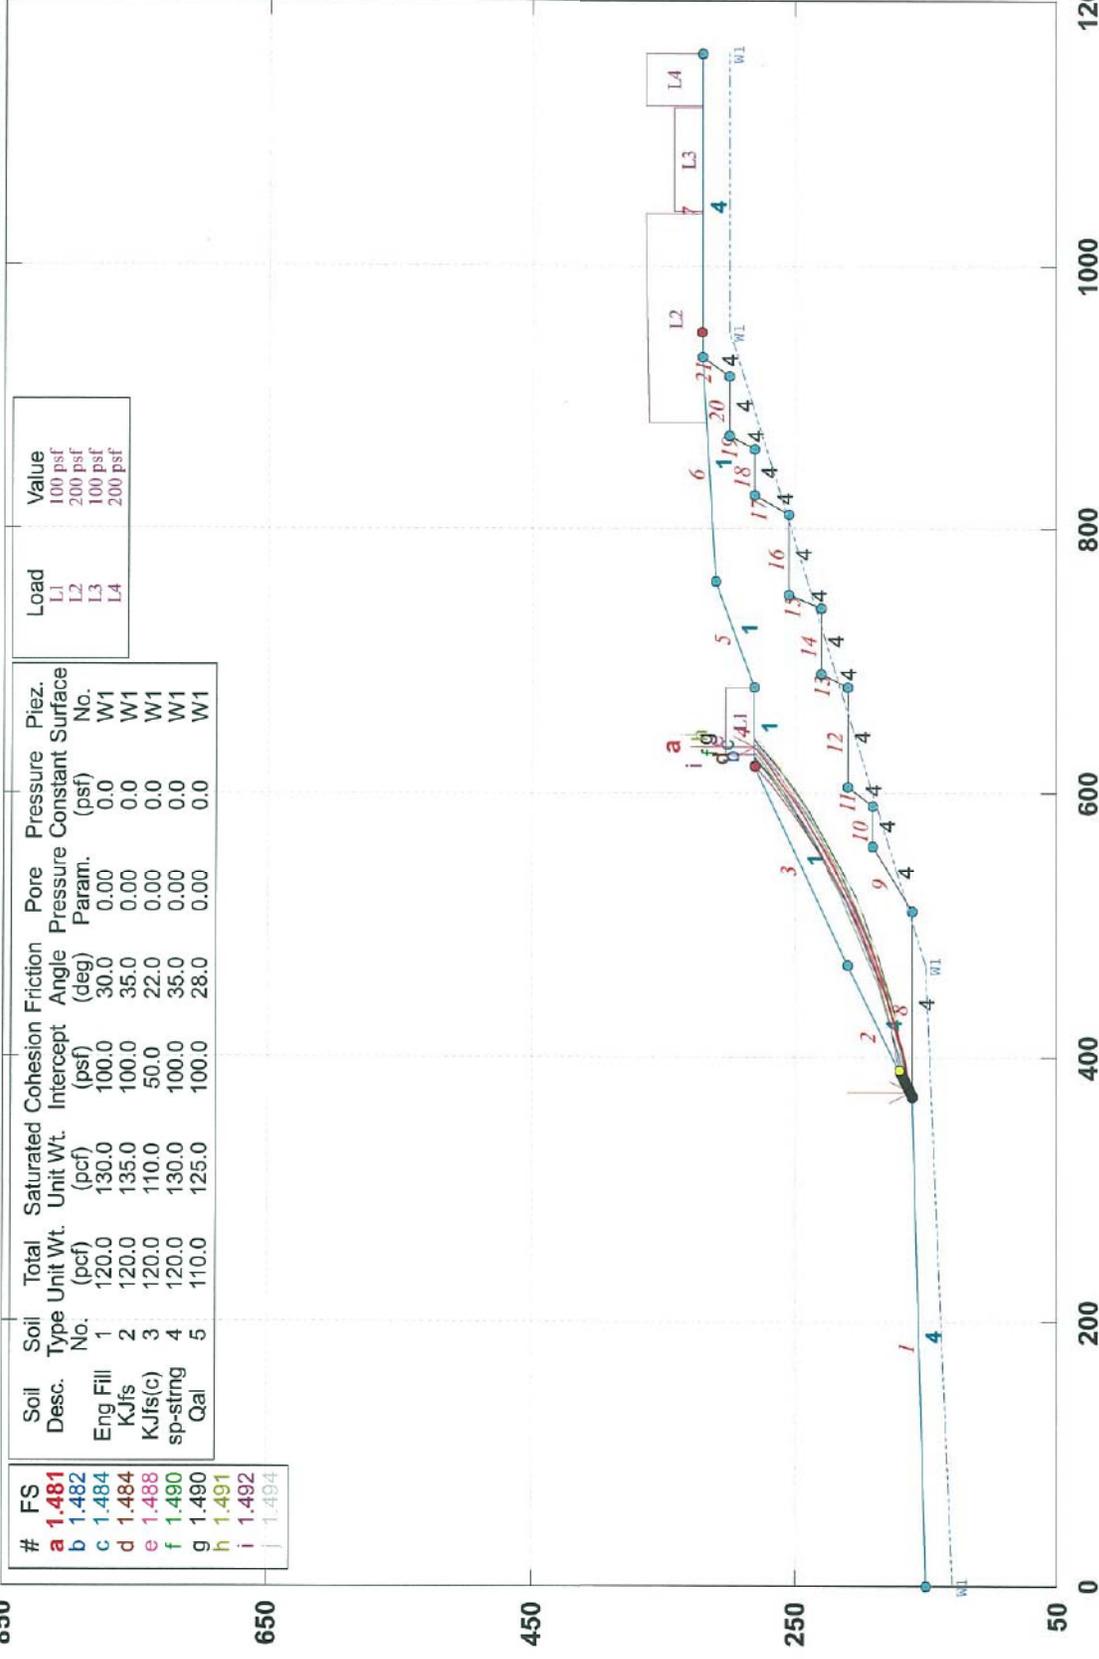
118-38-1 Comm Hill II- Section 2-2' static no mitigation

GSTABL7 v.2 FSmin=1.481
Safety Factors Are Calculated By The Modified Bishop Method

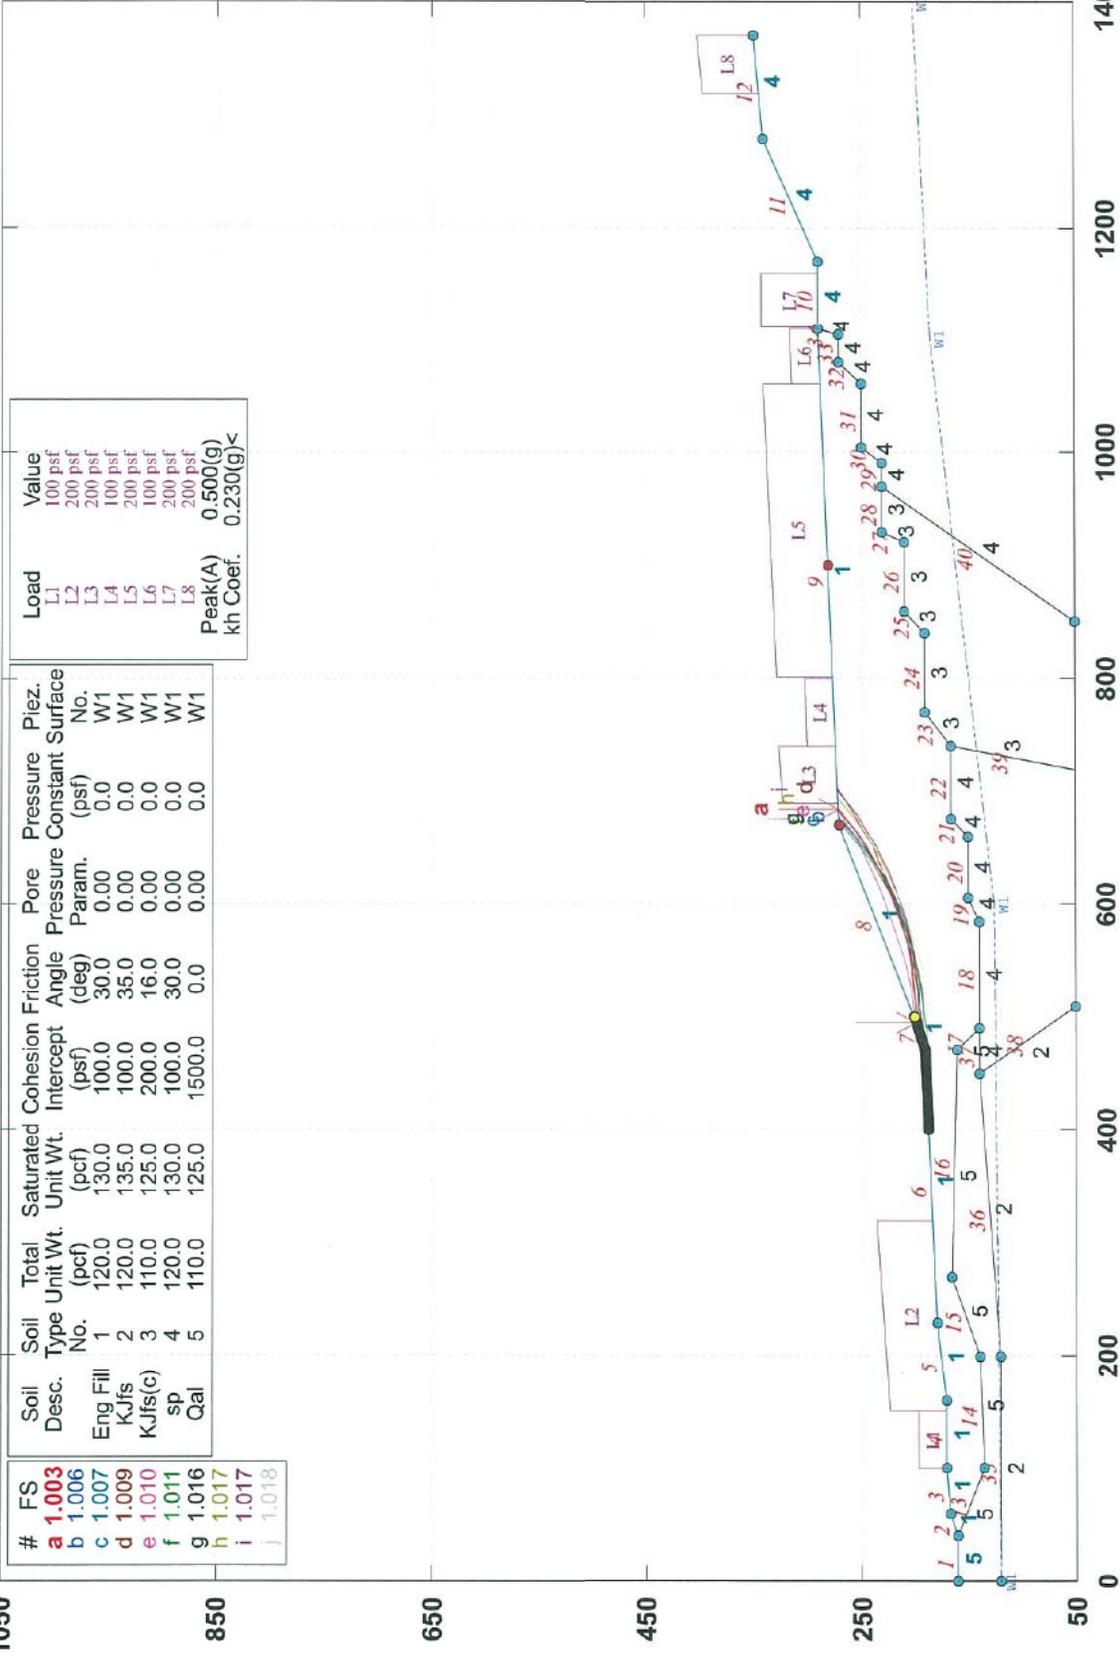
118-38-1 Comm Hill II- Section 3-3' seismic no mitigation

GSTABL7 v.2 FSmin=1.003

Safety Factors Are Calculated By The Modified Bishop Method

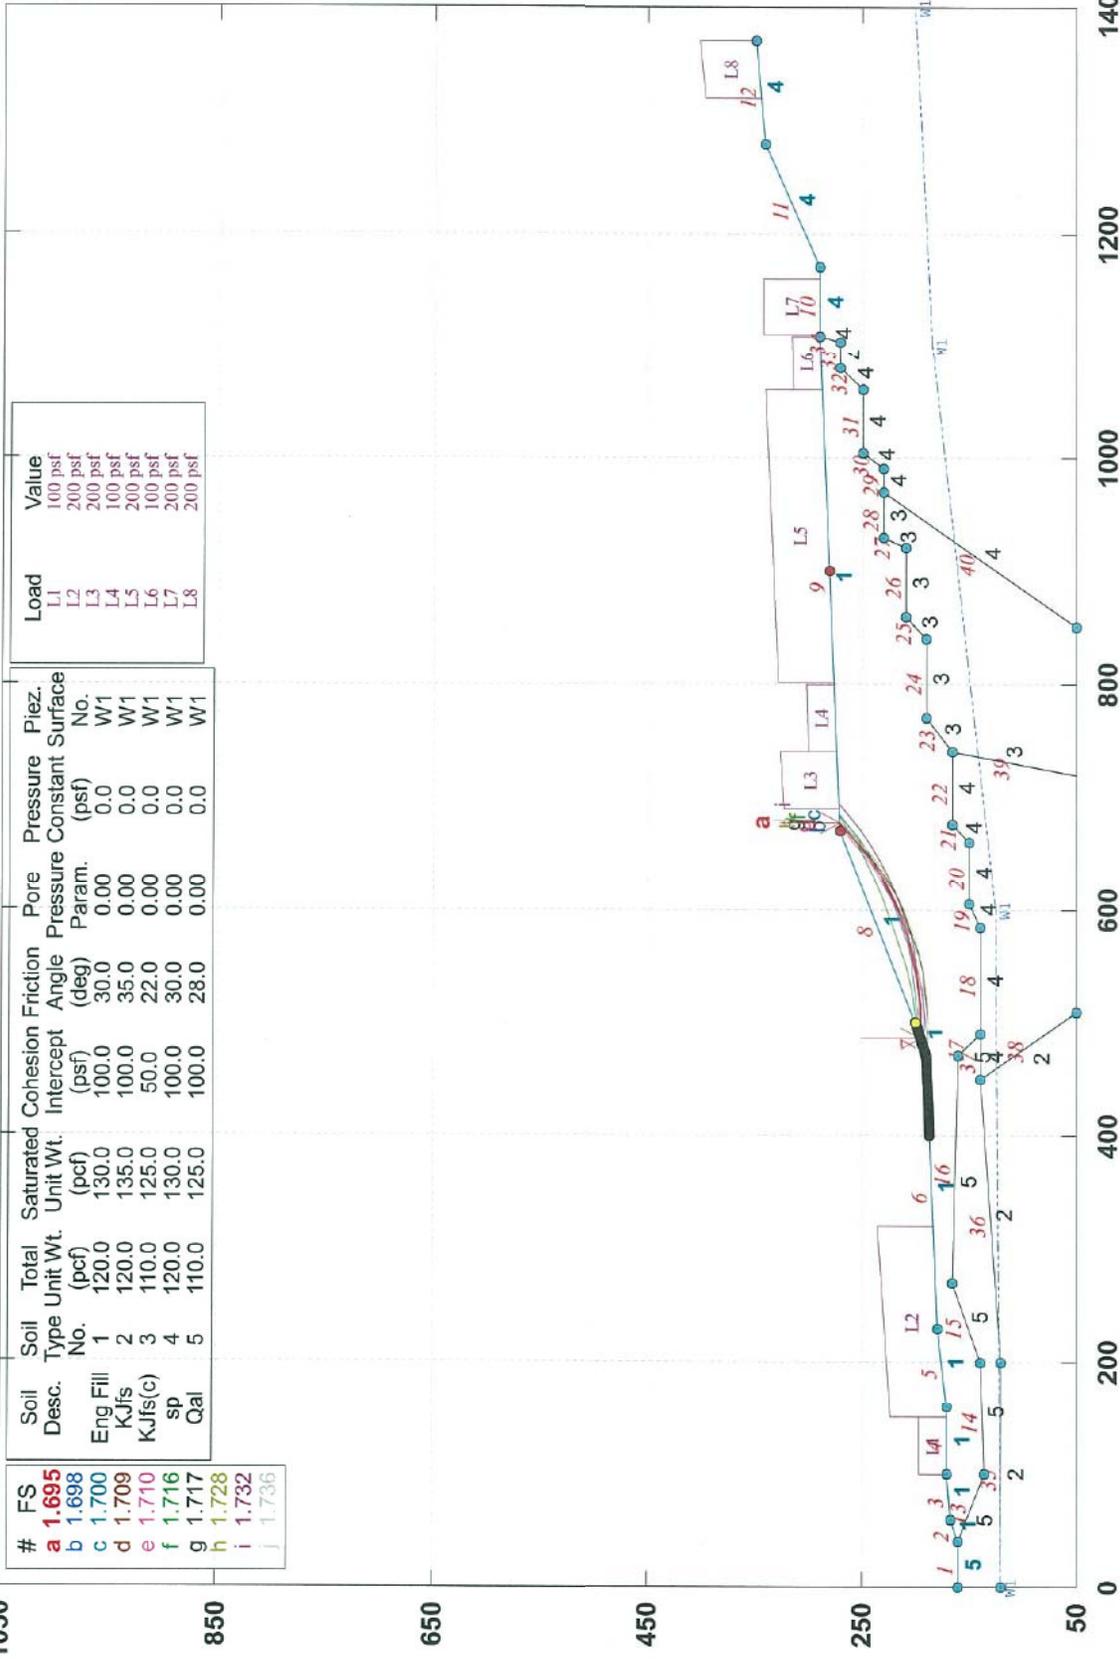
118-38-1 Comm Hill II- Section 3-3' static no mitigation

#	FS	Soil Desc.	Soil Type No.	Total Unit Wt. (pcf)	Saturated Unit Wt. (pcf)	Cohesion Intercept (psf)	Friction Angle (deg)	Pore Pressure Param. (psf)	Pressure Constant	Piez. Surface No.
a	1.695	Eng Fill	1	120.0	130.0	100.0	30.0	0.0	0.0	W1
b	1.698	Eng Fill	2	120.0	135.0	100.0	35.0	0.0	0.0	W1
c	1.700	KJfs	3	110.0	125.0	50.0	22.0	0.0	0.0	W1
d	1.709	KJfs(c)	4	120.0	130.0	100.0	30.0	0.0	0.0	W1
e	1.710	sp	5	110.0	125.0	100.0	28.0	0.0	0.0	W1
f	1.716	Qal	5	110.0	125.0	100.0	28.0	0.0	0.0	W1
g	1.717									
h	1.728									
i	1.732									
j	1.736

GSTABL7 v.2 FSmin=1.695
 Safety Factors Are Calculated By The Modified Bishop Method

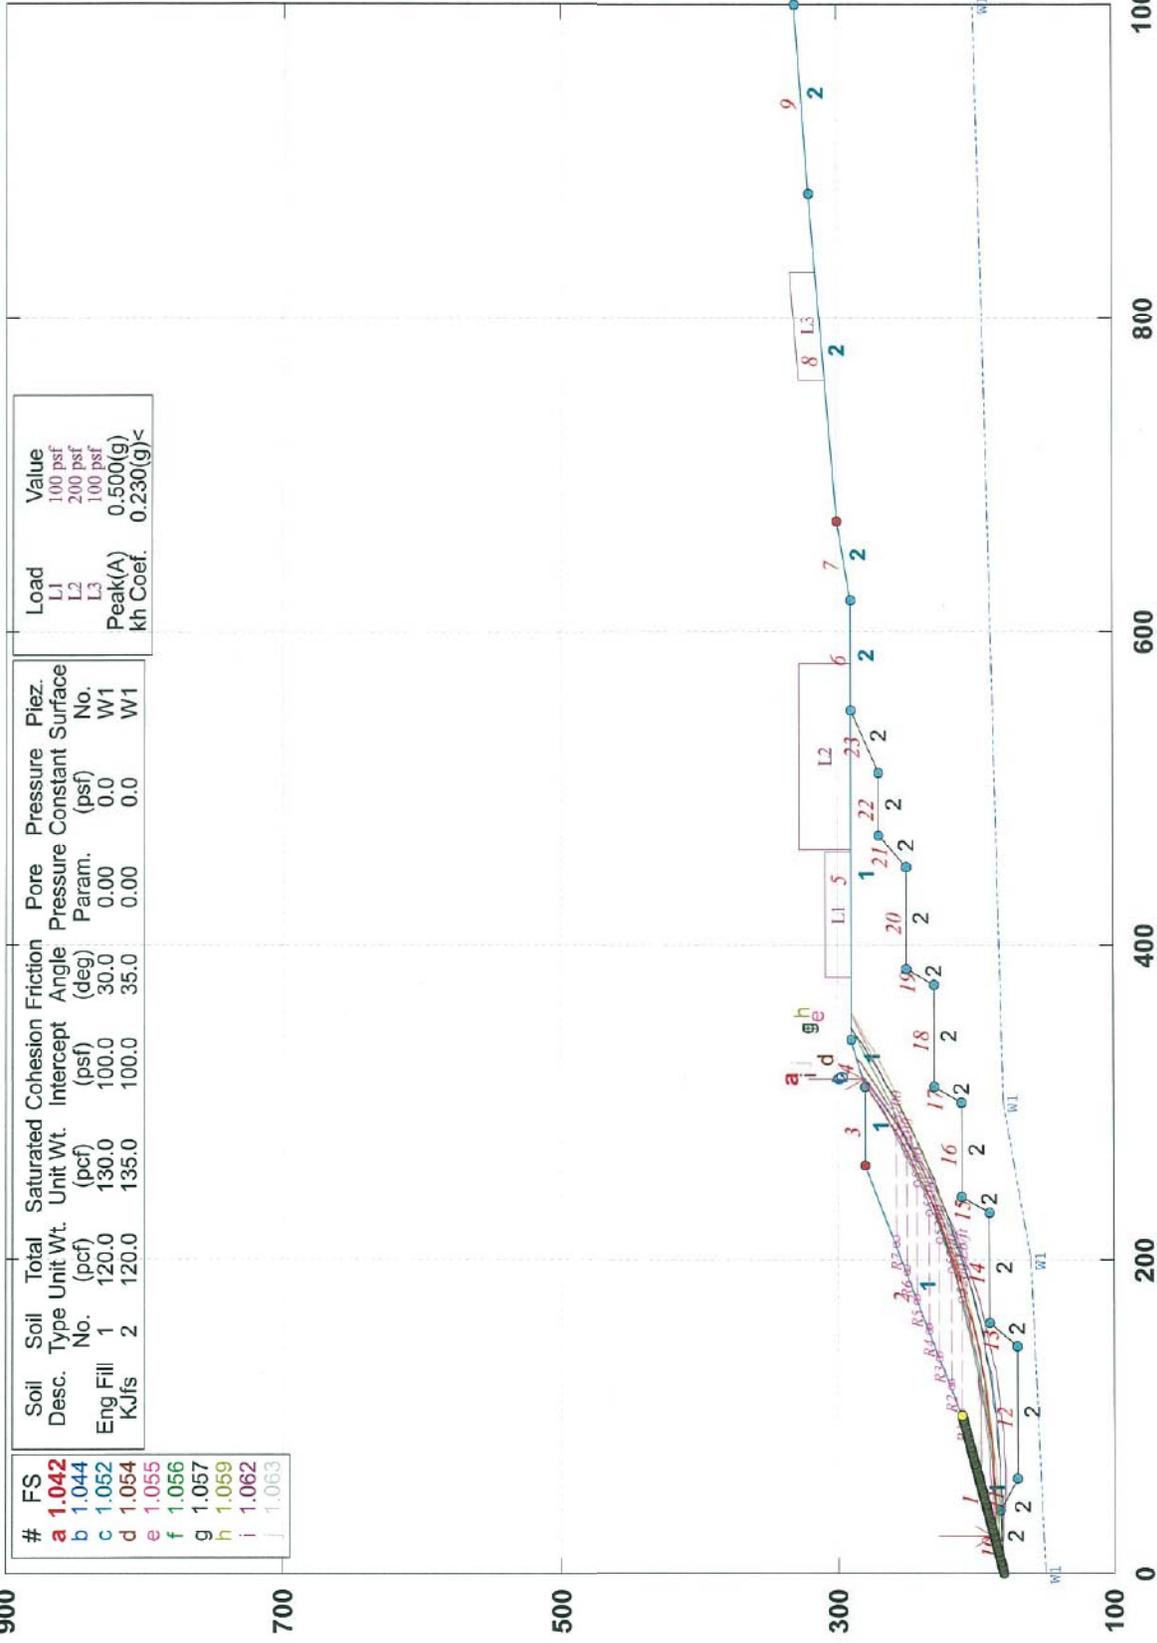
118-38-1 Comm Hill II- Section 4-4' seismic (8' grid spacing @ 75'L)

GSTABL7 v.2 FSmin=1.042
Safety Factors Are Calculated By The Modified Bishop Method

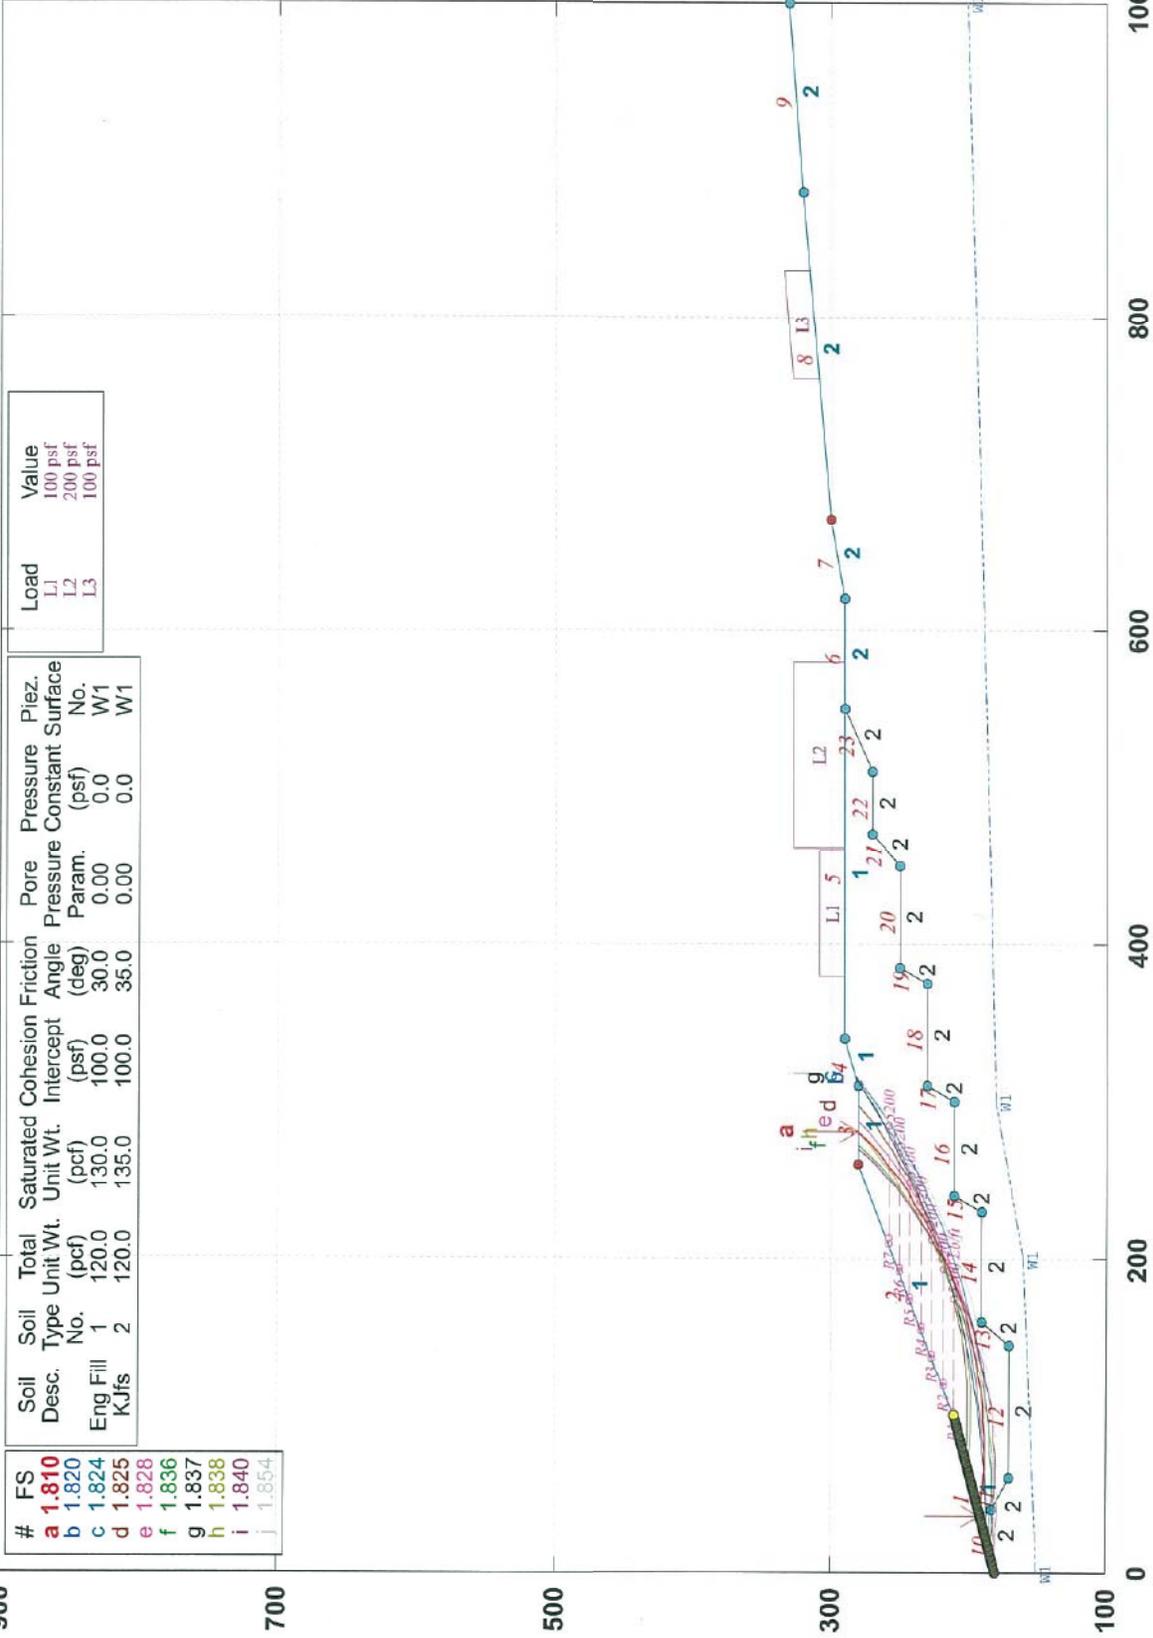
118-38-1 Comm Hill II- Section 4-4' static (8' grid spacing @ 75'L)

#	FS	Soil Desc.	Soil Type No.	Total Unit Wt. (pcf)	Saturated Unit Wt. (pcf)	Intercept (psf)	Friction Angle (deg)	Pore Pressure Param.	Pressure Constant (psf)	Piez. Constant	Surface No.
a	1.810		1	120.0	135.0	100.0	30.0	0.00	0.0	0.0	W1
b	1.820		2	120.0	135.0	100.0	35.0	0.00	0.0	0.0	W1
c	1.824										
d	1.825										
e	1.828										
f	1.836										
g	1.837										
h	1.838										
i	1.840										
j	1.854

Load	Value
L1	100 psf
L2	200 psf
L3	100 psf

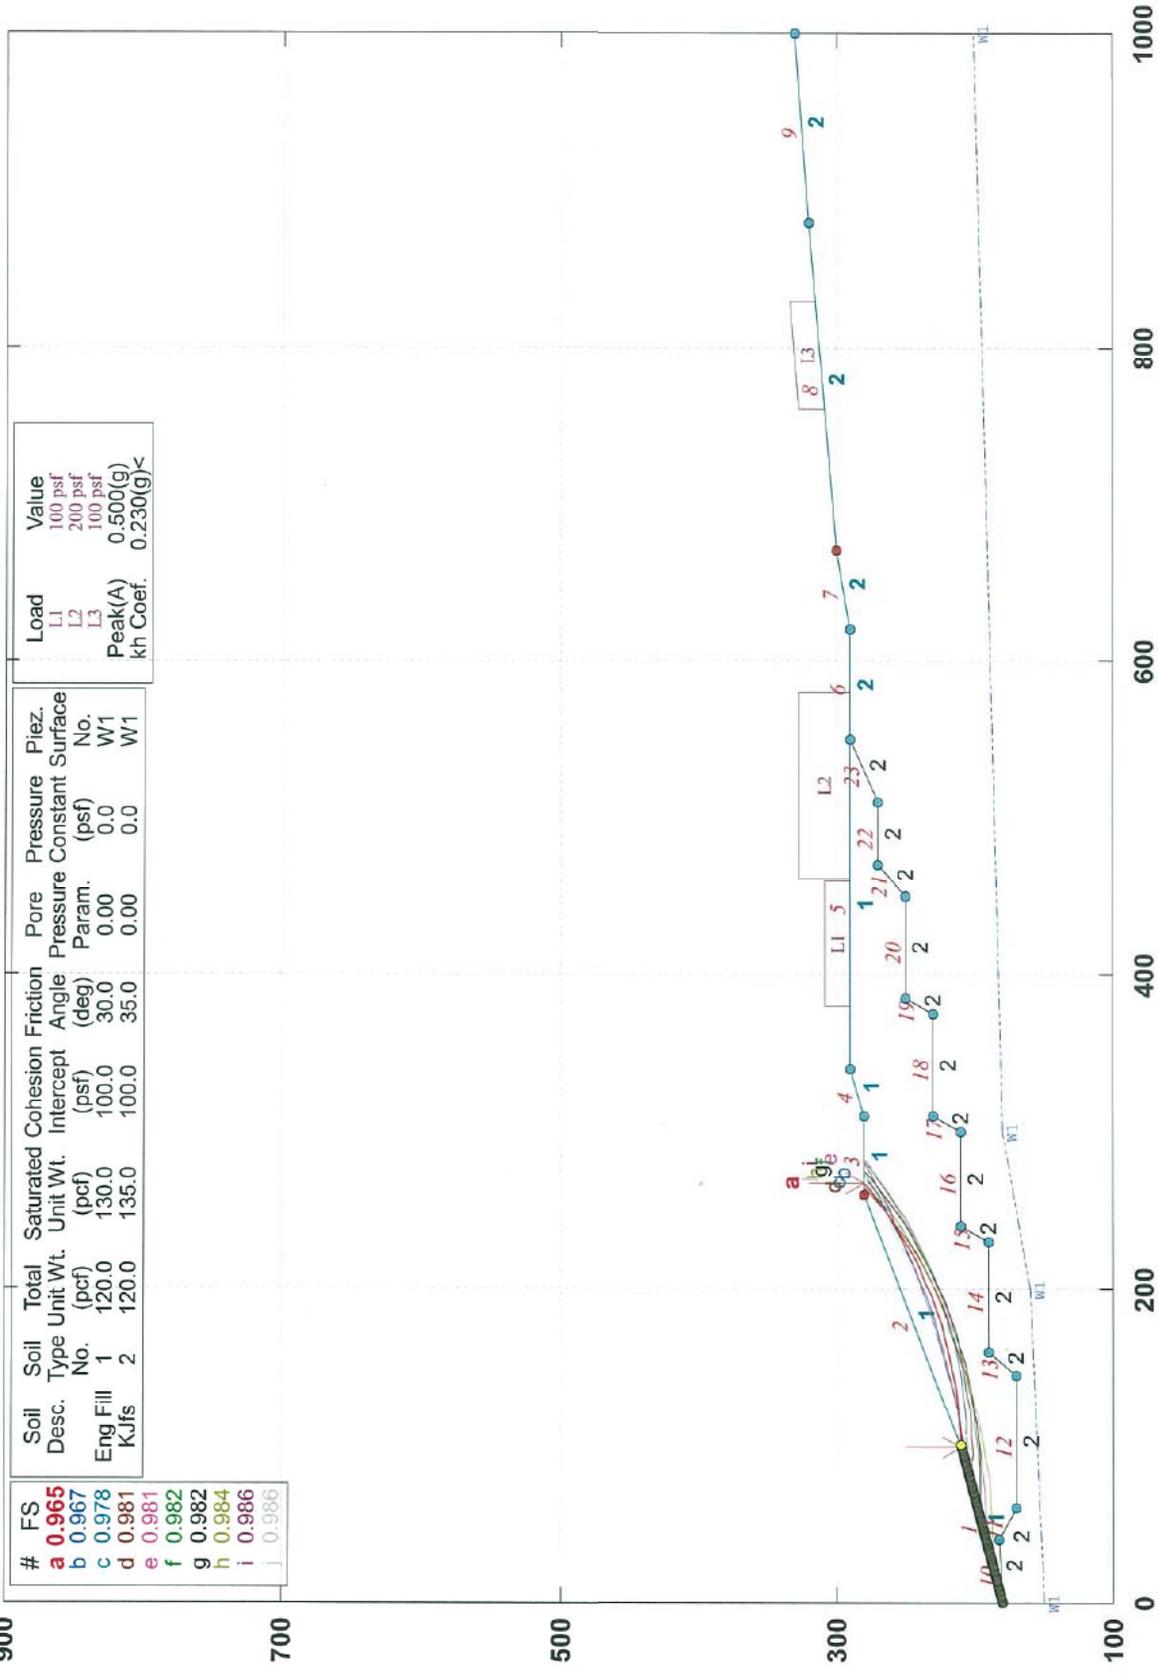
118-38-1 Comm Hill II- Section 4-4' seismic no mitigation

GSTABL7 v.2 FSmin=0.965
Safety Factors Are Calculated By The Modified Bishop Method

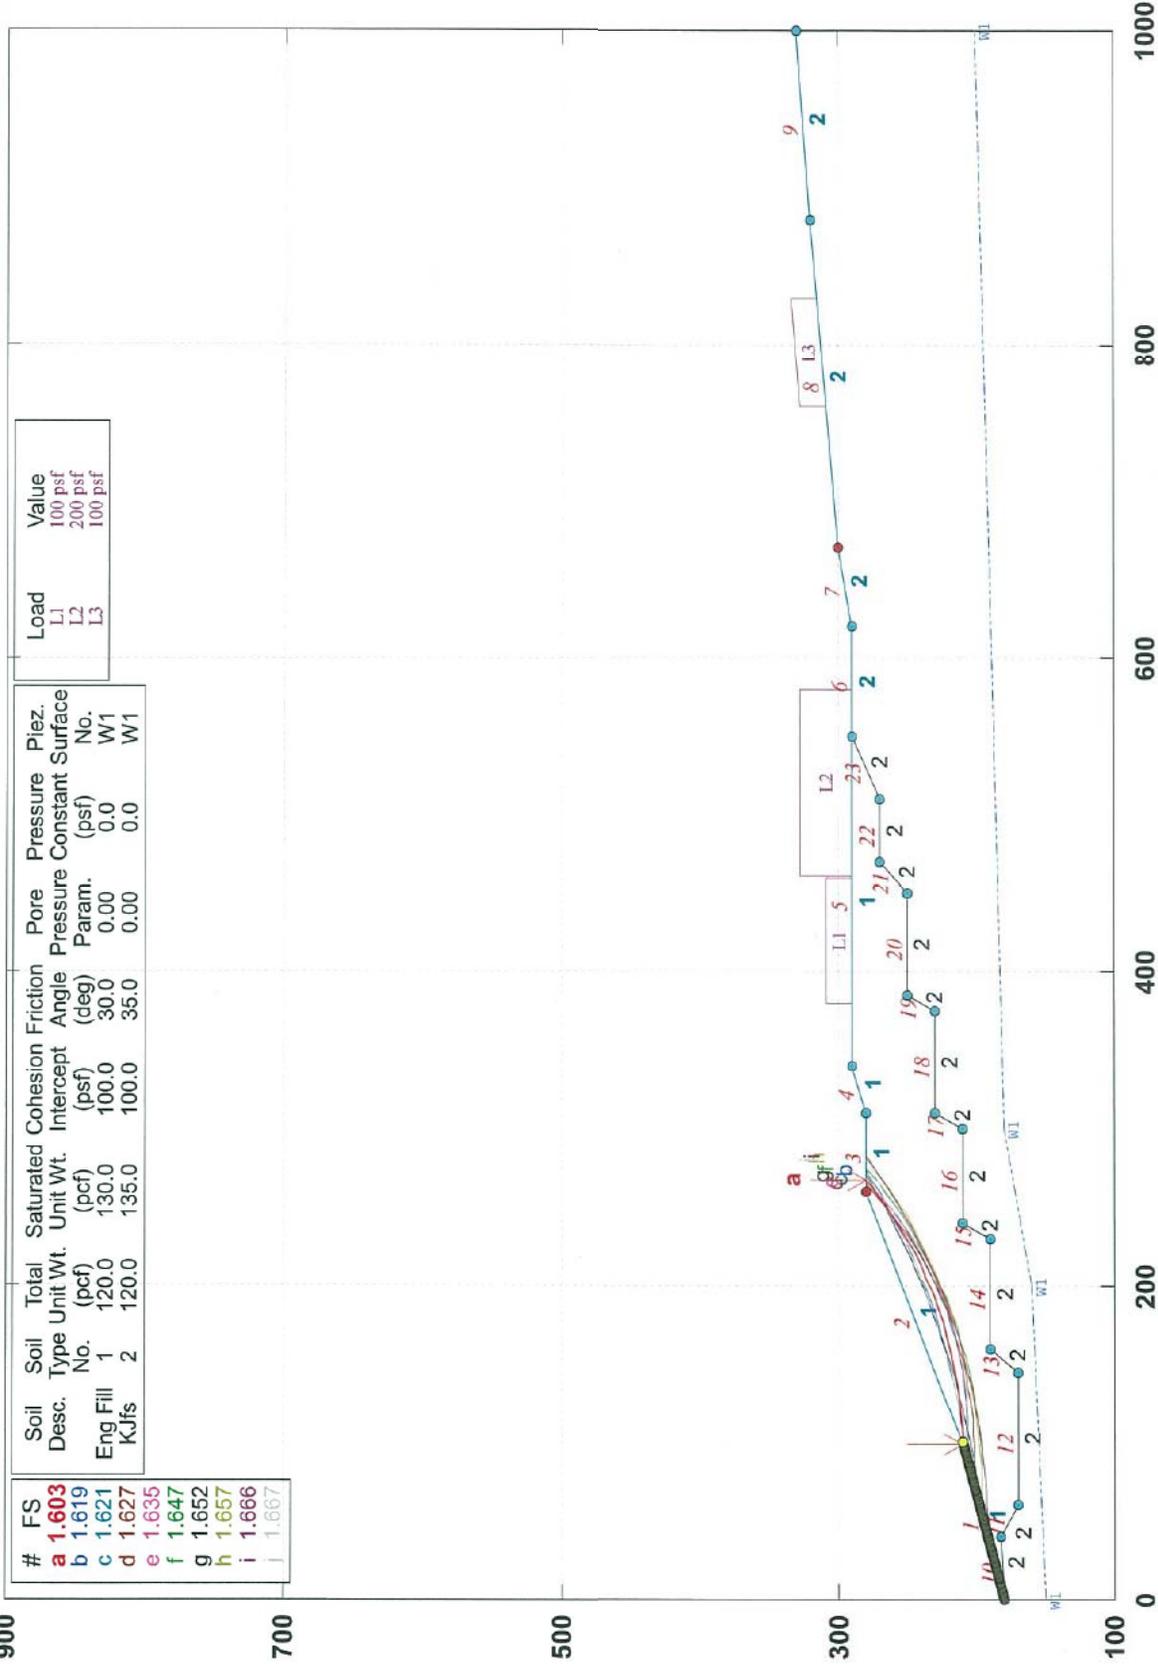
118-38-1 Comm Hill II- Section 4-4' static no mitigation

GSTABL7 v.2 FSmin=1.603
Safety Factors Are Calculated By The Modified Bishop Method

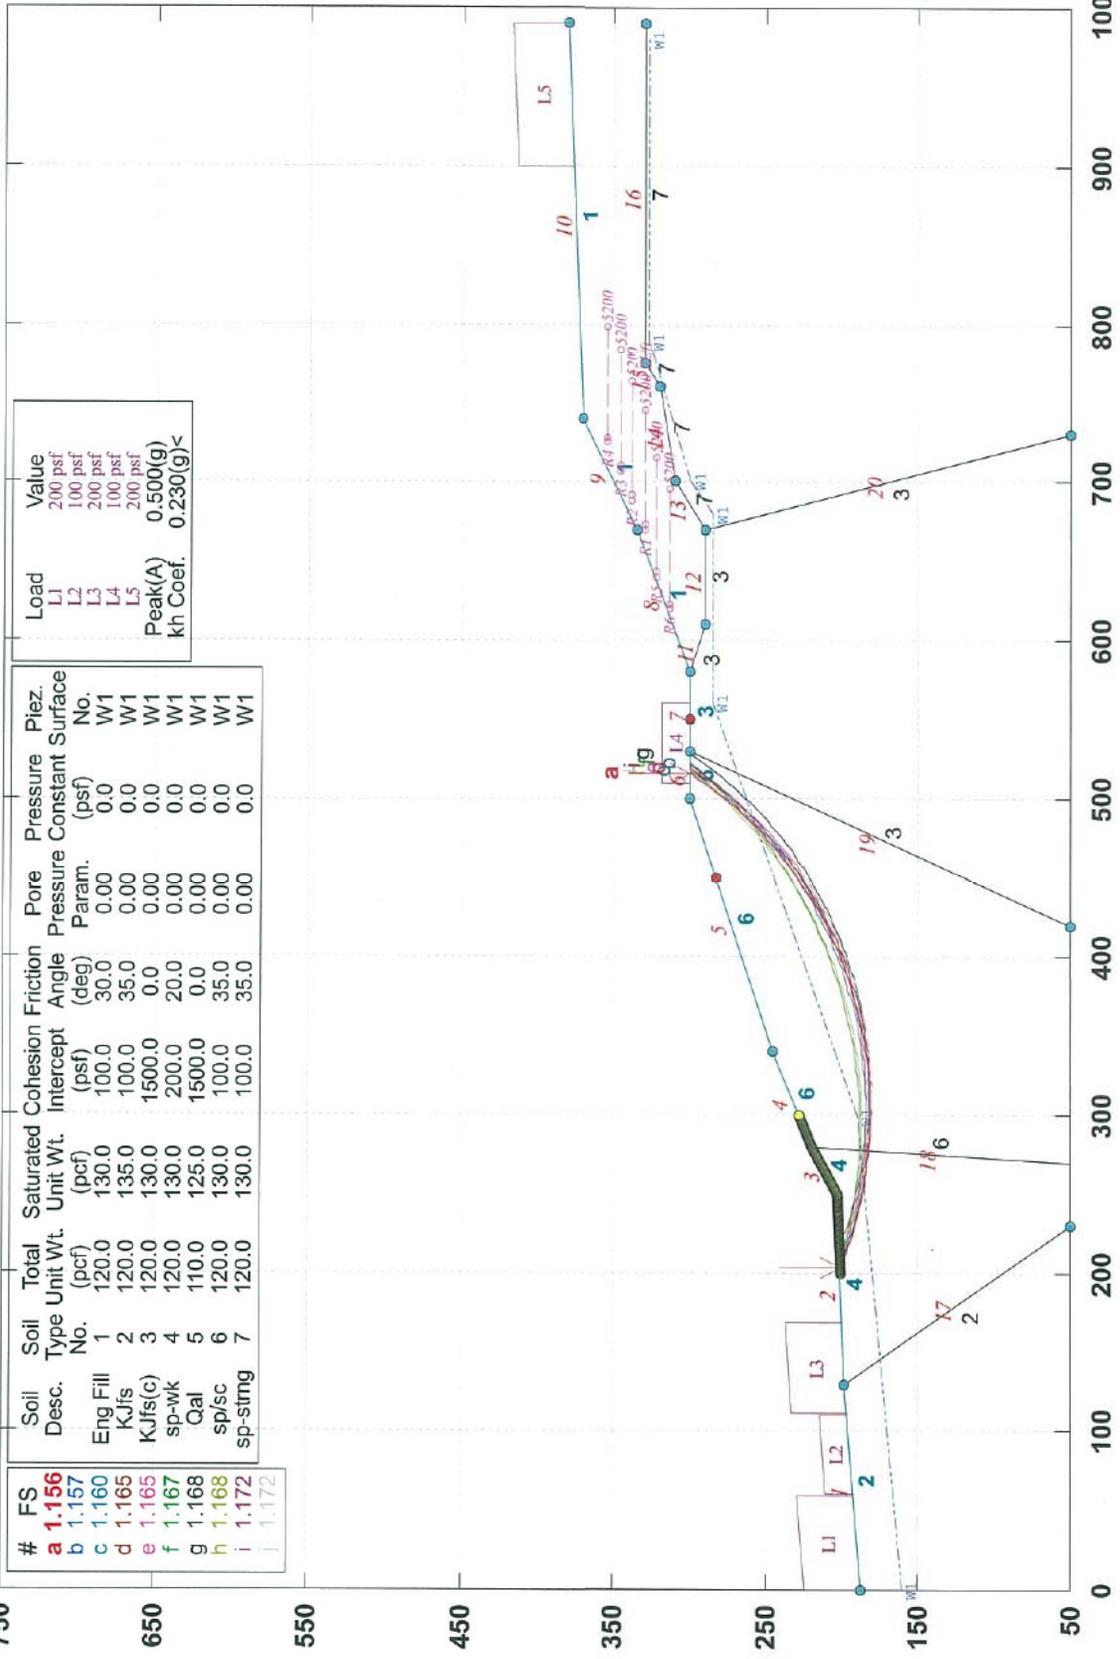
118-38-1 Comm Hill II- Section 5-5' seismic lower slope

Load	Value
L1	200 psf
L2	100 psf
L3	200 psf
L4	100 psf
L5	200 psf

Soil Desc.	Soil Type No.	Total Unit Wt. (pcf)	Saturated Unit Wt. (pcf)	Cohesion Intercept (psf)	Friction Angle (deg)	Pore Pressure Param.	Constant (psf)	Piez. No.
Eng Fill	1	120.0	130.0	100.0	30.0	0.0	0.0	W1
KJfs	2	120.0	135.0	100.0	35.0	0.0	0.0	W1
KJfs(c)	3	120.0	130.0	1500.0	0.0	0.0	0.0	W1
sp-wk	4	120.0	130.0	200.0	20.0	0.0	0.0	W1
Qal	5	110.0	125.0	1500.0	0.0	0.0	0.0	W1
sp/sc	6	120.0	130.0	100.0	35.0	0.0	0.0	W1
sp-string	7	120.0	130.0	100.0	35.0	0.0	0.0	W1

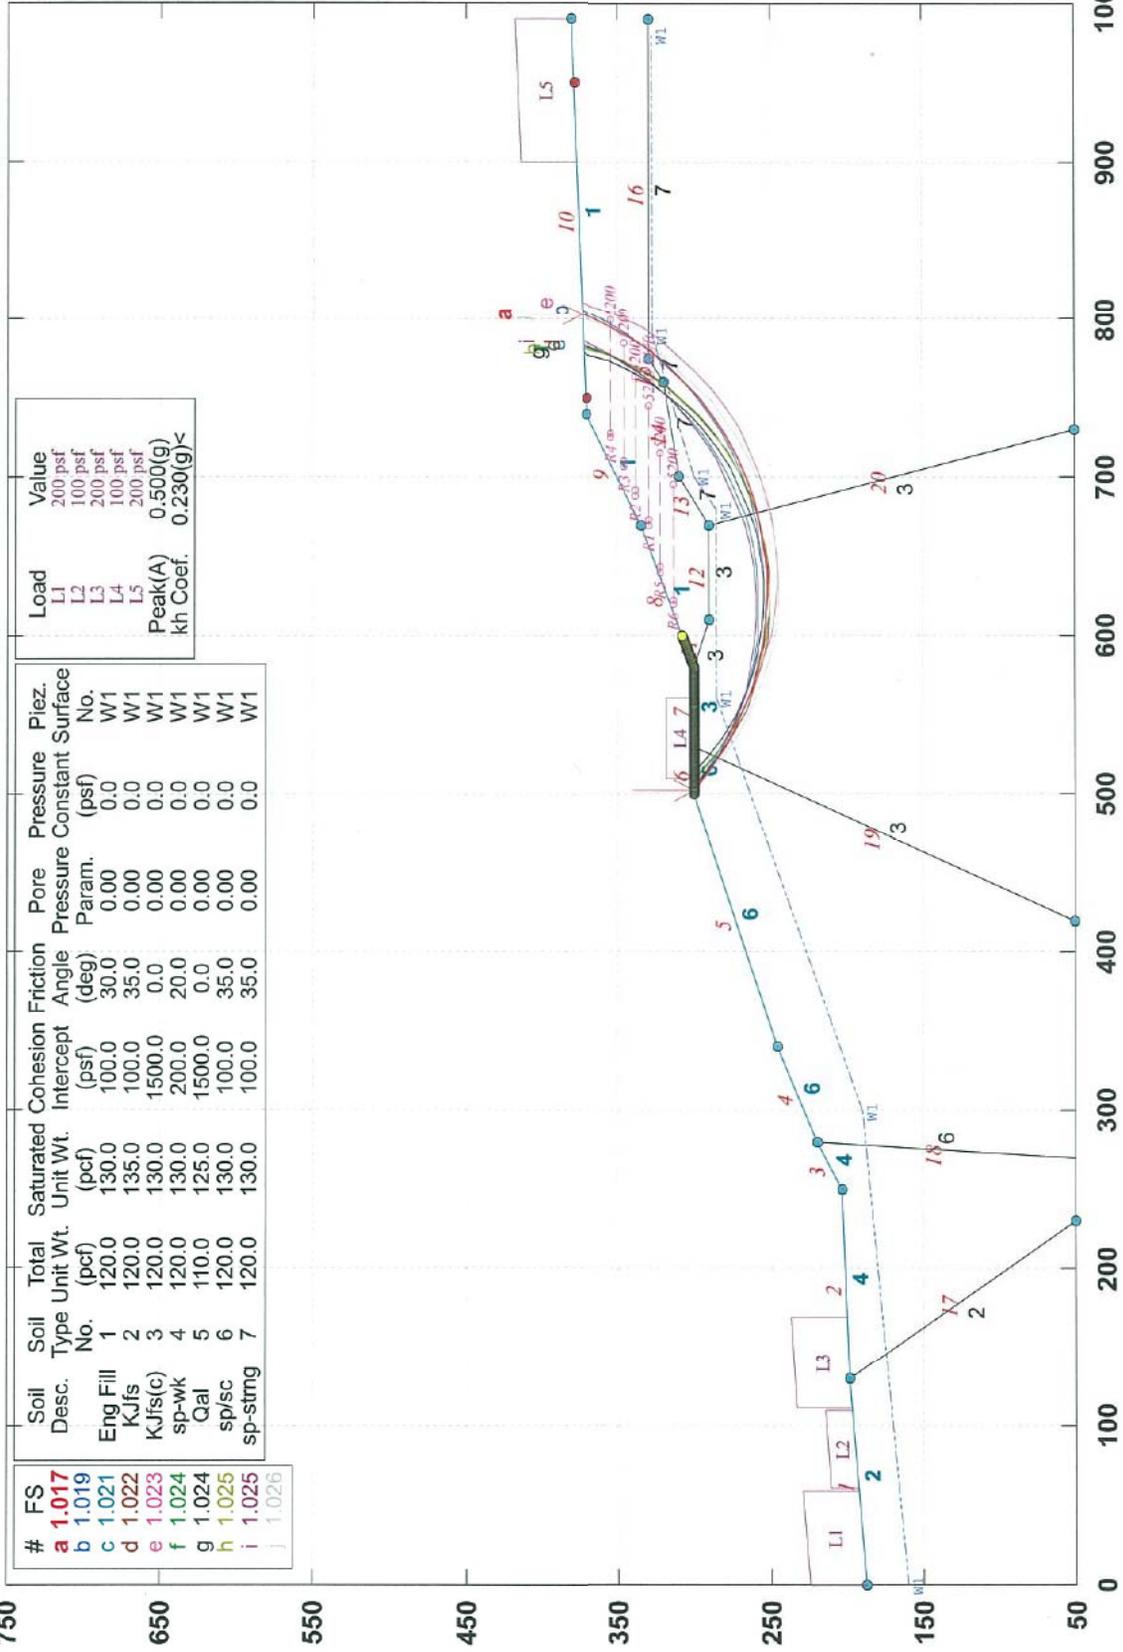
118-38-1 Comm Hill II- Section 5-5' seismic upper slope

#	FS	Soil Desc.	Soil Type No.	Total Unit Wt. (pcf)	Saturated Unit Wt. (pcf)	Cohesion Intercept (psf)	Friction Angle (deg)	Pore Pressure Param. (psf)	Pressure Constant	Piez. No.
a	1.017	Eng Fill	1	120.0	130.0	100.0	30.0	0.0	0.0	W1
b	1.019	KJfs	2	120.0	135.0	100.0	35.0	0.0	0.0	W1
c	1.021	KJfs(c)	3	120.0	130.0	1500.0	0.0	0.0	0.0	W1
d	1.022	sp-wk Gal	4	120.0	130.0	200.0	20.0	0.0	0.0	W1
e	1.023	sp/sc	5	110.0	125.0	1500.0	0.0	0.0	0.0	W1
f	1.024	sp-string	6	120.0	130.0	100.0	35.0	0.0	0.0	W1
g	1.024		7	120.0	130.0	100.0	35.0	0.0	0.0	W1
h	1.025									
i	1.025									
j	1.026

Load	Value
L1	200 psf
L2	100 psf
L3	200 psf
L4	100 psf
L5	200 psf
Peak(A)	0.500(g)
kh Coef.	0.230(g)<

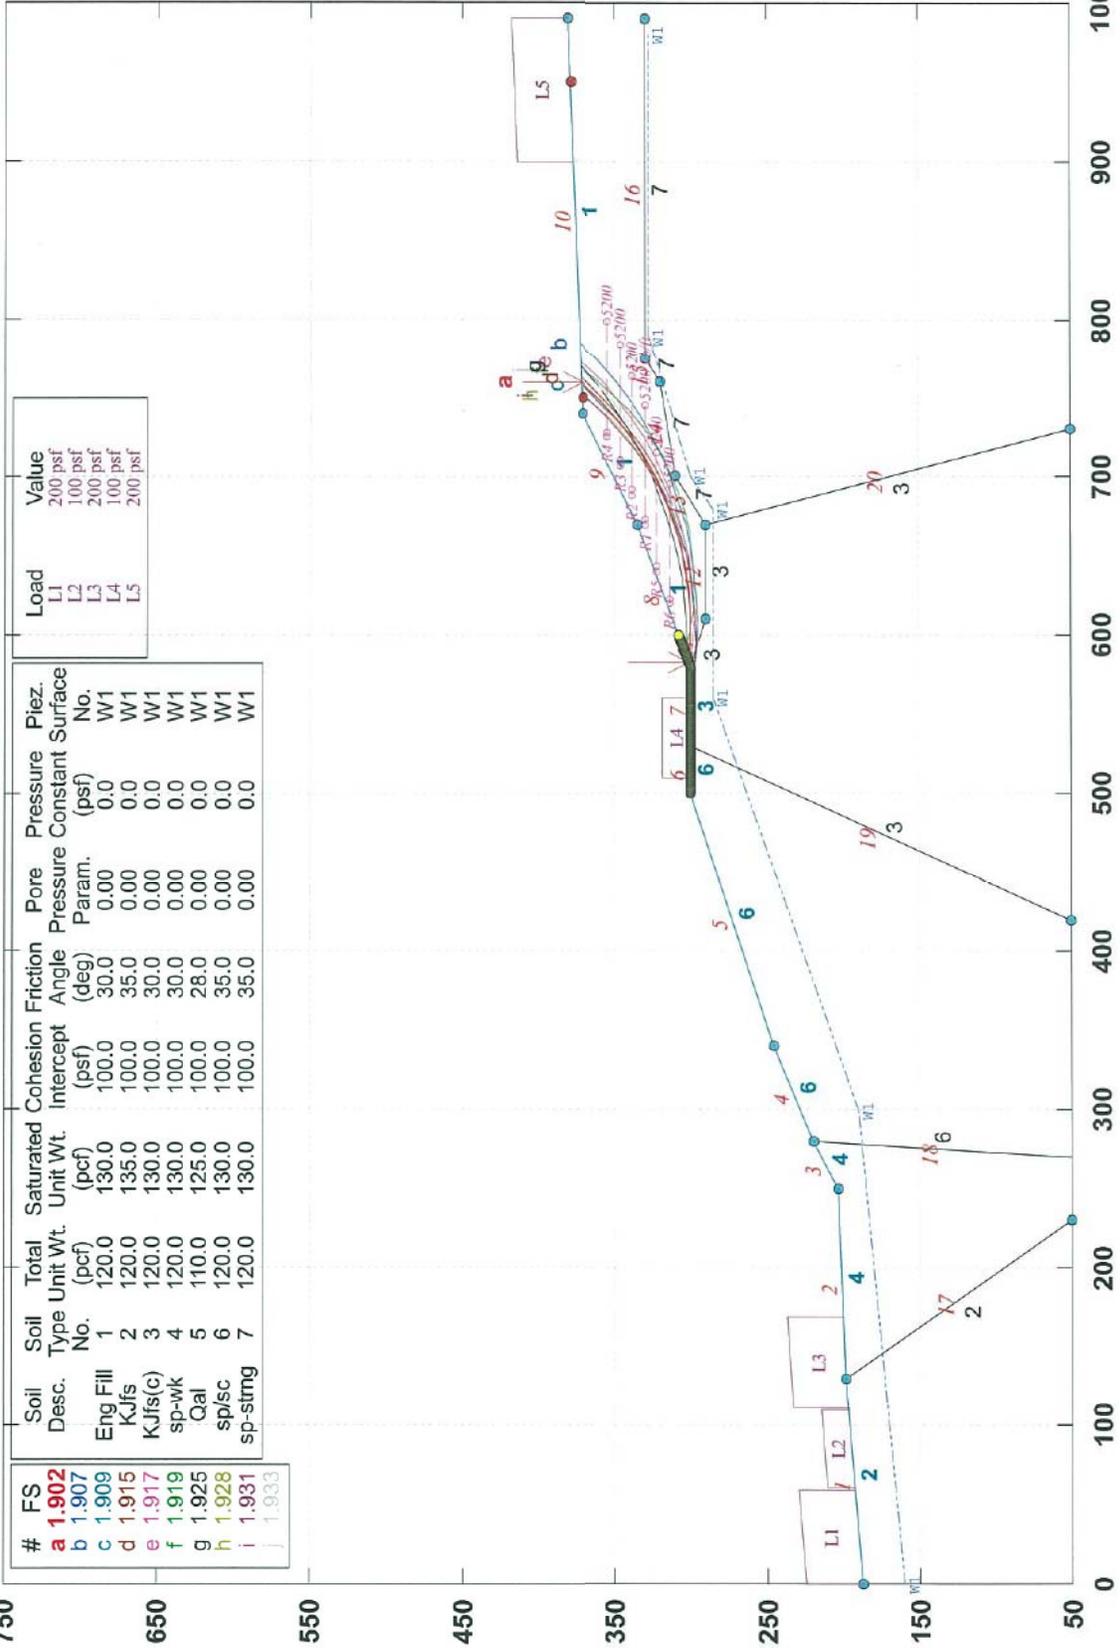
118-38-1 Comm Hill II- Section 5-5' static upper slope

Load	Value
L1	200 psf
L2	100 psf
L3	200 psf
L4	100 psf
L5	200 psf

#	FS	Soil Desc.	Soil Type No.	Total Unit Wt. (pcf)	Saturated Unit Wt. (pcf)	Cohesion Intercept (psf)	Friction Angle (deg)	Pore Pressure Param.	Pressure Constant (psf)	Piez. No.
a	1.902	Eng Fill	1	120.0	130.0	100.0	30.0	0.00	0.0	W1
b	1.907	KJfs	2	120.0	135.0	100.0	35.0	0.00	0.0	W1
c	1.909	KJfs(c)	3	120.0	130.0	100.0	30.0	0.00	0.0	W1
d	1.915	sp-wk	4	120.0	130.0	100.0	30.0	0.00	0.0	W1
e	1.917	Qal	5	110.0	125.0	100.0	28.0	0.00	0.0	W1
f	1.919	sp/sc	6	120.0	130.0	100.0	35.0	0.00	0.0	W1
g	1.925	sp-sitm	7	120.0	130.0	100.0	35.0	0.00	0.0	W1
h	1.928									
i	1.931									
j	1.933
