Geologic and Geotechnical Hazards Investigation

Type of Services	Geologic and Geotechnical Hazards Investigation
Project Name	Communications Hill – Phase 2
Location	Communications Hill Boulevard San Jose, California
Client	David J. Powers & Associates, Inc.
Client Address	1871 The Alameda, Suite 200 San Jose, CA 95126
Project Number	118-38-1
Date	April 21, 2014

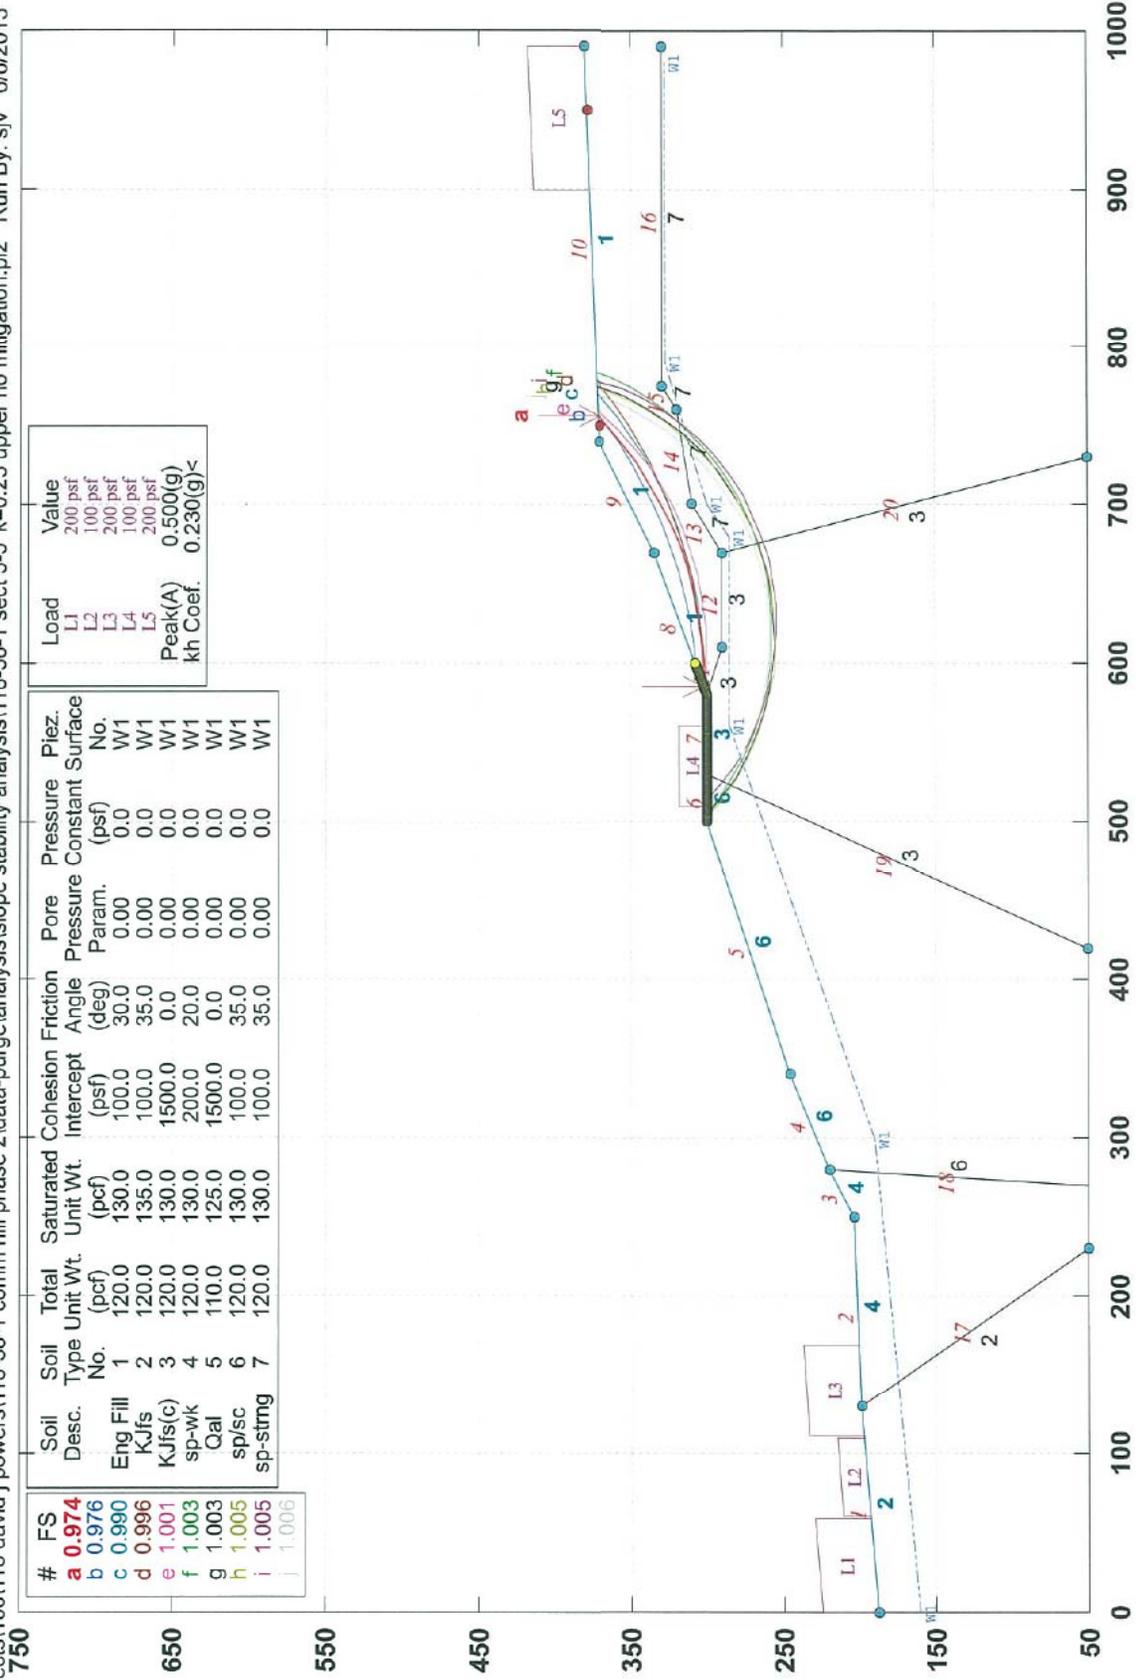
118-38-1 Comm Hill II- Section 5-5' seismic upper slope no mitigation

Load	Value
L1	200 psf
L2	100 psf
L3	200 psf
L4	100 psf
L5	200 psf
Peak(A)	0.500(g)
kh Coef.	0.230(g)<

GSTABL7 v.2 FSmin=0.974

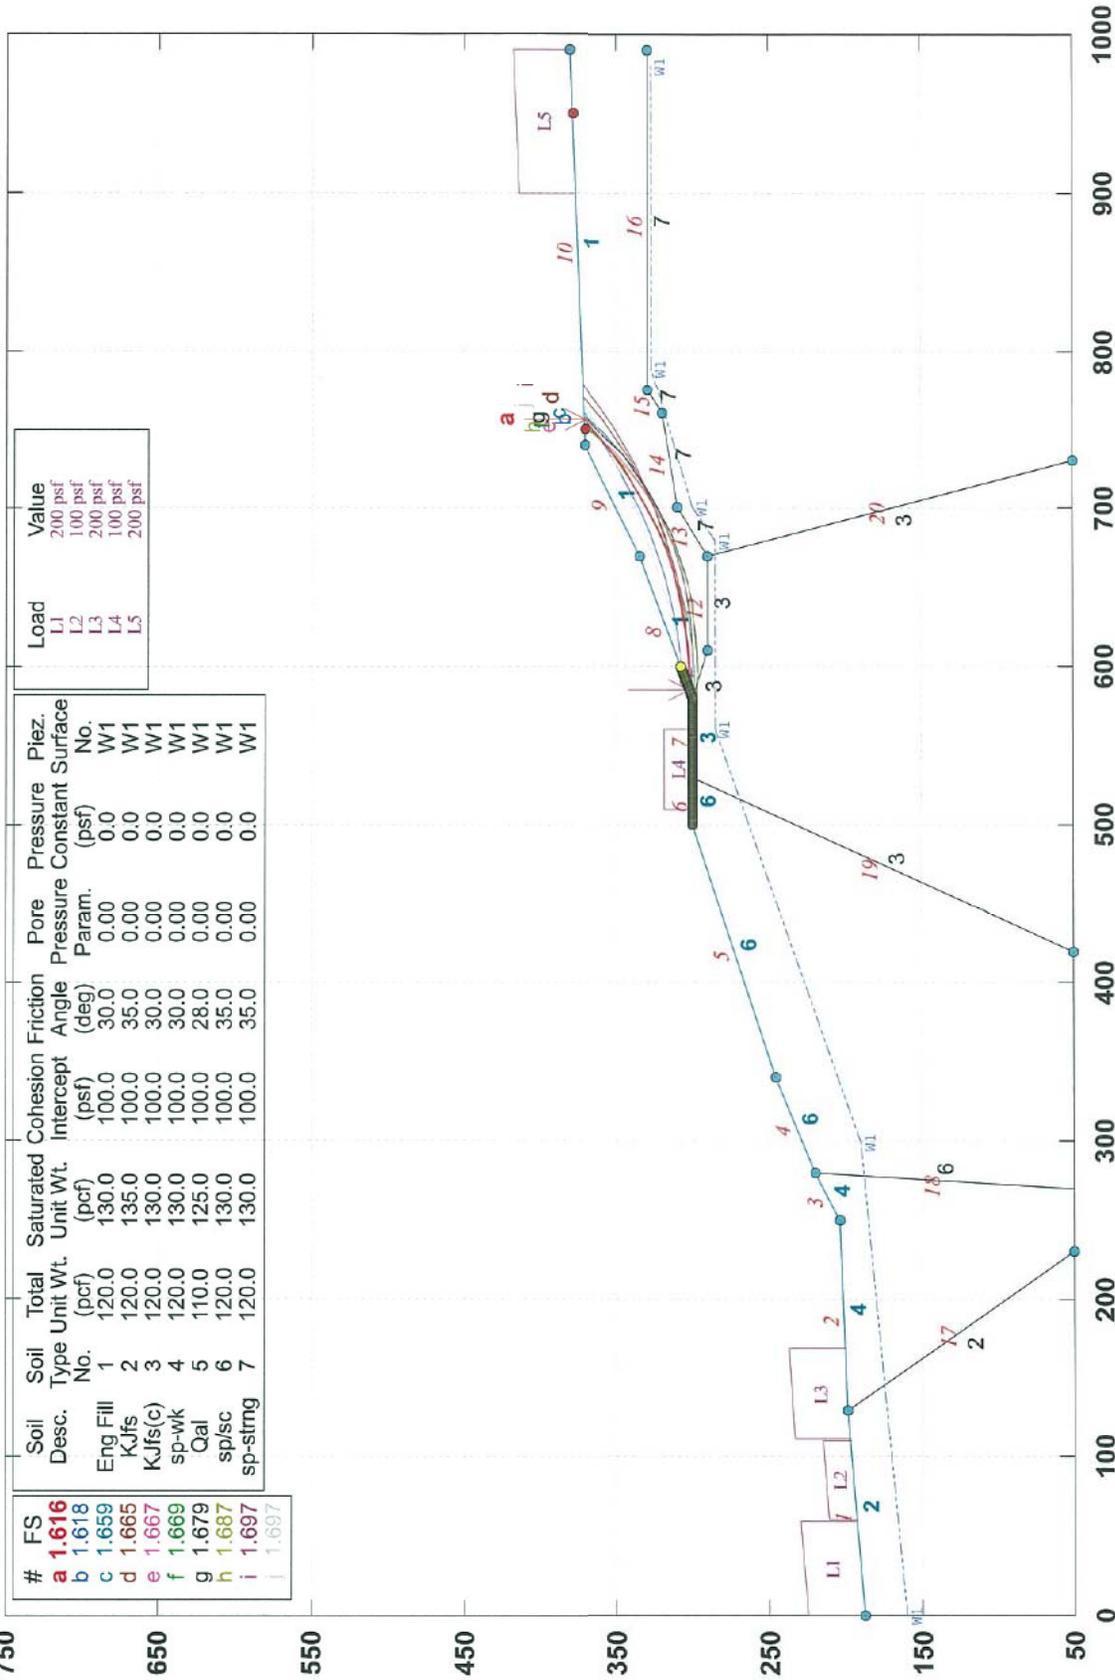
118-38-1 Comm Hill II- Section 5-5' static upper slope no mitigation

GSTABL7 v.2 FSmin=1.616
Safety Factors Are Calculated By The Modified Bishop Method

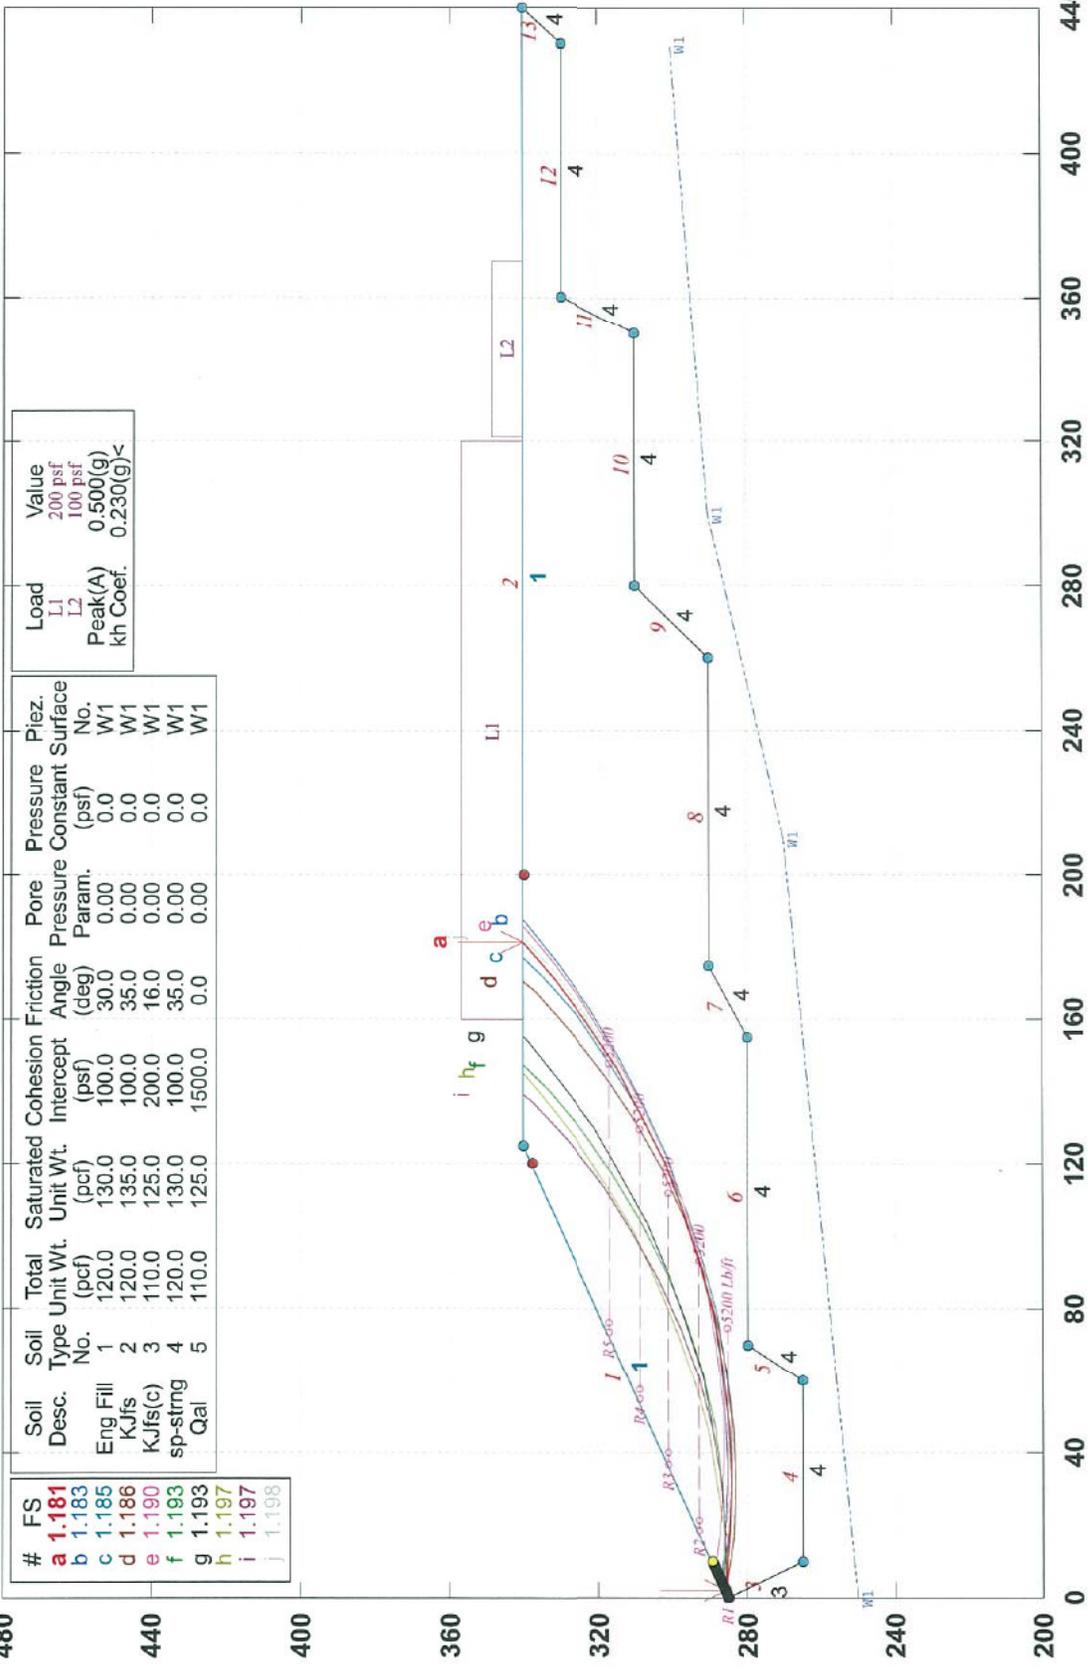
118-38-1 Comm Hill II- Section 6-6' seismic (8' geogrid spacing @ 75'L)

GSTABL7 v.2 FSmin=1.181

Safety Factors Are Calculated By The Modified Bishop Method

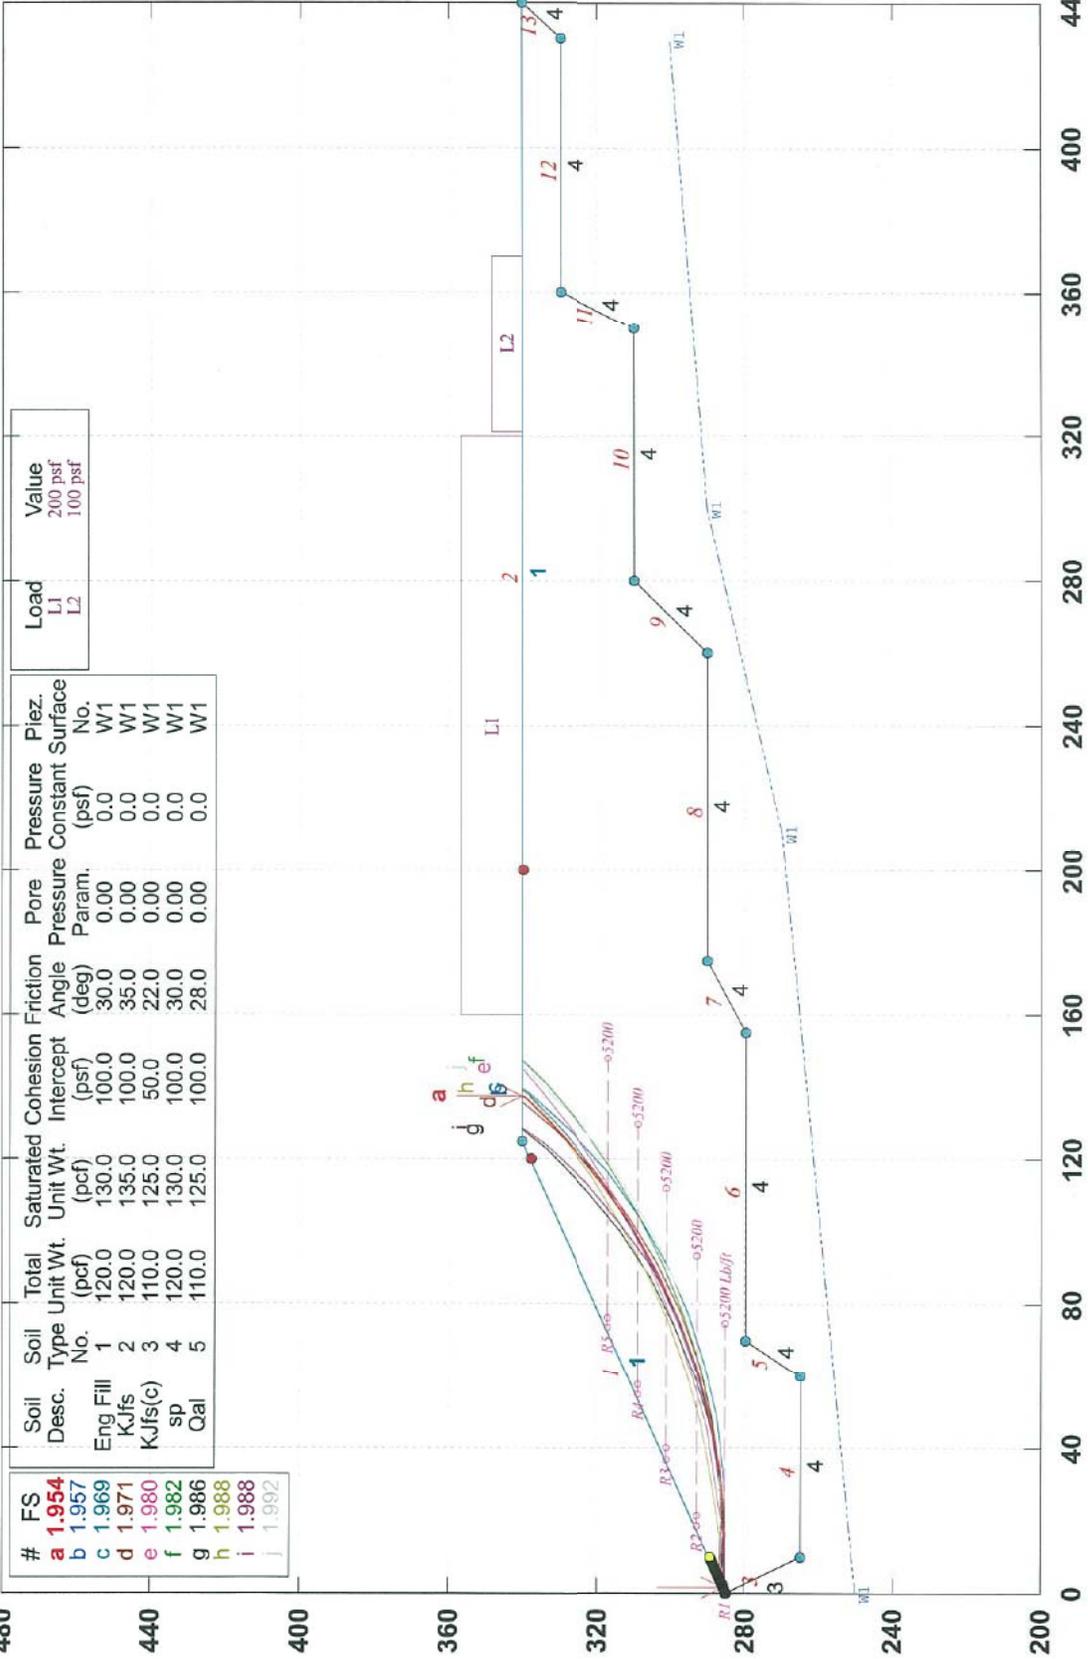
118-38-1 Comm Hill II- Section 6-6' static

#	FS	Soil Desc.	Soil Type No.	Total Unit Wt. (pcf)	Saturated Unit Wt. (pcf)	Cohesion Intercept (psf)	Friction Angle (deg)	Pore Pressure Param.	Pressure Constant (psf)	Piez. Surface No.	Load	Value
a	1.954	Eng Fill	1	120.0	130.0	100.0	30.0	0.00	0.0	W1	L1	200 psf
b	1.957	KJfs	2	120.0	135.0	100.0	35.0	0.00	0.0	W1	L2	100 psf
c	1.969	KJfs(c)	3	110.0	125.0	50.0	22.0	0.00	0.0	W1		
d	1.971	sp	4	120.0	130.0	100.0	30.0	0.00	0.0	W1		
e	1.980	Gal	5	110.0	125.0	100.0	28.0	0.00	0.0	W1		
f	1.982											
g	1.986											
h	1.988											
i	1.988											
j	1.992

GSTABL7 v.2 FSmin=1.954

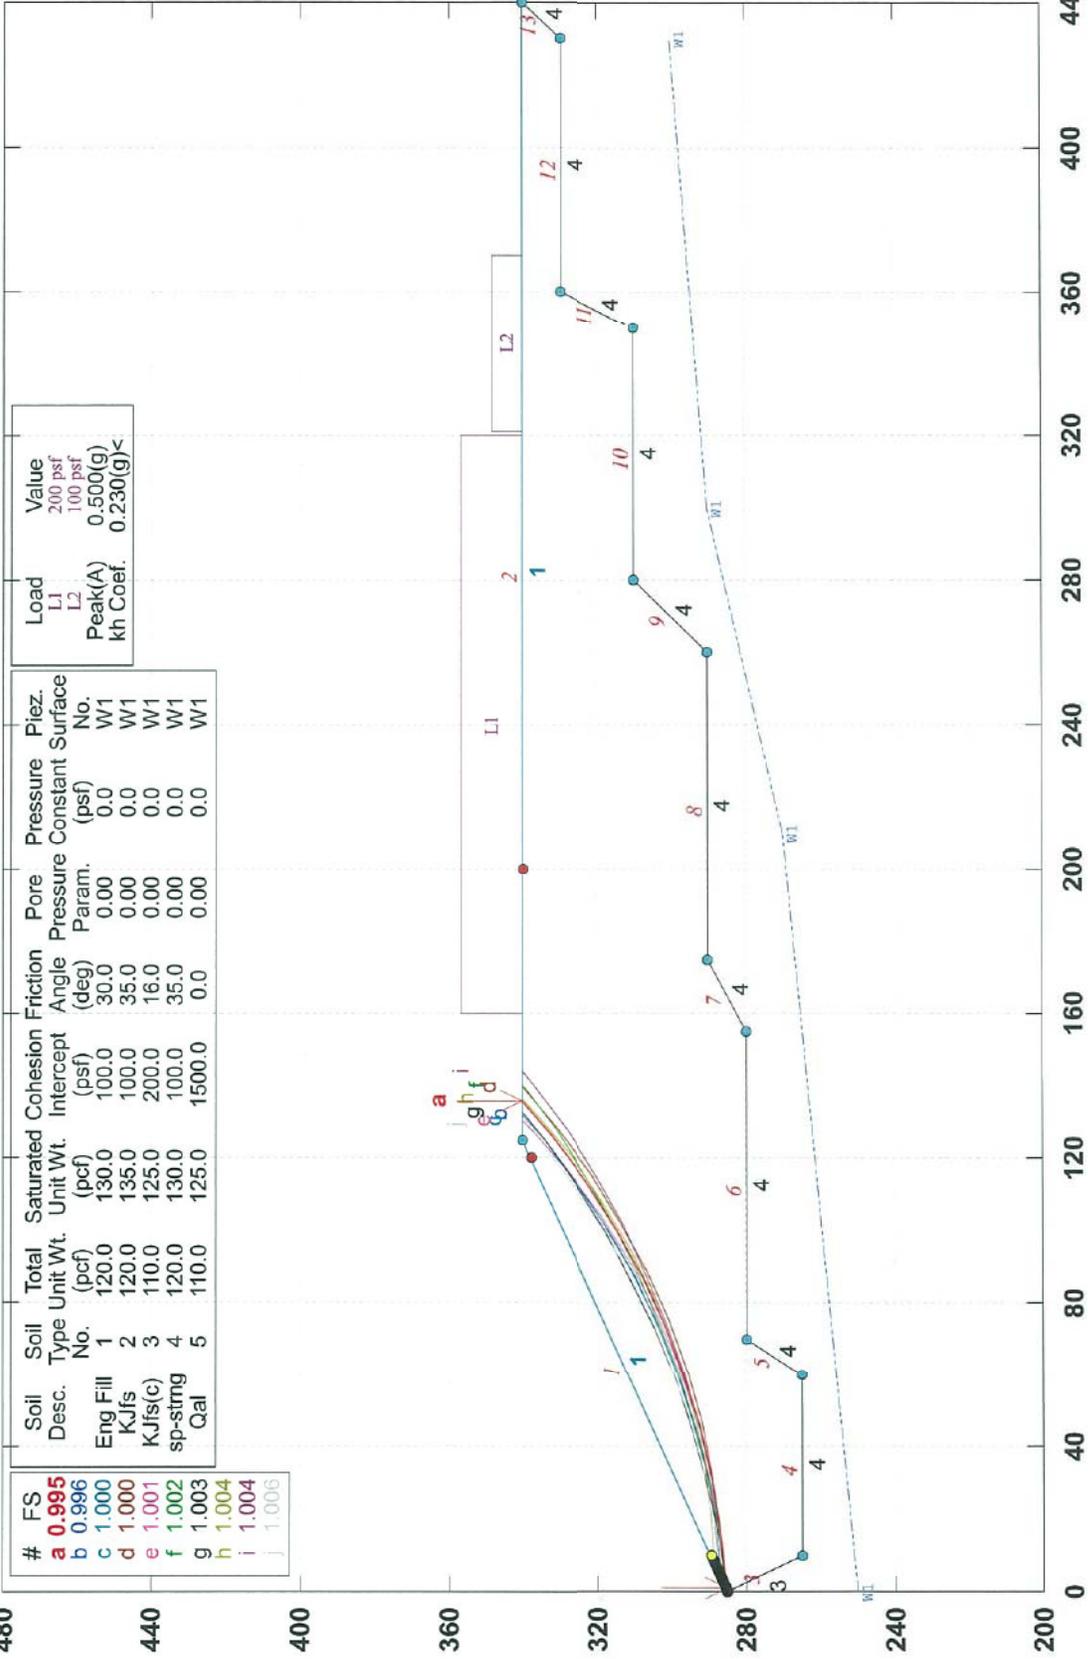
118-38-1 Comm Hill II- Section 6-6' seismic no mitigation

Load	Value
L1	200 psf
L2	100 psf
Peak(A)	0.500(g)
kh Coef.	0.230(g)<

Soil Desc.	Soil Type No.	Total Unit Wt. (pcf)	Saturated Unit Wt. (pcf)	Cohesion Intercept (psf)	Friction Angle (deg)	Pore Pressure Param.	Pressure Constant (psf)	Piez. No.
Eng Fill	1	120.0	130.0	100.0	30.0	0.00	0.0	W1
KJfs	2	120.0	135.0	100.0	35.0	0.00	0.0	W1
KJfs(c)	3	110.0	125.0	200.0	16.0	0.00	0.0	W1
sp-stmg	4	120.0	130.0	100.0	35.0	0.00	0.0	W1
Qal	5	110.0	125.0	1500.0	0.0	0.00	0.0	W1

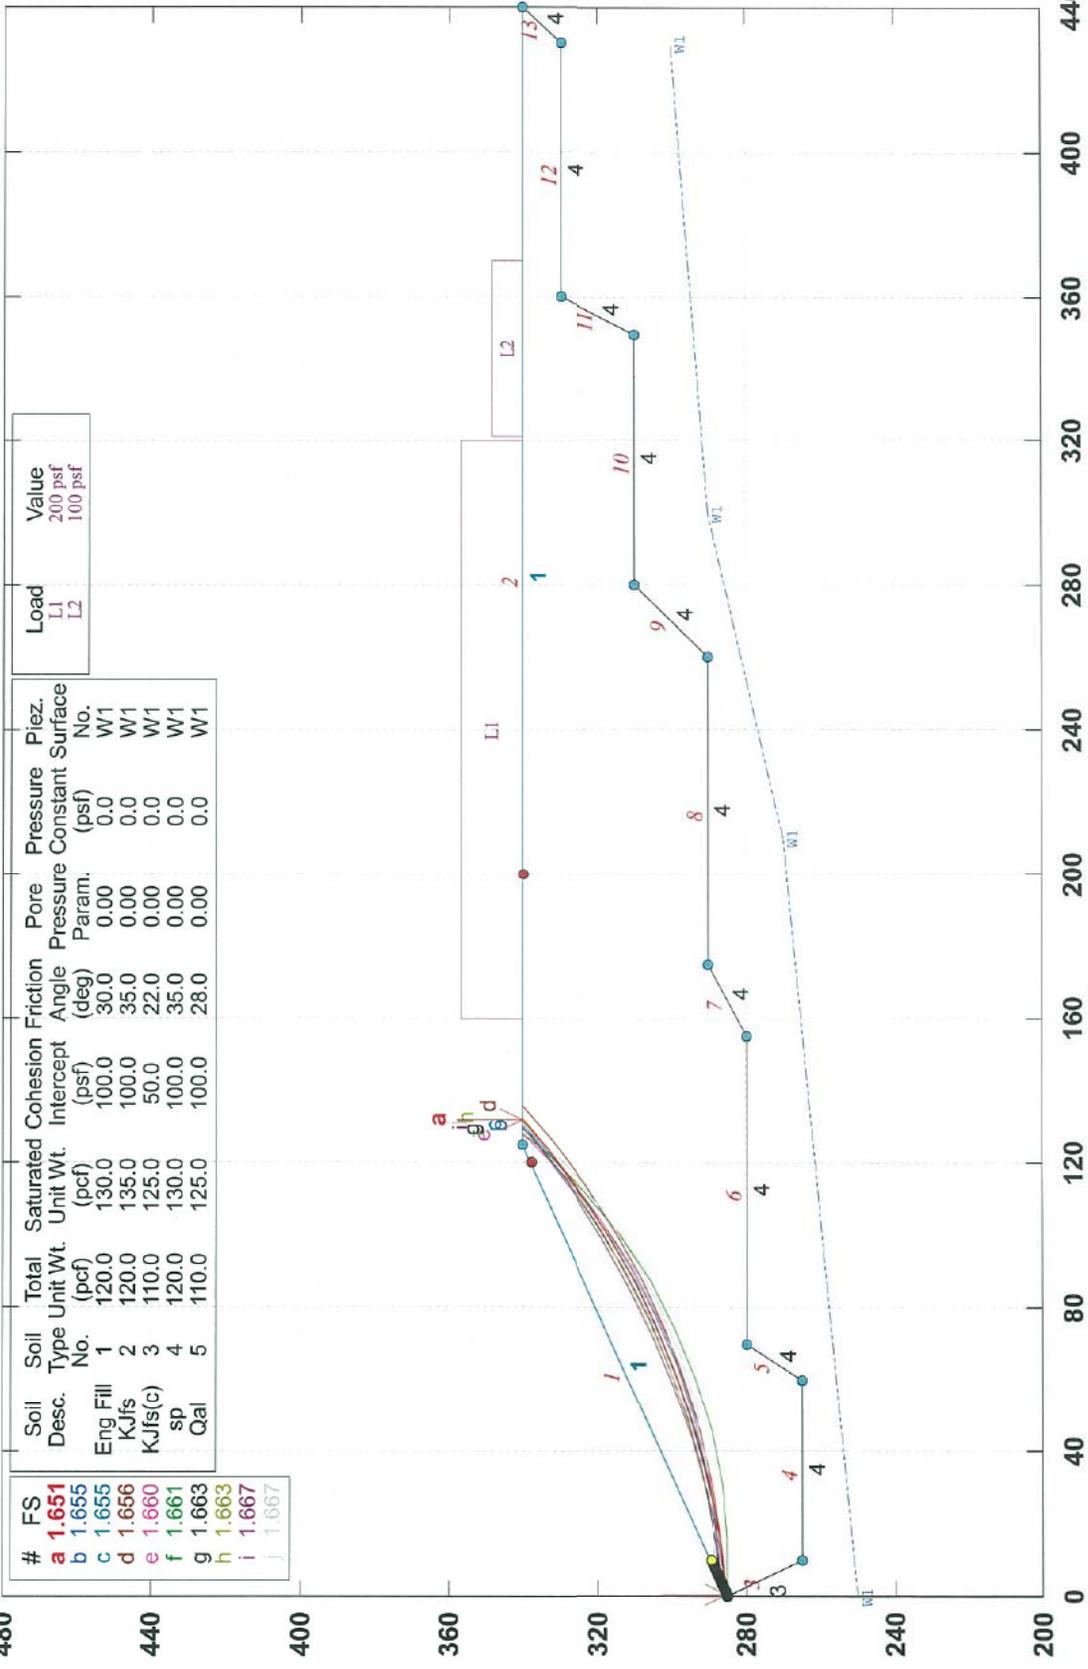
118-38-1 Comm Hill II- Section 6-6' static no mitigation

GSTABL7 v.2 FSmin=1.651
Safety Factors Are Calculated By The Modified Bishop Method

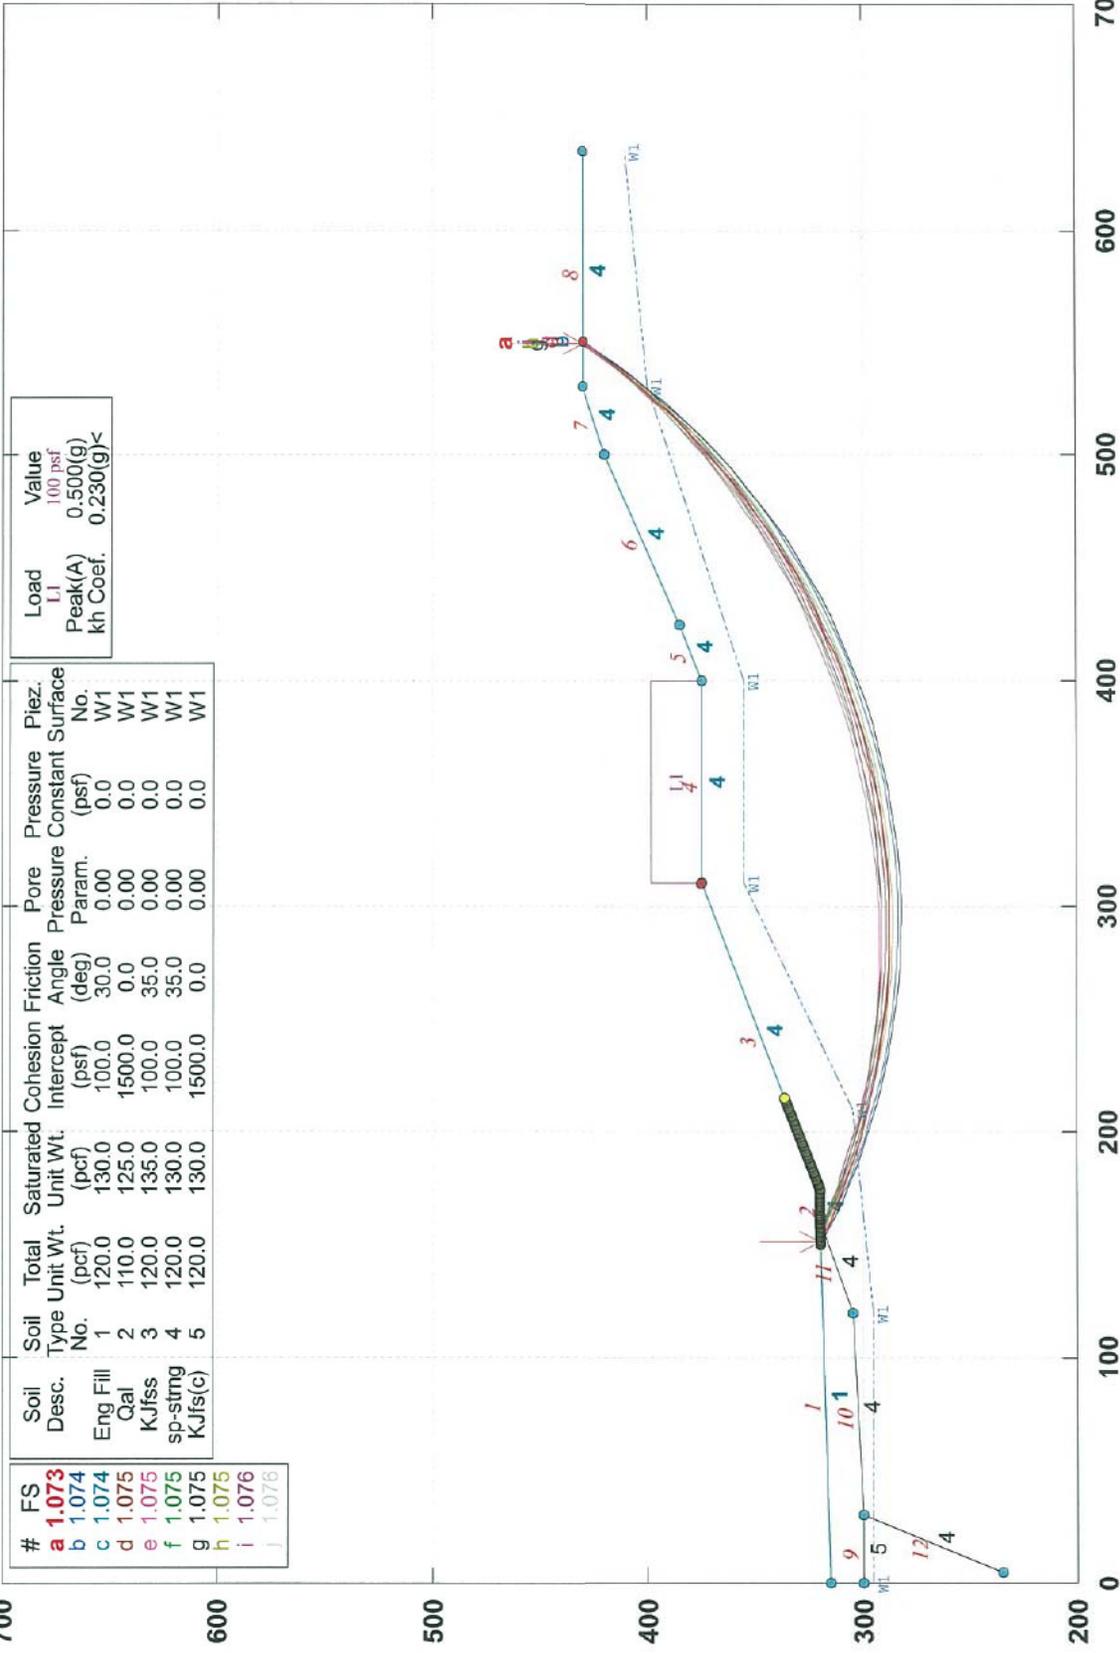
Comm Hill II Sect 7-7' seismic 2.5:1 slope mitigation

GSTABL7 v.2 FSmin=1.073

Safety Factors Are Calculated By The Simplified Janbu Method

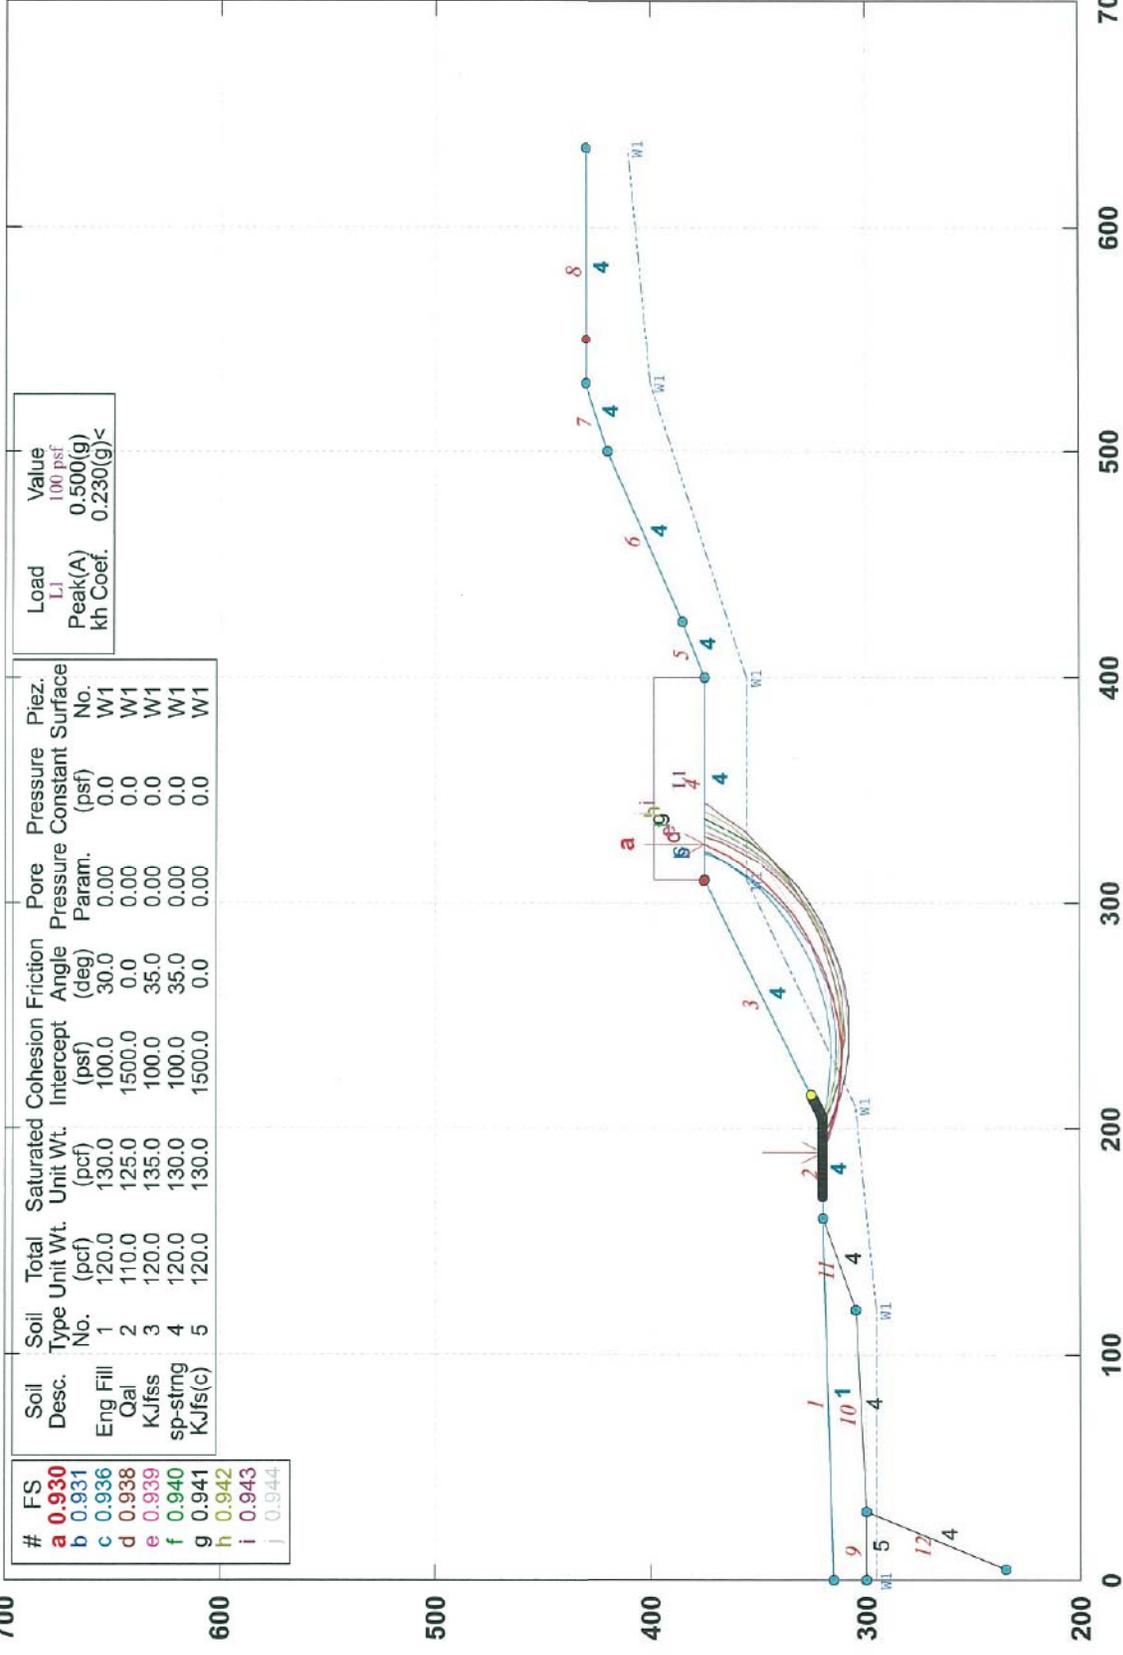
Comm Hill II Sect 7-7' no mitigation Seismic Stability - Kh = 0.23

GSTABL7 v.2 FSmin=0.930
Safety Factors Are Calculated By The Simplified Janbu Method

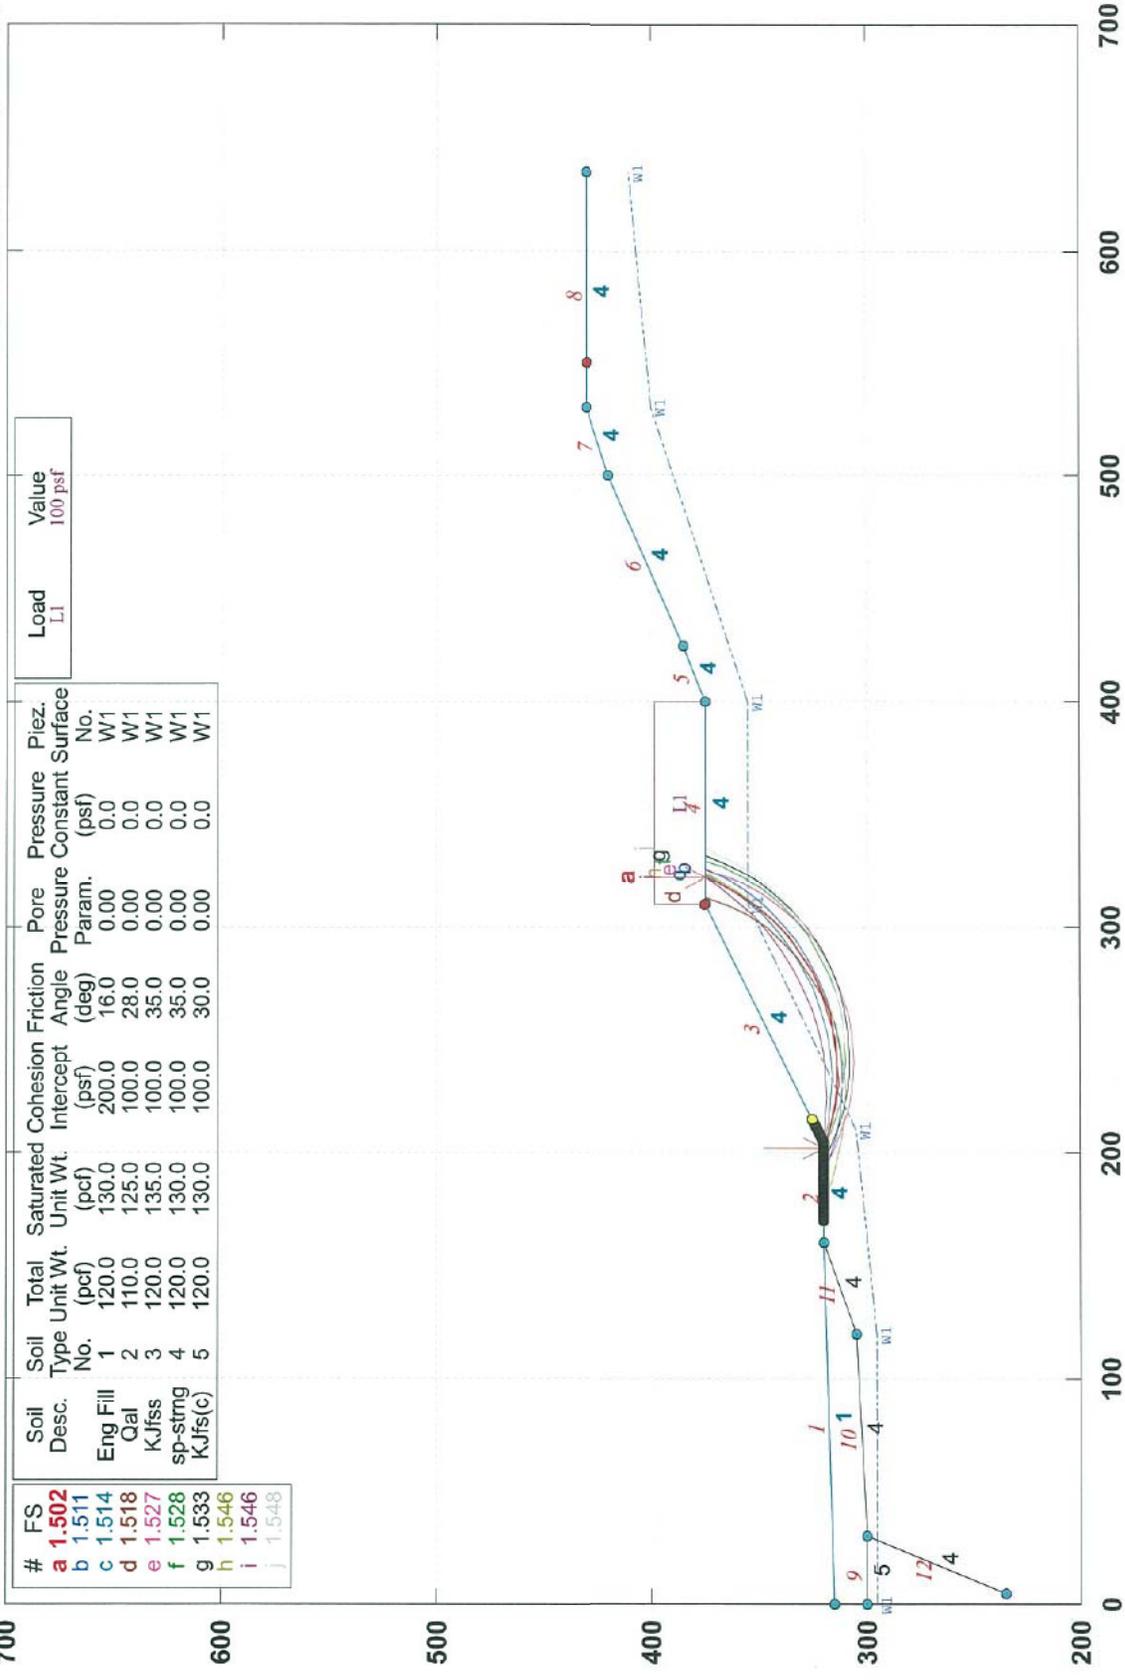
Comm Hill II Sect 7-7' no mitigation static Stability -

#	FS	Soil Desc.	Soil Type No.	Total Unit Wt. (pcf)	Saturated Unit Wt. (pcf)	Cohesion Intercept (psf)	Friction Angle (deg)	Pore Pressure Param. (psf)	Pressure Constant (psf)	Piez. No.
a	1.502	Eng Fill	1	120.0	130.0	200.0	16.0	0.00	0.0	W1
b	1.511	Eng Fill	1	120.0	130.0	200.0	16.0	0.00	0.0	W1
c	1.514	Qal	2	110.0	125.0	100.0	28.0	0.00	0.0	W1
d	1.518	KJfss	3	120.0	135.0	100.0	35.0	0.00	0.0	W1
e	1.527	sp-strng	4	120.0	130.0	100.0	35.0	0.00	0.0	W1
f	1.528	KJfs(c)	5	120.0	130.0	100.0	30.0	0.00	0.0	W1
g	1.533									
h	1.546									
i	1.546									
j	1.548

Load	Value
L1	100 psf

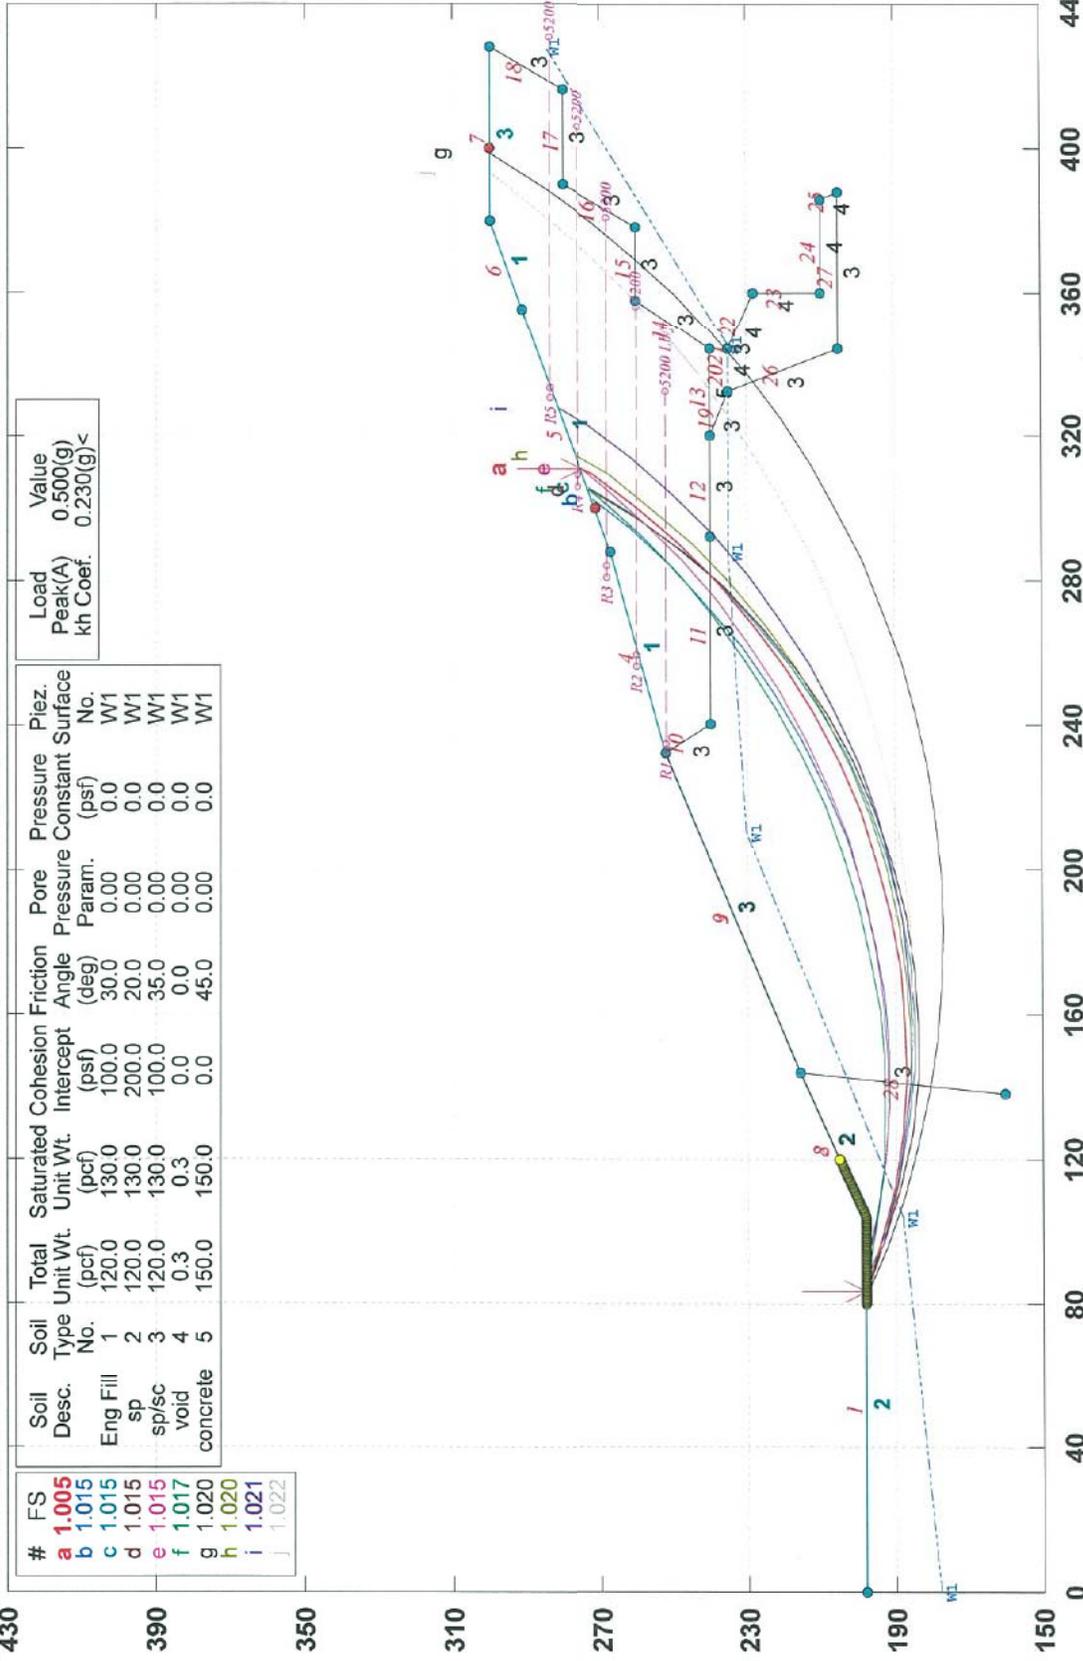
118-38-1 Comm Hill II- Section 8-8' seismic Mine (100'L Geogrids @ 8'V)

GSTABL7 v.2 FSmin=1.005
Safety Factors Are Calculated By The Modified Bishop Method

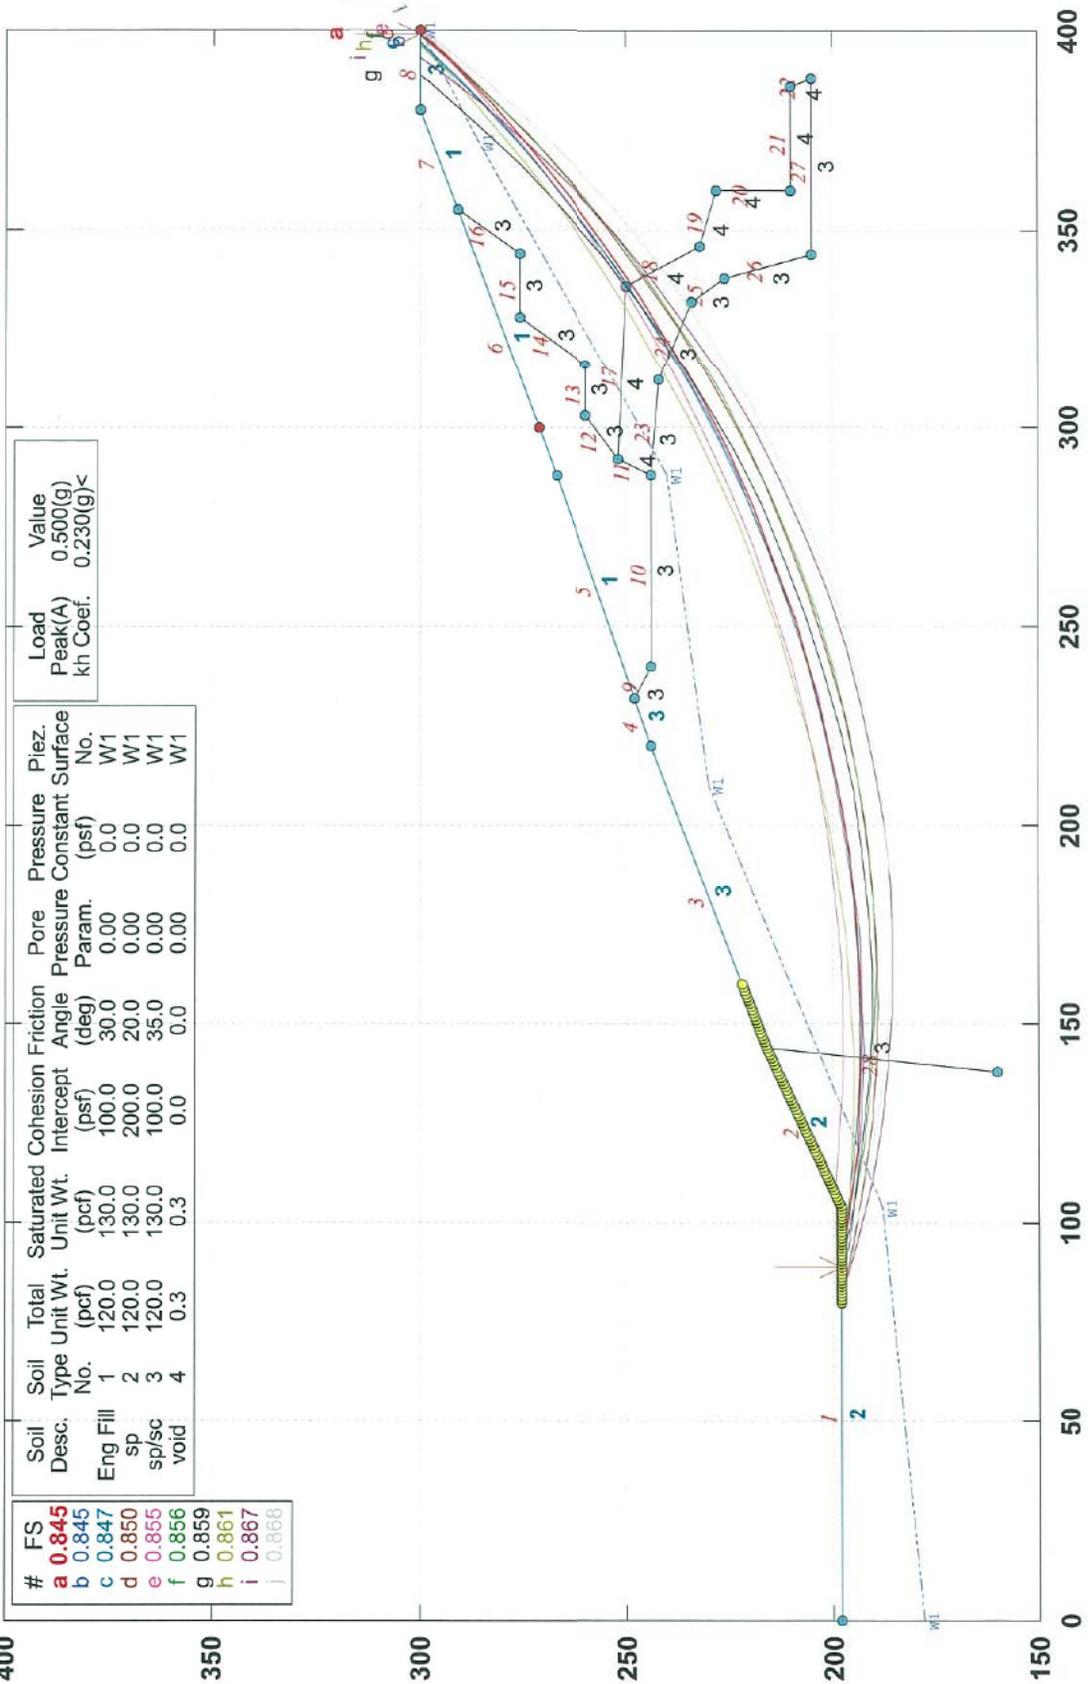
118-38-1 Comm Hill II- Section 8-8' seismic Mine no mitigation

Load	Value
Peak(A)	0.500(g)
kh Coef.	0.230(g)<

Soil Desc.	Soil Type No.	Total Unit Wt. (pcf)	Saturated Unit Wt. (pcf)	Cohesion (psf)	Friction Angle (deg)	Pore Pressure Param.	Pressure Constant (psf)	Piez. No.
Eng Fill	1	120.0	130.0	100.0	30.0	0.00	0.0	W1
sp	2	120.0	130.0	200.0	20.0	0.00	0.0	W1
sp/sc	3	120.0	130.0	100.0	35.0	0.00	0.0	W1
void	4	0.3	0.3	0.0	0.0	0.00	0.0	W1

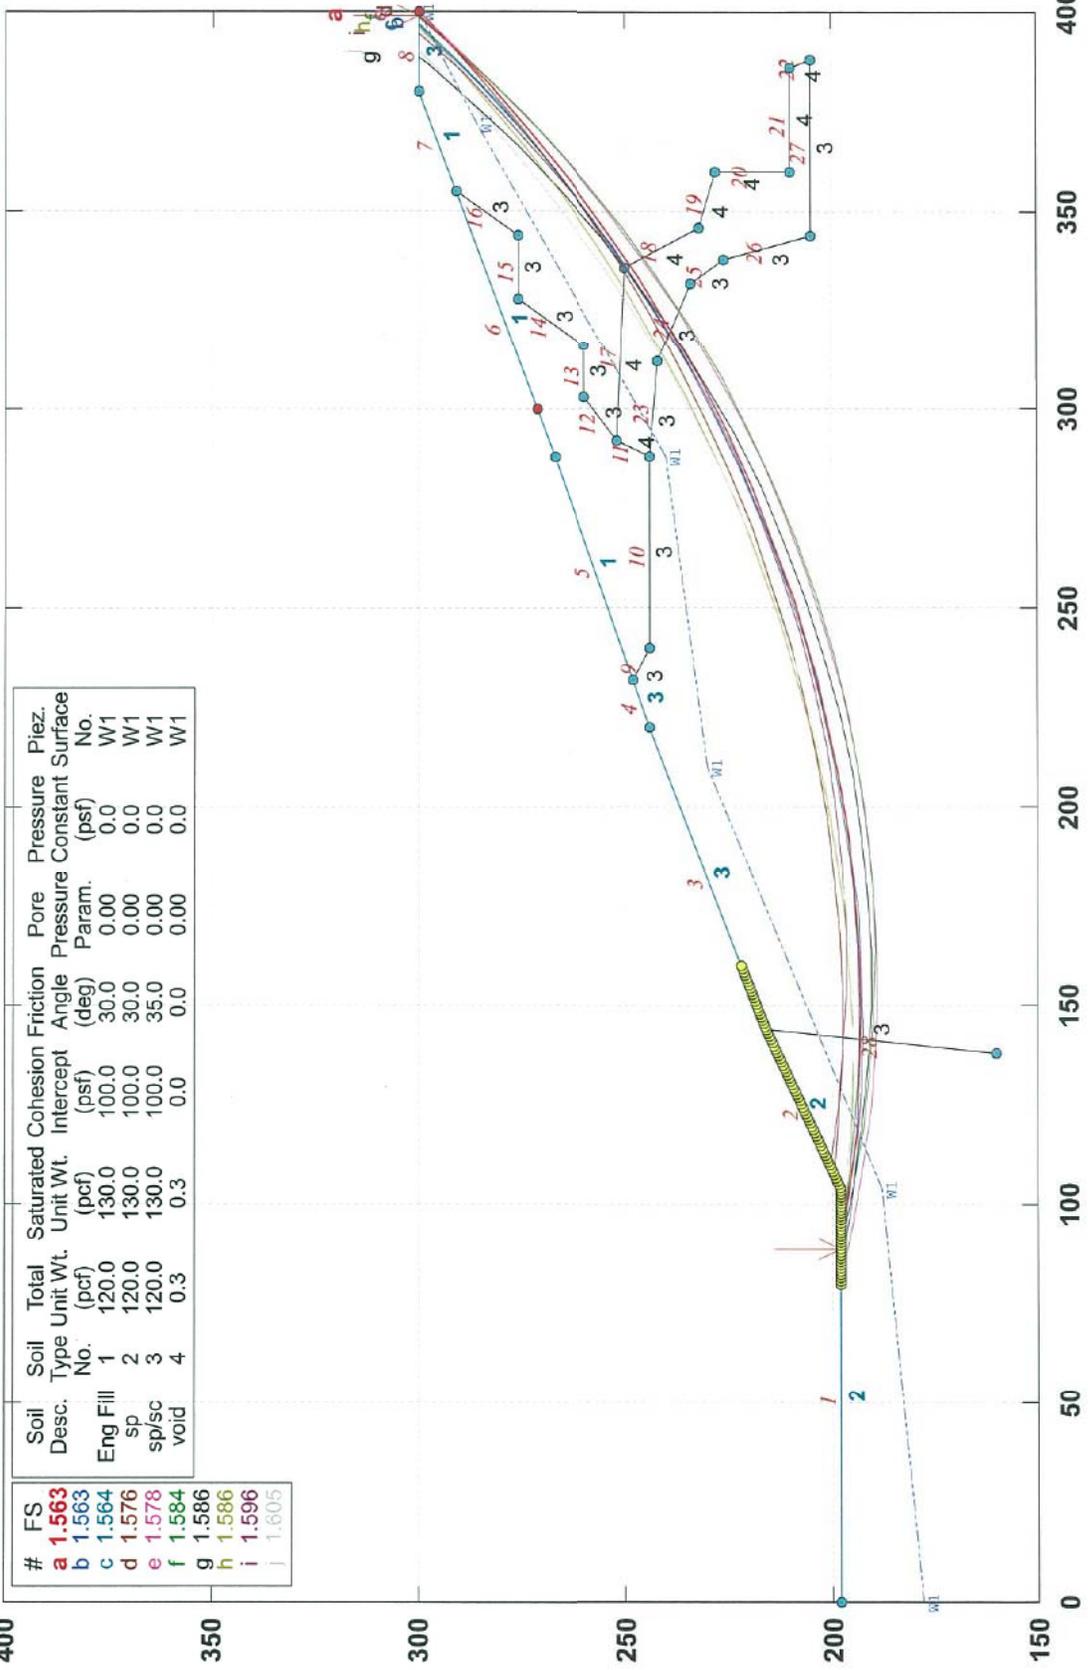
118-38-1 Comm Hill II- Section 8-8' static Mine no mitigation

GSTABL7 v.2 FSmin=1.563

Safety Factors Are Calculated By The Modified Bishop Method
