Geologic and Geotechnical Hazards Investigation

Type of Services	Geologic and Geotechnical Hazards Investigation
Project Name	Communications Hill – Phase 2
Location	Communications Hill Boulevard San Jose, California
Client	David J. Powers & Associates, Inc.
Client Address	1871 The Alameda, Suite 200 San Jose, CA 95126
Project Number	118-38-1
Date	April 21, 2014

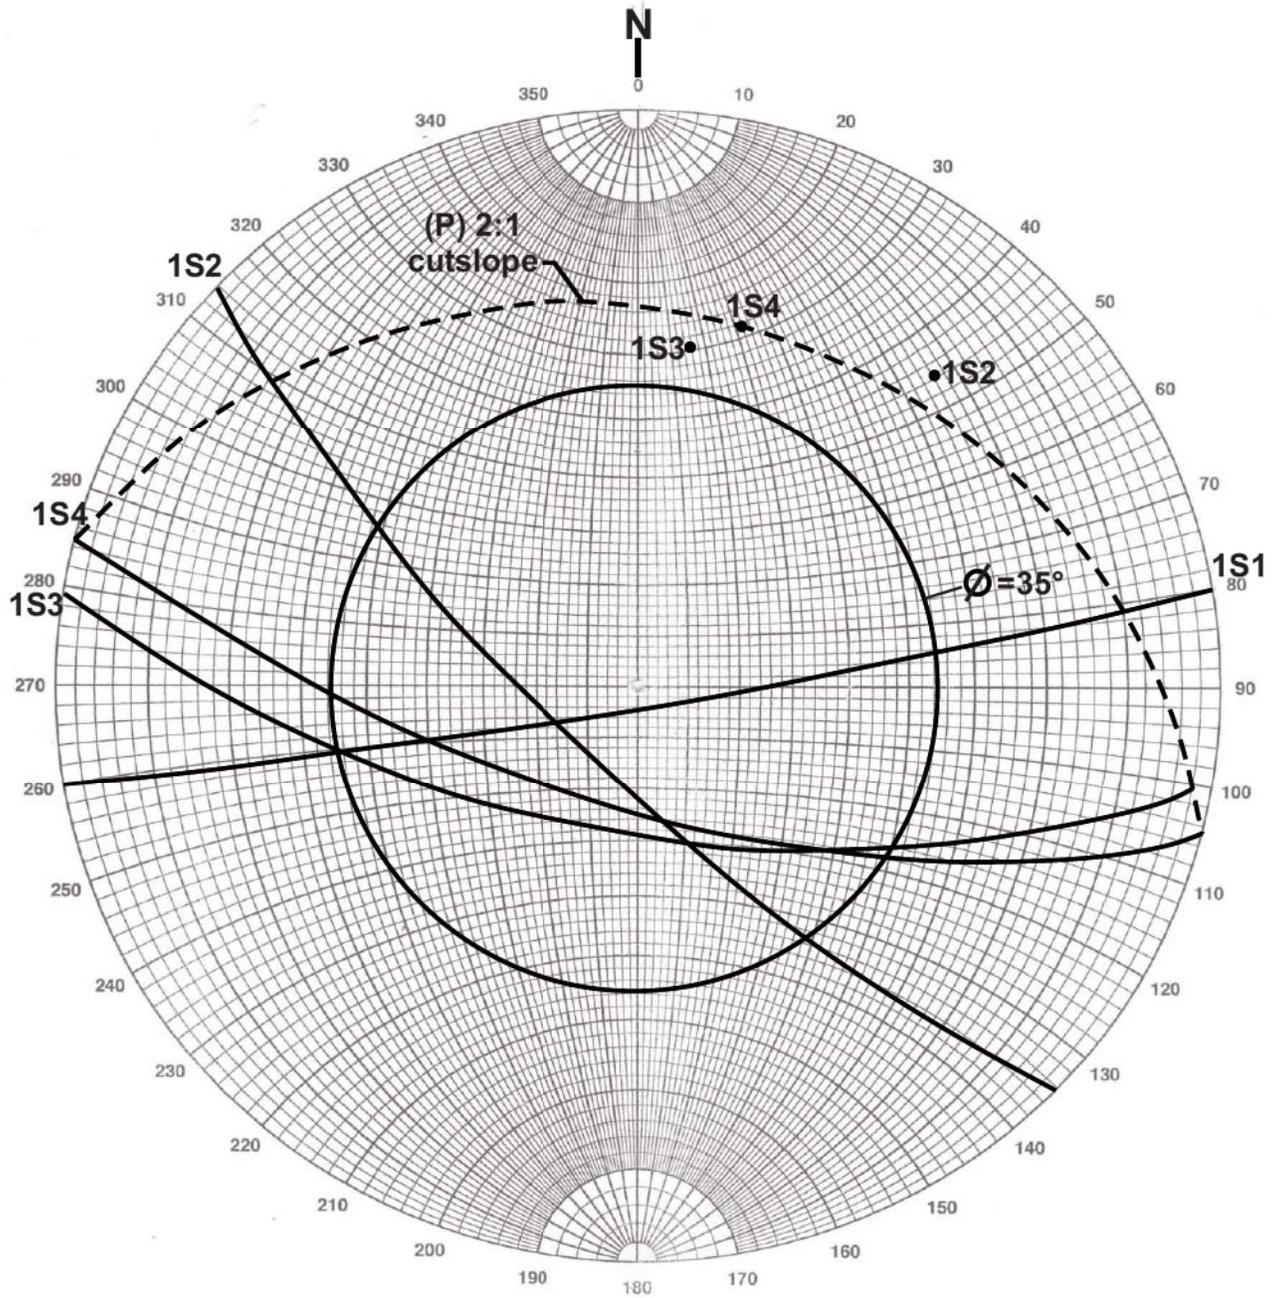
Markland Test Plots - Test Pit 1A

Proposed Cutslope in Region of TP-1A

Bedrock = Silica Carbonate

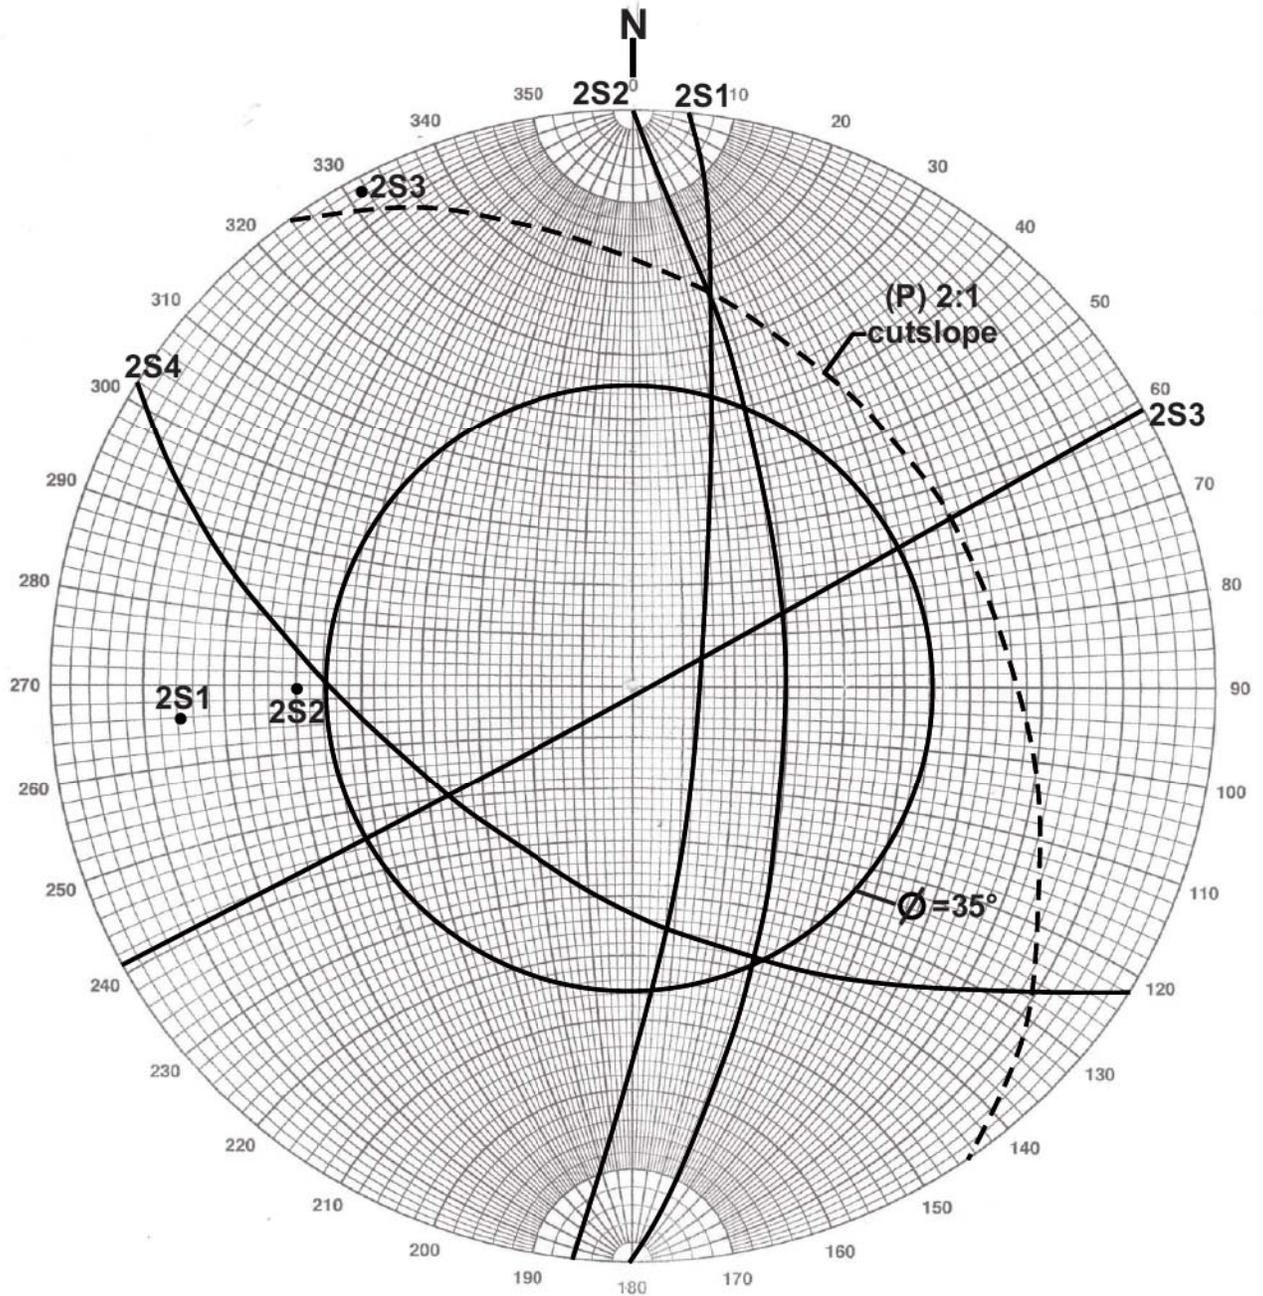
Markland Test Plots - Test Pit 2A

Proposed Cutslope in Region of TP-2A

Bedrock = Silica Carbonate

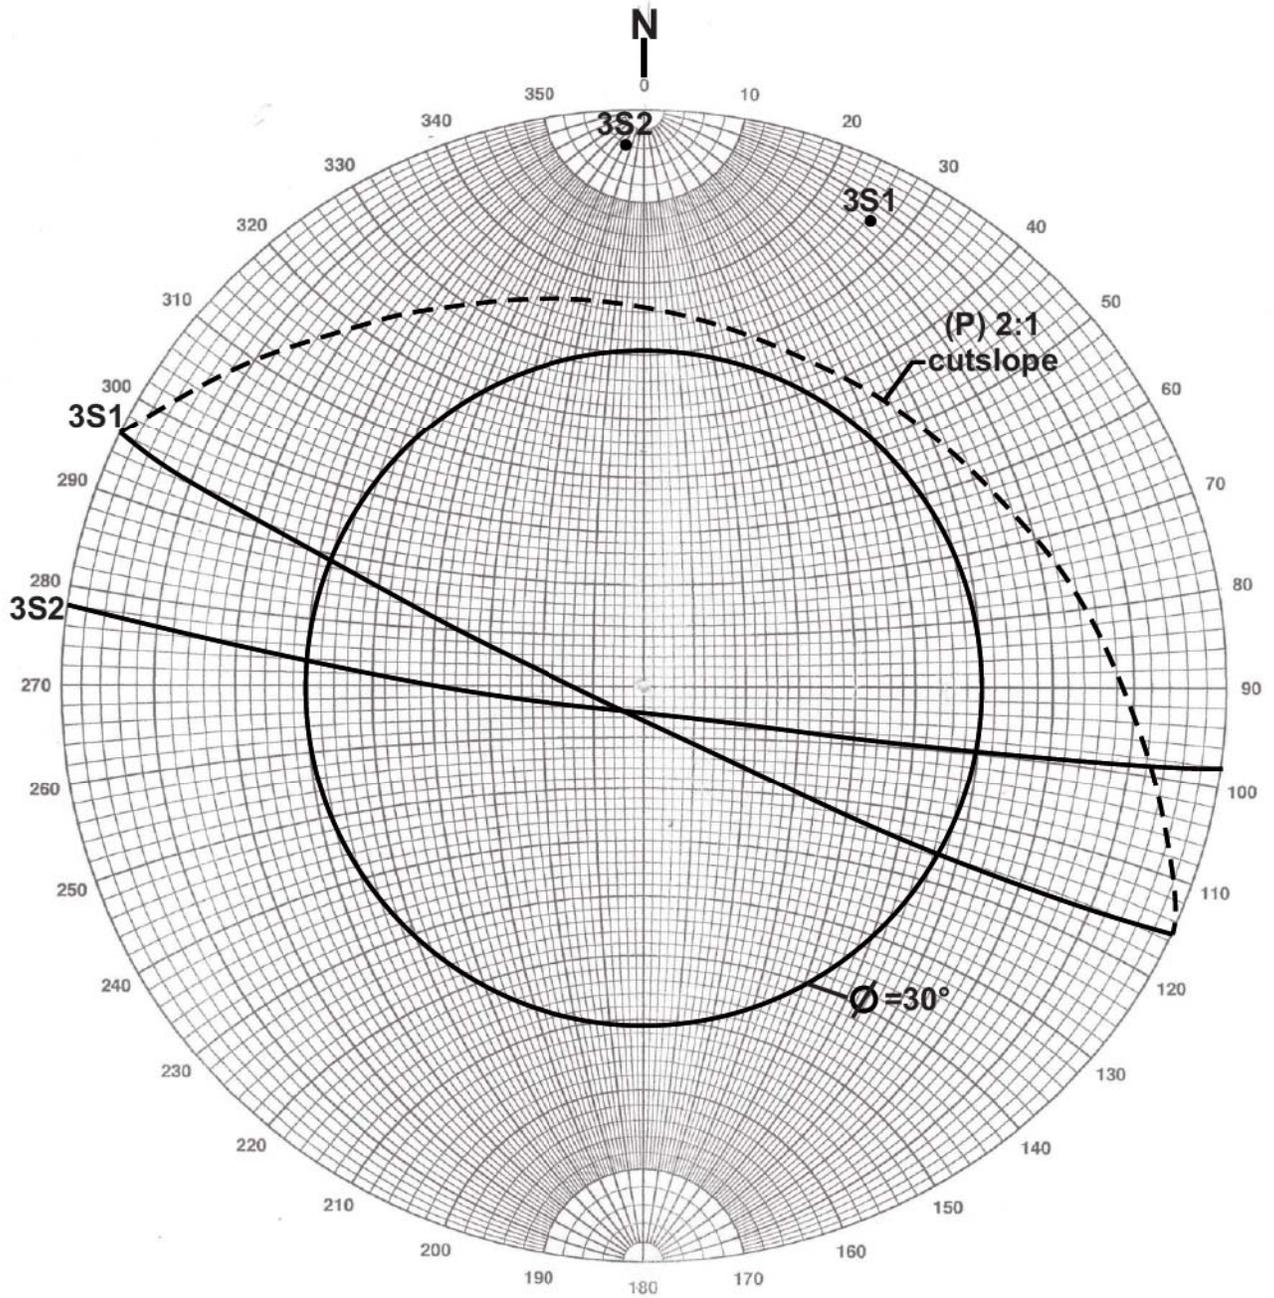
Markland Test Plots - Test Pit 3A

Proposed Cutslope in Region of TP-3A

Bedrock = Claystone

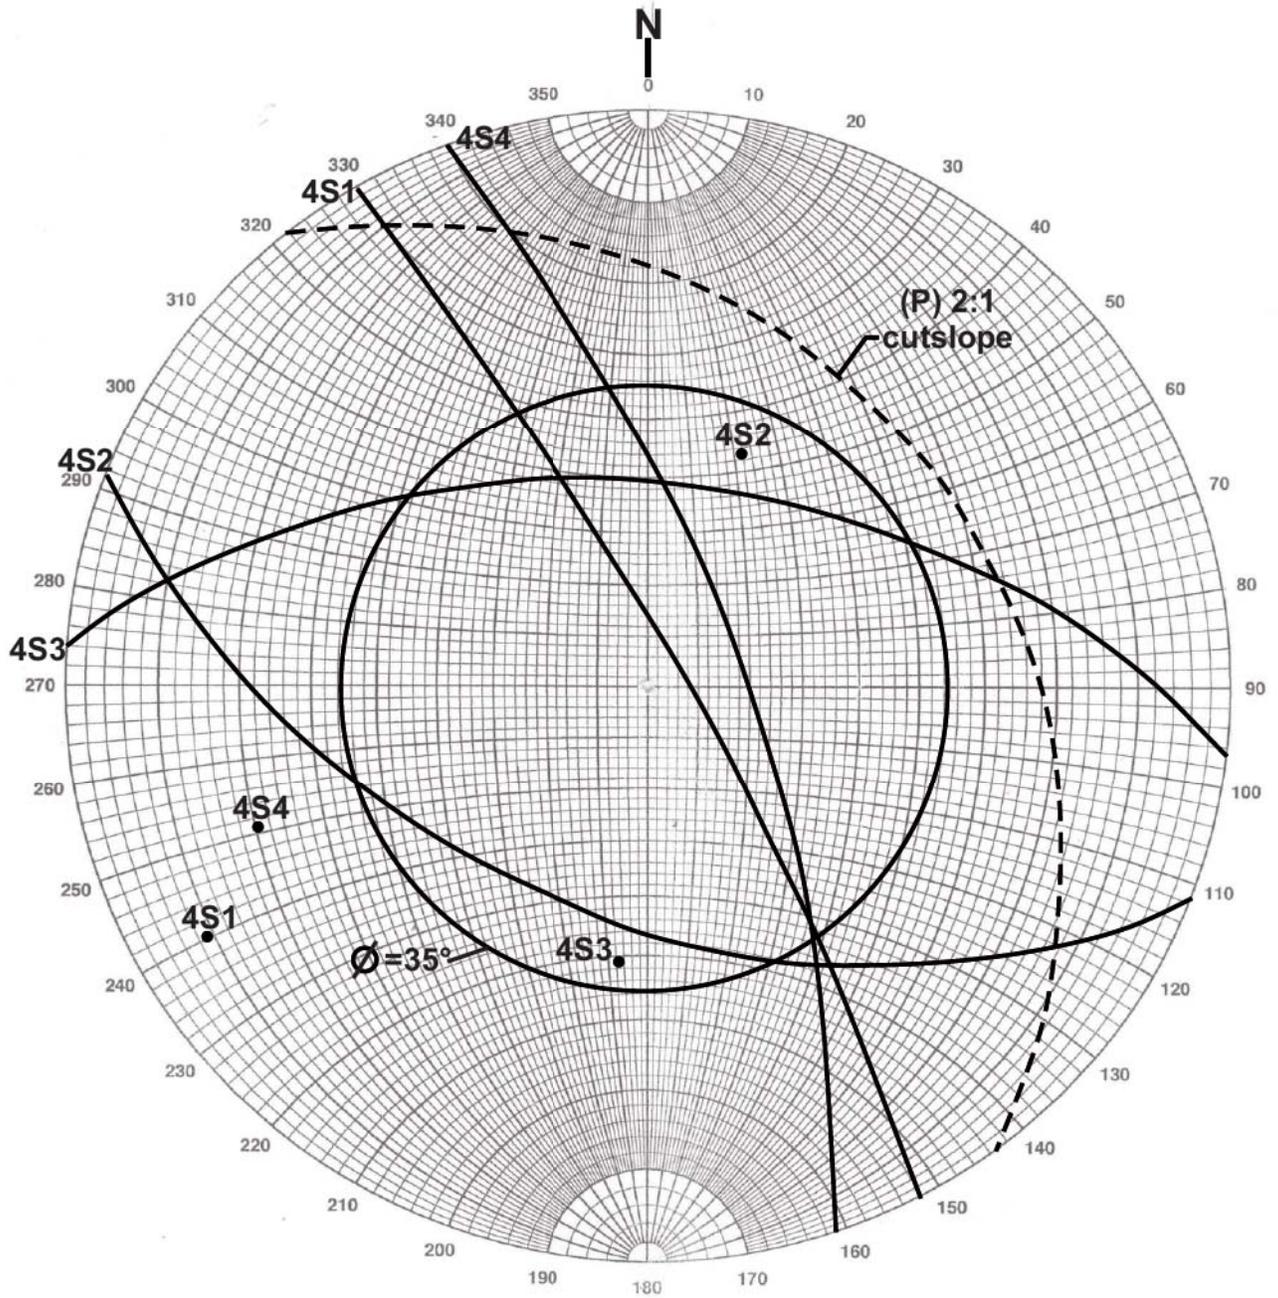
Markland Test Plots - Test Pit 4A

Proposed Cutslope in Region of TP-4A

Bedrock = Silica Carbonate

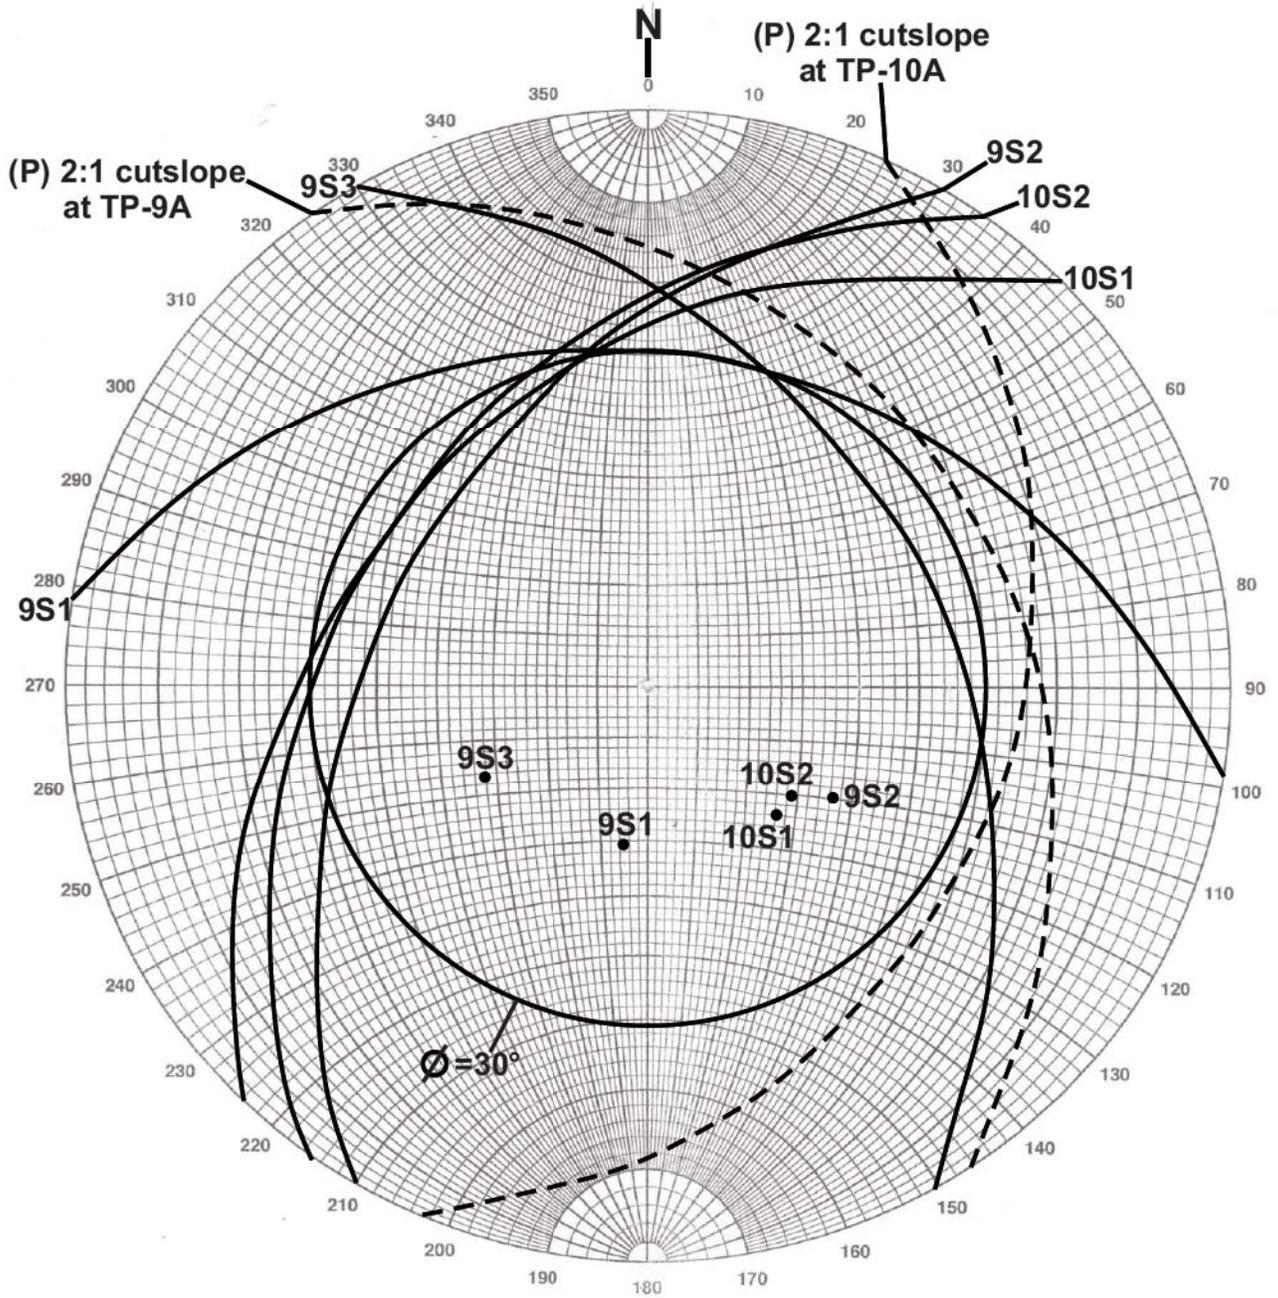
Markland Test Plots - Test Pit 9A and TP-10A

Proposed Cutslope in Region of TP-9A and TP-10A

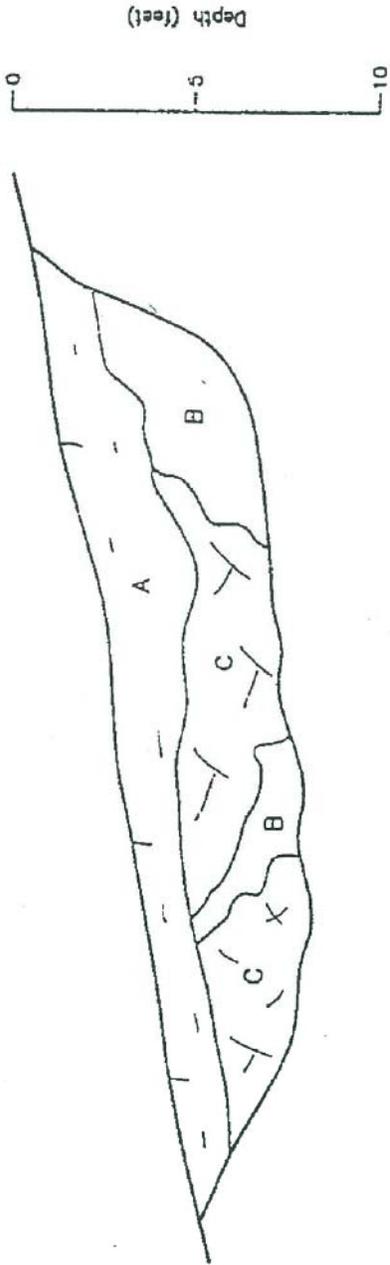
EXPLORATORY TEST PIT LOG TP-1
 COMMUNICATIONS HILL,
 San Jose, California

A: CLAY (CL-CH): Surficial Soil, many fine roots, some carbonate nodules and silica-carbonate rock float, dusky yellow brown

B: SILICA-CARBONATE ROCK: Hard, strong, moderate red brown with grayish pink carbonate-rich zones, pale yellow brown stains on fractures

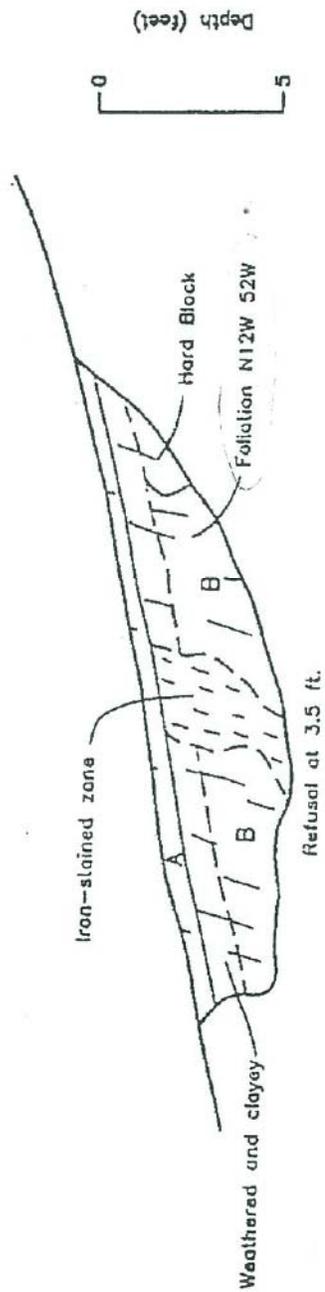
A: CLAY (CL-Clt): Surficial Soil

B: SERPENTINITE: Hard, strong, foliation joints spaced 8", N12W 52W, dark green-gray with olive black inclusions, excavation spoils are angular chunks to 10" dia., but most are less than 6"

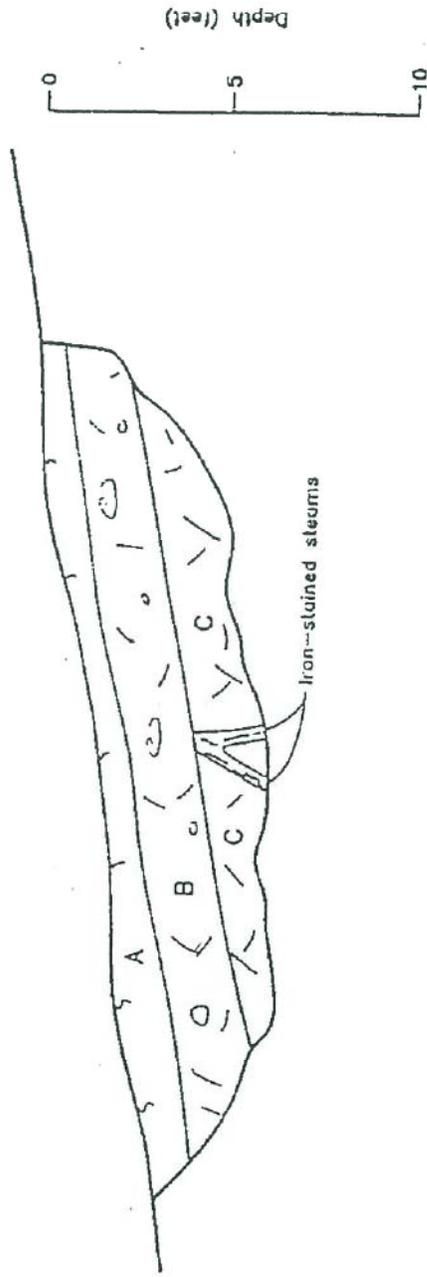
- A: CLAY (CH): Surficial Soil, minor fine sand, rare gravel, moist below 1', dusky yellow brown
- B: SERPENTINITE: Severely weathered with much gray-orange clay and clay coatings, some hard, rounded fucoids
- C: SERPENTINITE: Hard, fresh, random fracturing, no preferred foliation, some polished surfaces and facoids, dark green-gray and olive black, excavations into angular blocks to 1.5' dia., most are less than 6"

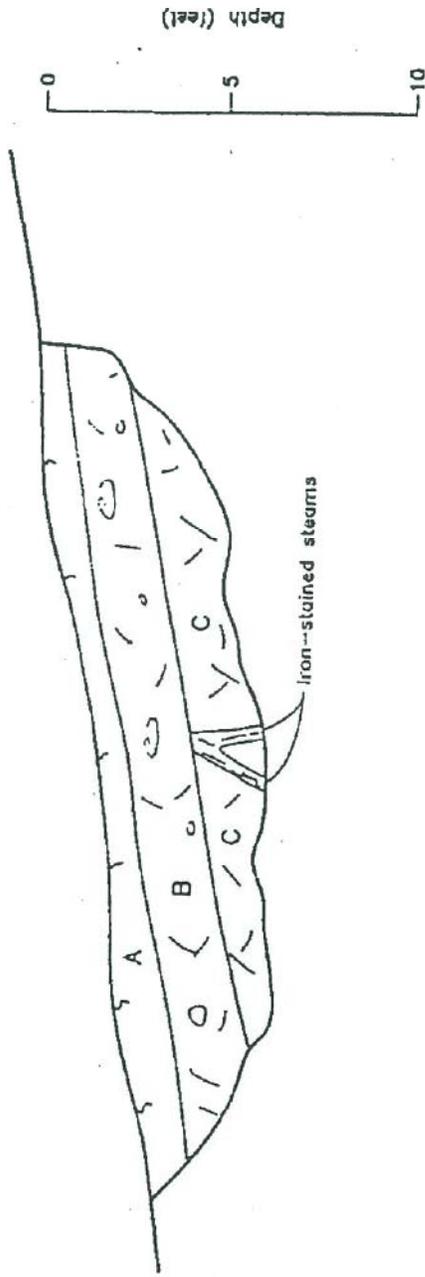
- A: CLAY (CH): Surficial Soil, minor fine sand, rare gravel, moist below 1', dusky yellow brown
- B: SERPENTINITE: Severely weathered with much gray-orange clay and clay coatings, some hard, rounded fucoids
- C: SERPENTINITE: Hard, fresh, random fracturing, no preferred foliation, some polished surfaces and fucoids, dark green-gray and olive black, excavations into angular blocks to 1.5' dia., most are less than 6"

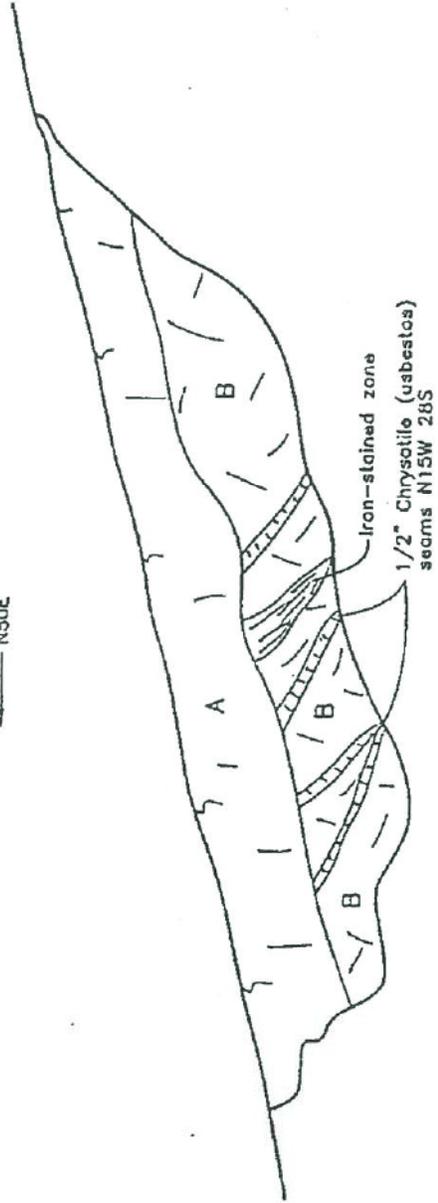
A: CLAY (CH): Surficial Soil, minor fine sand, rare gravel, moist below 1', dusky yellow brown

B: SERPENTINITE: Massive with fibrous asbestos (chrysotile) seams to 0.5', light olive brown clay coatings on fractures, excavation spoils are angular blocks to 8" dia., difficult excavation below 2'

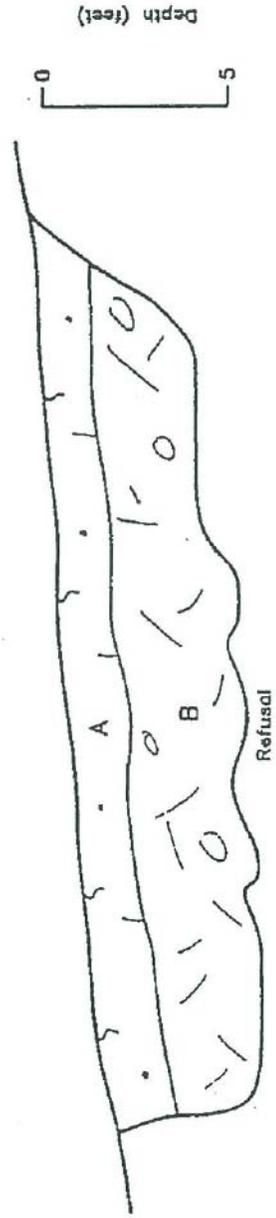
Joints N55W 64N, N46E vertical

- A: CLAY (CH): Surficial Soil, minor fine sand, rare gravel, moist below 1', dusky yellow brown
- B: SERPENTINITE: Hard, strong, massive, no obvious foliation, but common joints oriented N55W 64N and N46E Vertical, occasional rounded, polished facoids in slightly softer matrix rock, olive black and dark green-gray some light olive brown clay in weathered joints

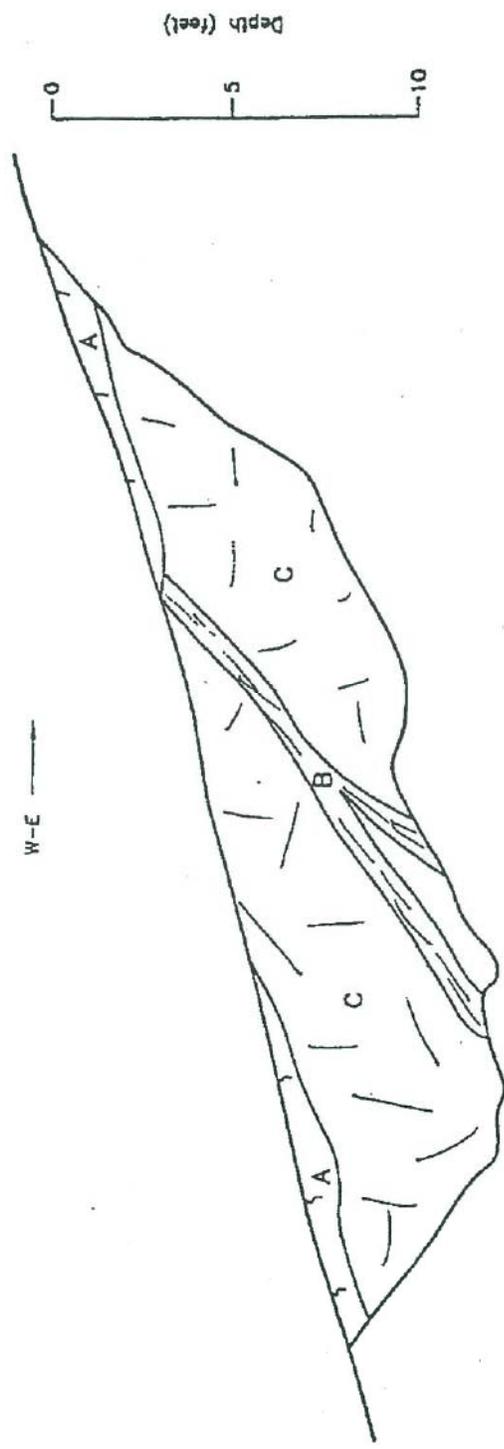
EXPLORATORY TEST PIT LOG TP--6
 COMMUNICATIONS HILL
 San Jose, California

A: CLAY (CH): Surficial Soil, minor fine sand, rare gravel, moist below 1', dusky yellow brown

B: Weathered, iron-rich, clayey zones, dip 21 degrees to west clay and clay coatings, some hard, rounded facoids

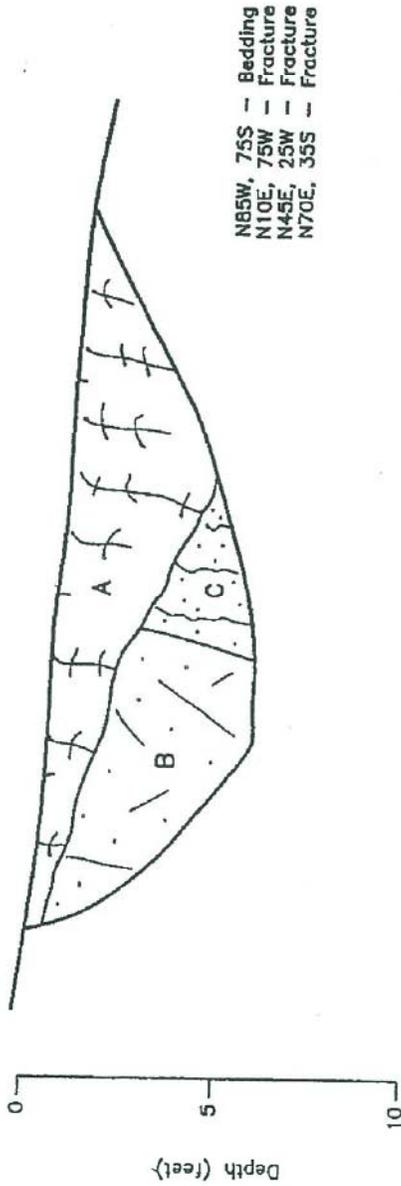
EXPLORATORY TEST PIT LOG TP-7
 COMMUNICATIONS HILL,
 San Jose, California

A: SILTY CLAY (CH), stiff, dry, dark brown, with coarse sand and rock fragments up to 2 inch

B: SANDSTONE, Brown, moderately weathered, weak, friable, medium grained, with iron oxide staining, highly fractured, 1-5 inch spacing

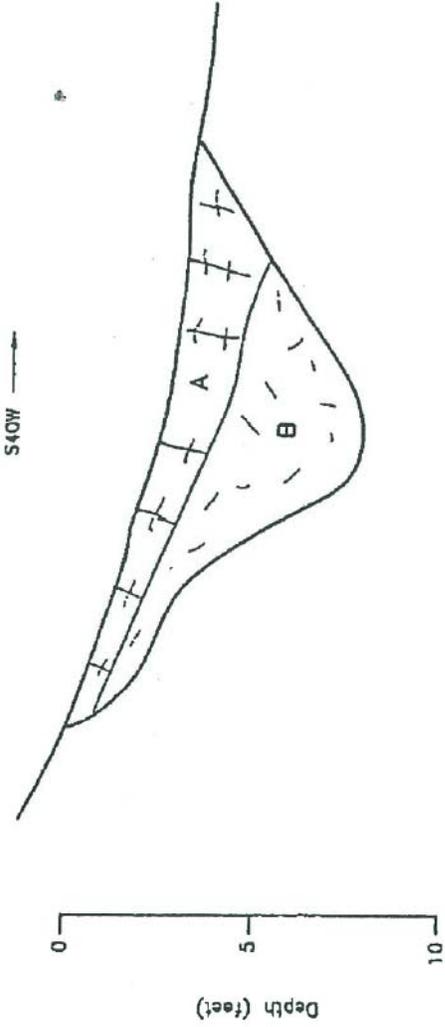
- A: SILTY CLAY (CH), stiff, dry, dark brown, with 2 inch rock fragments, rootlets
- B: SERPENTINIZED BASALT, Black to green, slightly weathered, hard, strong, no fractures, forms random surfaces when excavated

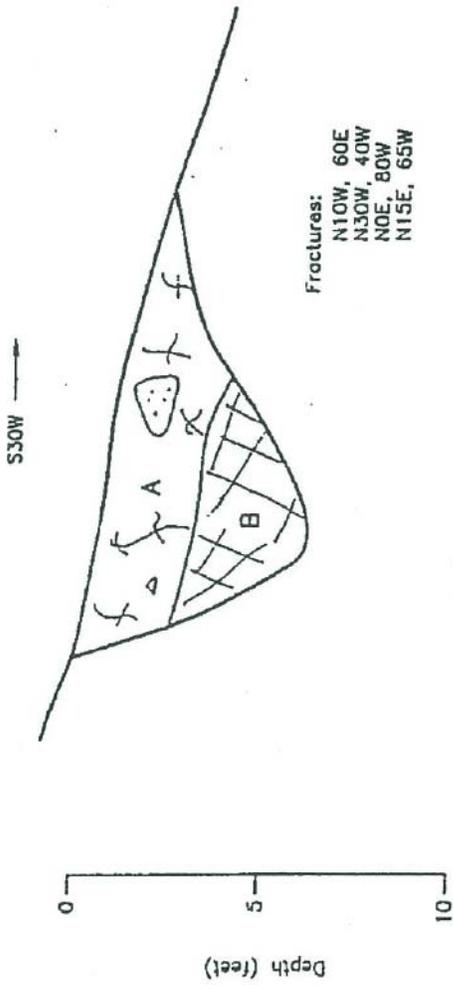
A: SILTY CLAY (CH), stiff, dry, dark brown, with rock fragments up to 2 feet, with rootlets

B: SERPENTINIZED BASALT, Black to green, slightly weathered, hard, strong, moderate serpentinization, 6-8 inch fracture spacing, iron oxide staining along fractures

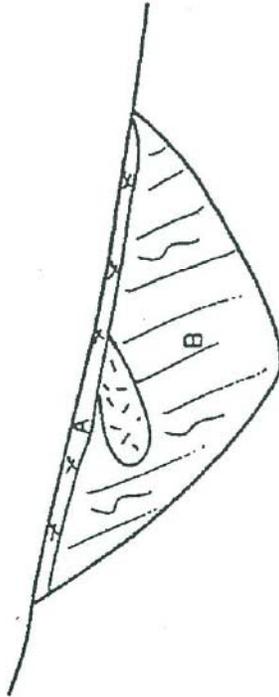
Foliation: N60W, 80E
Fracture: N40W, 40S
Fracture: N60E, 65S

A: SILTY CLAY (CH), medium stiff, dry, dark brown,
with serpentinite clasts up to 3 inches

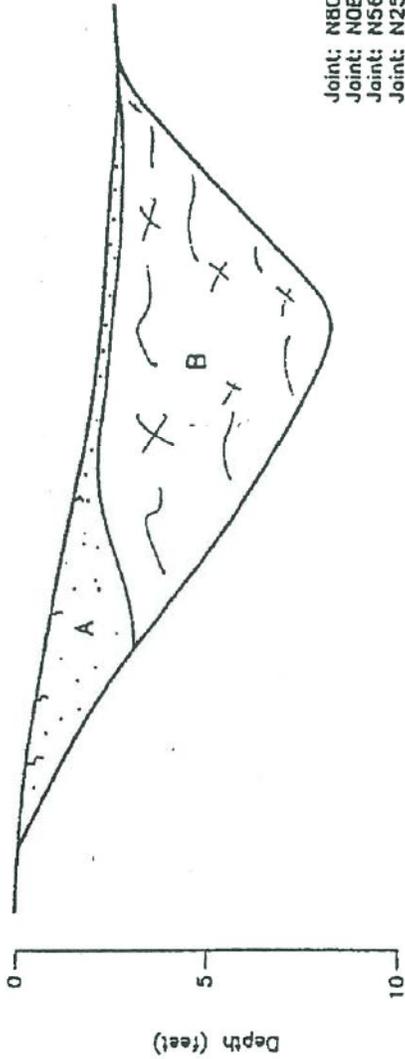
Joint: N80E, 90
Joint: N0E, 54E
Joint: N56E, 55E
Joint: N25E, 82W
Joint: N25E, 81W

A: SILTY CLAY (CL/CH), medium stiff, dry, medium brown, serpentinite (abundant) blocks up to 2 inches, medium sand, roots up to 6 inches (Fill)

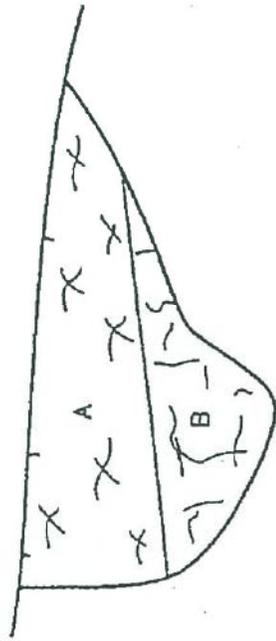
Foliation: N10E, 32W
 Joint: N45E, 90
 Joint: N40E, 90
 Joint: N25W, 62W
 Joint: N45W, 68E

- A: SILTY CLAY (Cl), medium stiff, dry, dark brown, roots up to 1 ft, medium to coarse sand, angular serpentinite clasts up to 1 inch (Calluvium)
- B: SERPENTINITE, Light green to black, hard, strong, moderate weathered, 4-5 inch joint spacing, but mostly massive, iron oxide and manganese staining, joint surfaces are rough

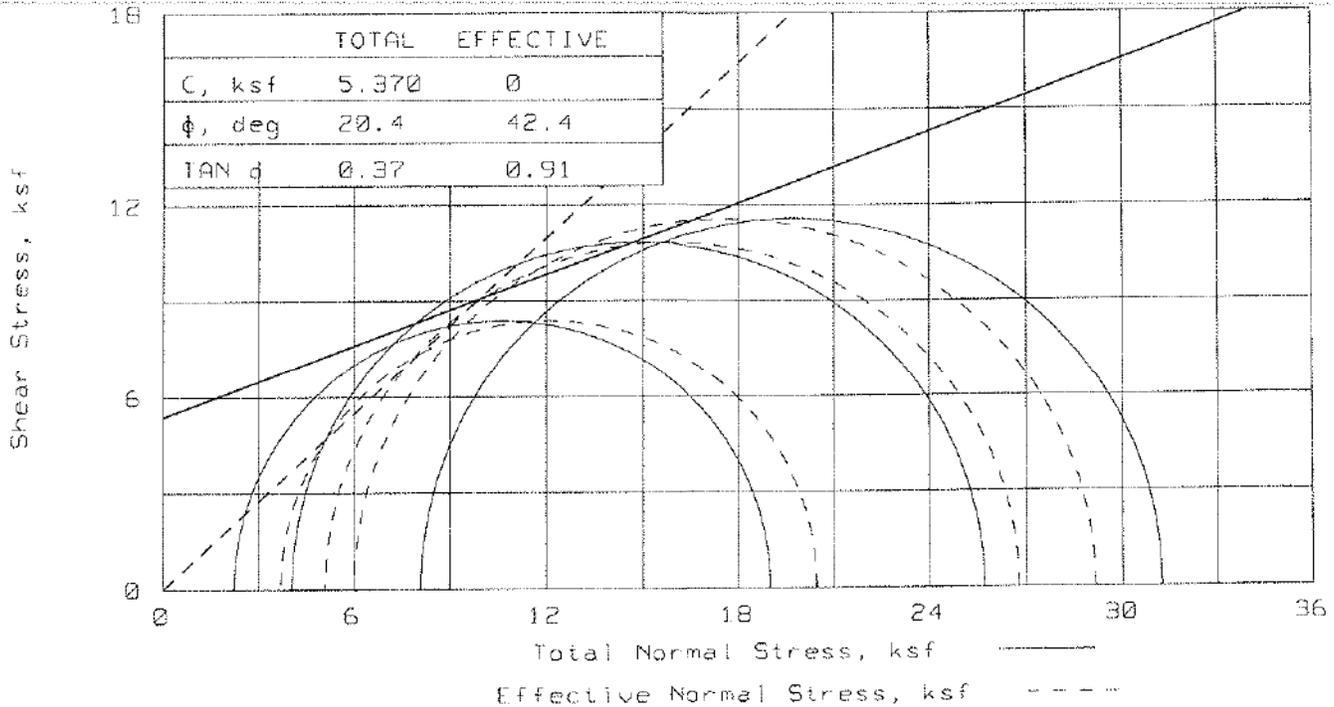
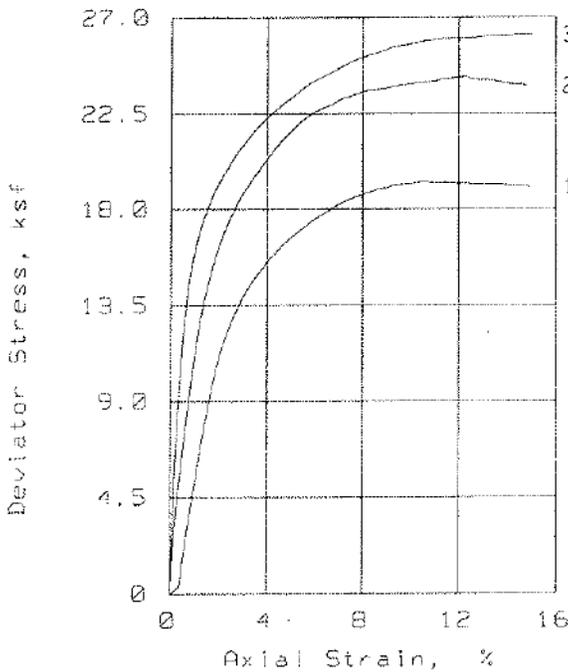
1	2	3
SAMPLE NO.:	1	2	3
INITIAL WATER CONTENT, %	12.6	12.2	12.3
INITIAL DRY DENSITY, pcf	128.9	129.8	129.7
INITIAL SATURATION, %	99.3	98.7	98.8
INITIAL VOID RATIO	0.356	0.346	0.347
INITIAL DIAMETER, in	4.000	4.000	4.000
INITIAL HEIGHT, in	8.070	8.020	8.030
AT TEST WATER CONTENT, %	13.4	13.3	13.0
AT TEST DRY DENSITY, pcf	127.1	127.3	128.2
AT TEST SATURATION, %	100.0	100.0	100.0
AT TEST VOID RATIO	0.375	0.373	0.364
AT TEST DIAMETER, in	4.042	4.051	4.039
AT TEST HEIGHT, in	8.014	7.972	7.970
Strain rate, %/min	0.03	0.03	0.03
EFF CELL PRESSURE, ksf	2.22	4.03	8.00
Deviator Stress, ksf	16.79	21.69	23.16
EXCESS PORE PR., ksf	-1.45	-1.05	2.09
STRAIN, %	5.1	5.0	4.9
Ultimate Stress, ksf			
EXCESS PORE PR., ksf			
STRAIN, %			
σ_1 FAILURE, ksf	20.46	26.77	29.15
σ_3 FAILURE, ksf	3.67	5.08	5.99

TYPE OF TEST:
 CU with Pore Pressures
 SAMPLE TYPE: 95% of 136pcf @13%
 DESCRIPTION: Brown Sandy GRAVEL
 with Silt

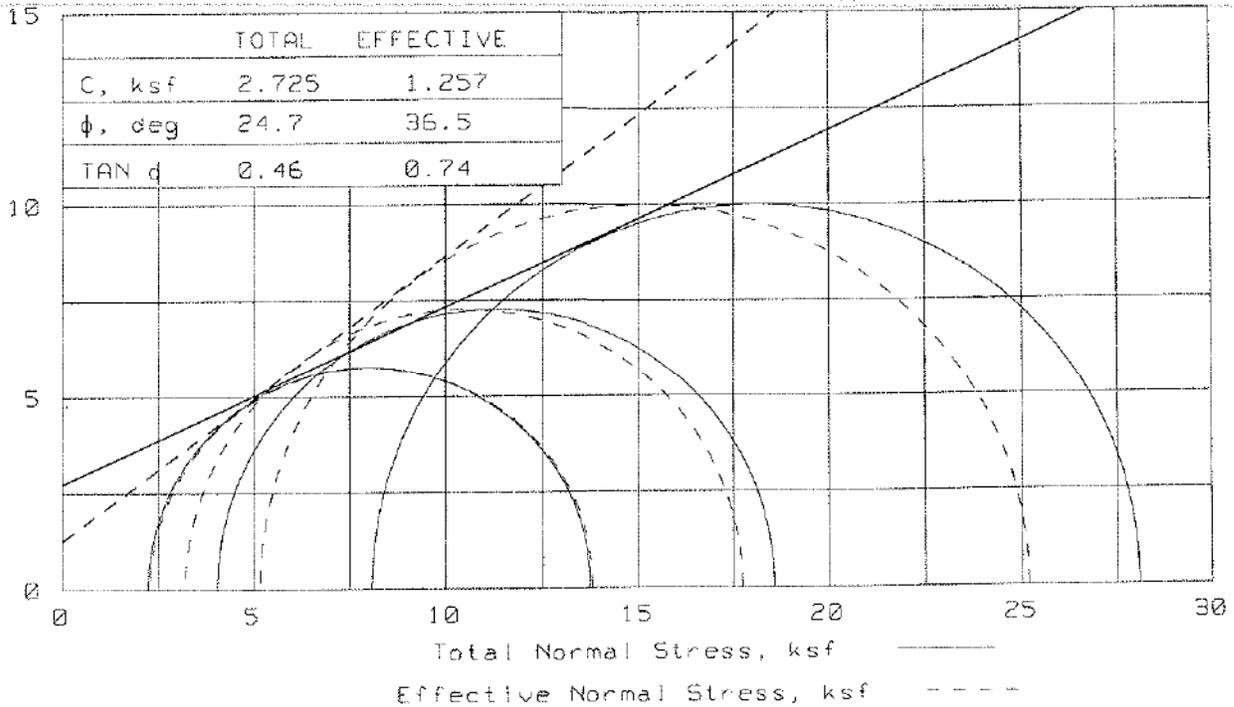
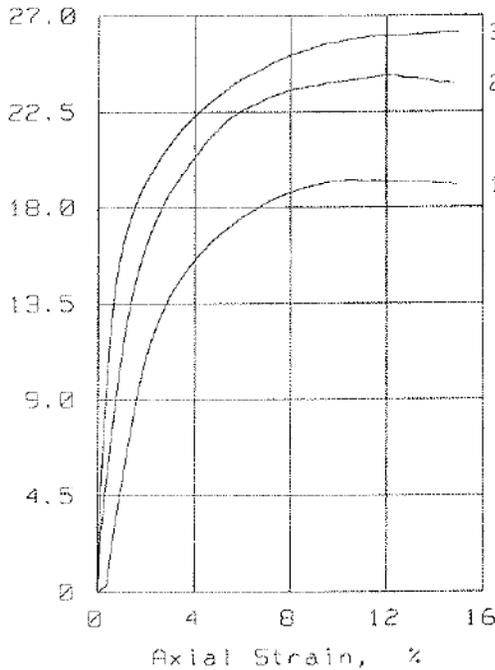
1	2	3
SAMPLE NO.:			
INITIAL			
WATER CONTENT, %	12.6	12.2	12.3
DRY DENSITY, pcf	128.9	129.8	129.7
SATURATION, %	99.3	98.7	98.8
VOID RATIO	0.356	0.346	0.347
DIAMETER, in	4.000	4.000	4.000
HEIGHT, in	8.070	8.020	8.030
AT TEST			
WATER CONTENT, %	13.4	13.3	13.0
DRY DENSITY, pcf	127.1	127.3	128.2
SATURATION, %	100.0	100.0	100.0
VOID RATIO	0.375	0.373	0.364
DIAMETER, in	4.042	4.051	4.039
HEIGHT, in	8.014	7.972	7.970
Strain rate, %/min	0.03	0.03	0.03
EFF CELL PRESSURE, ksf	2.22	4.03	8.08
Deviator Stress, ksf	11.52	14.55	20.02
EXCESS PORE PR., ksf	-0.06	0.84	2.92
STRAIN, %	2.1	1.6	2.4
Ultimate Stress, ksf			
EXCESS PORE PR., ksf			
STRAIN, %			
σ_1 FAILURE, ksf	13.80	17.74	25.17
σ_3 FAILURE, ksf	2.28	3.20	5.16

TYPE OF TEST:
CU with Pore Pressures
SAMPLE TYPE: 95% of 136pcf @13%
DESCRIPTION: Brown Sandy GRAVEL
with Silt

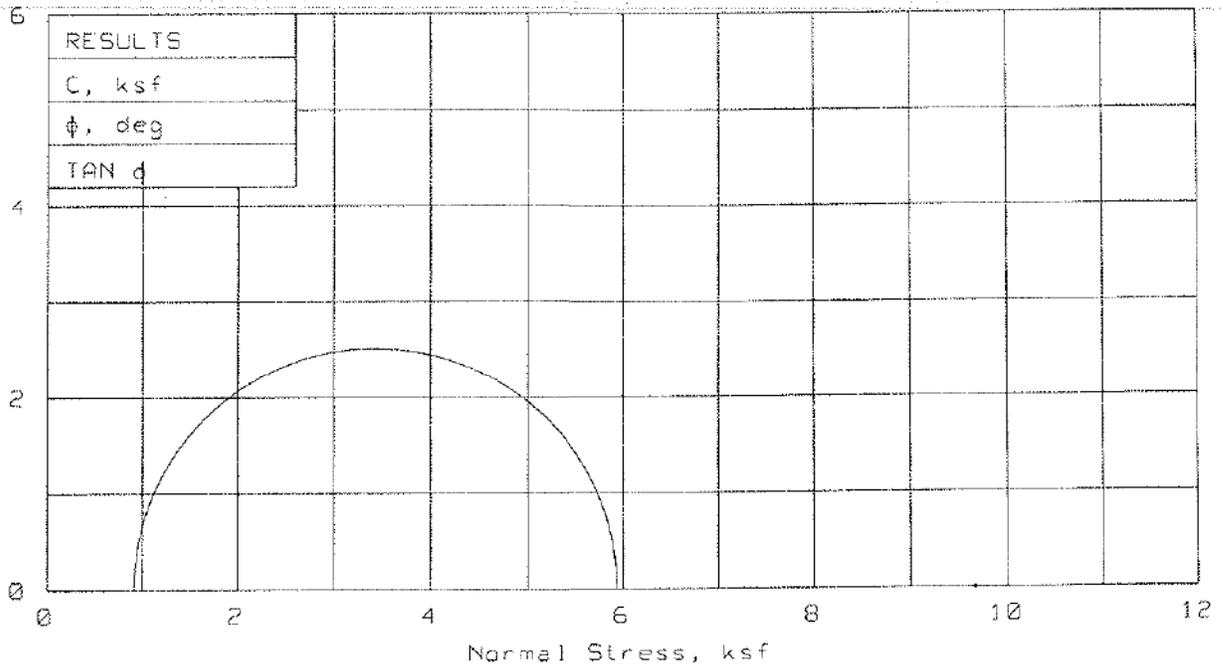
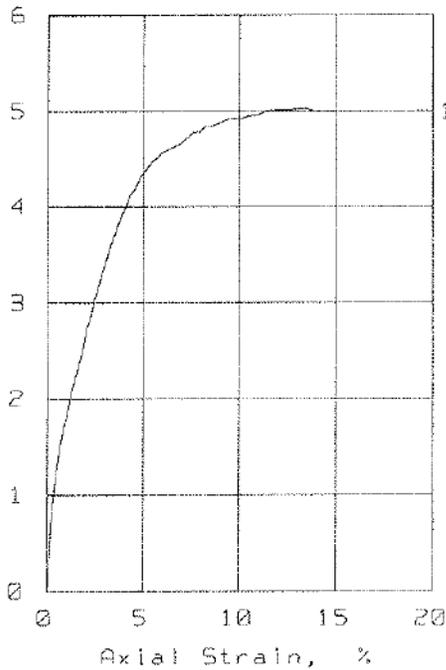
SAMPLE NO.:		1
INITIAL	WATER CONTENT, %	21.6
	DRY DENSITY, pcf	101.4
	SATURATION, %	88.3
	VOID RATIO	0.662
	DIAMETER, in	2.396
AT TEST	HEIGHT, in	5.000
	WATER CONTENT, %	21.6
	DRY DENSITY, pcf	101.4
	SATURATION, %	88.3
	VOID RATIO	0.662
	DIAMETER, in	2.396
	HEIGHT, in	5.000
	Strain rate, %/min	1.00
	BACK PRESSURE, ksf	0.000
	CELL PRESSURE, ksf	0.907
	DEVIATOR STRESS, ksf	5.029
	STRAIN, %	13.5
	ULT. STRESS, ksf	
	STRAIN, %	
	σ_1 FAILURE, ksf	5.936
	σ_3 FAILURE, ksf	0.907

TYPE OF TEST:
 Unconsolidated Undrained
 SAMPLE TYPE: Undisturbed
 DESCRIPTION: Lt. Olive Brown
 SILT, slightly plastic
 ASSUMED SPECIFIC GRAVITY= 2.7
 REMARKS:

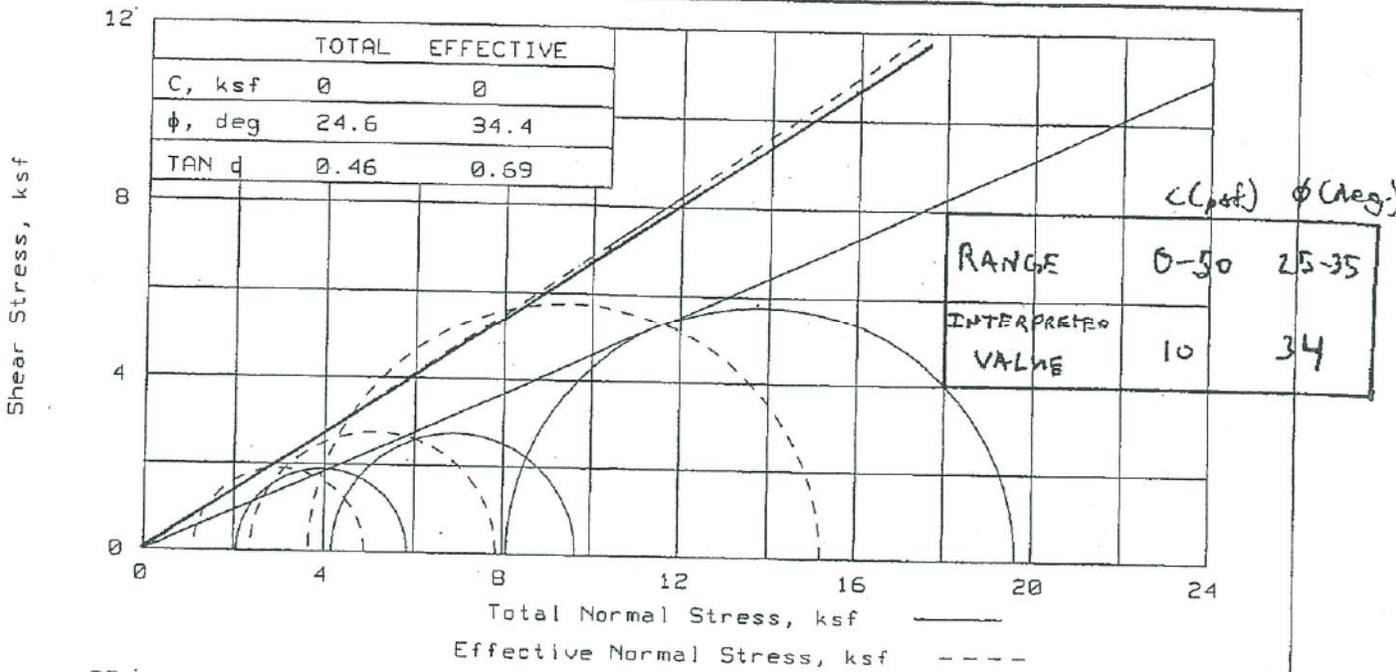
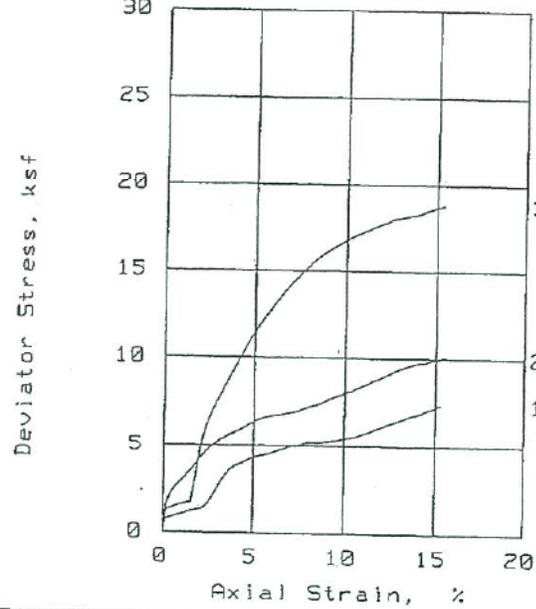
Lowney Associates – Villa Cortona – Laboratory Data (not on-site)

SAMPLE NO.:		1	2	3
INITIAL	WATER CONTENT, %	13.2	11.8	10.9
	DRY DENSITY, pcf	124.7	128.0	131.9
	SATURATION, %	96.7	95.3	99.4
	VOID RATIO	0.376	0.341	0.301
	DIAMETER, in	2.870	2.870	2.850
	HEIGHT, in	6.000	6.000	6.000
AT TEST	WATER CONTENT, %	13.8	12.7	12.3
	DRY DENSITY, pcf	124.4	127.3	128.2
	SATURATION, %	100.0	100.0	100.0
	VOID RATIO	0.380	0.349	0.339
	DIAMETER, in	2.890	2.918	2.915
	HEIGHT, in	5.935	5.838	5.902
1	Strain rate, %/min	0.03	0.03	0.03
	EFF CELL PRESSURE, ksf	2.06	4.16	8.08
	DEVIATOR STRESS, ksf	3.78	5.50	11.55
	EXCESS PORE PR., ksf	0.95	1.80	4.44
	STRAIN, %	3.9	3.4	5.1
	ULT. STRESS, ksf			
	EXCESS PORE PR., ksf			
	STRAIN, %			
	$\bar{\sigma}_1$ FAILURE, ksf	4.89	7.86	15.19
	$\bar{\sigma}_3$ FAILURE, ksf	1.11	2.36	3.64

TYPE OF TEST:
 CU with Pore Pressures
 SAMPLE TYPE: Undisturbed
 DESCRIPTION: Greenish Gray ROCK
 ASSUMED SPECIFIC GRAVITY= 2.75
 REMARKS: Strengths picked at peak stress ratios.

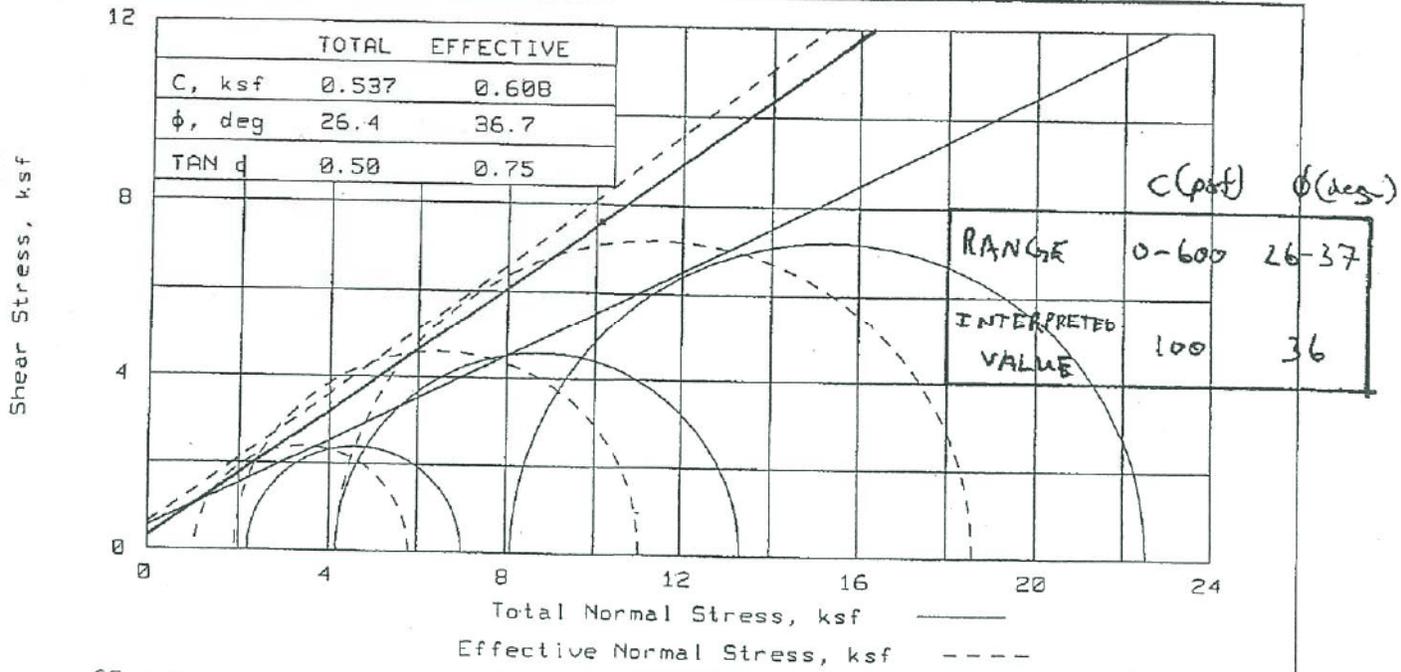
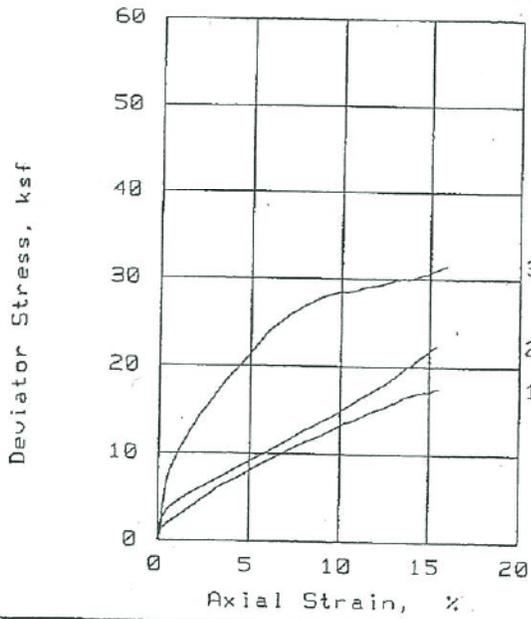
SAMPLE NO.:		1	2	3
INITIAL	WATER CONTENT, %	9.5	8.0	9.0
	DRY DENSITY, pcf	136.7	130.3	137.0
	SATURATION, %	94.9	65.6	91.9
	VOID RATIO	0.279	0.341	0.276
	DIAMETER, in	2.870	2.870	2.870
	HEIGHT, in	5.810	5.930	5.810
AT TEST	WATER CONTENT, %	10.4	12.1	8.7
	DRY DENSITY, pcf	135.4	130.5	140.6
	SATURATION, %	100.0	100.0	100.0
	VOID RATIO	0.291	0.339	0.243
	DIAMETER, in	2.891	2.884	2.855
	HEIGHT, in	5.780	5.862	5.720
Strain rate, %/min			0.03	0.03
EFF CELL PRESSURE, ksf		2.20	4.16	8.11
DEVIATOR STRESS, ksf		4.80	9.18	14.44
EXCESS PORE PR., ksf		1.18	2.26	3.93
STRAIN, %		2.4	5.0	2.3
ULT. STRESS, ksf				
EXCESS PORE PR., ksf				
STRAIN, %				
$\bar{\sigma}_1$ FAILURE, ksf		5.82	11.08	18.61
$\bar{\sigma}_3$ FAILURE, ksf		1.02	1.90	4.18

TYPE OF TEST:
CU with Pore Pressures
