Geologic and Geotechnical Hazards Investigation

Type of Services	Geologic and Geotechnical Hazards Investigation
Project Name	Communications Hill – Phase 2
Location	Communications Hill Boulevard San Jose, California
Client	David J. Powers & Associates, Inc.
Client Address	1871 The Alameda, Suite 200 San Jose, CA 95126
Project Number	118-38-1
Date	April 21, 2014

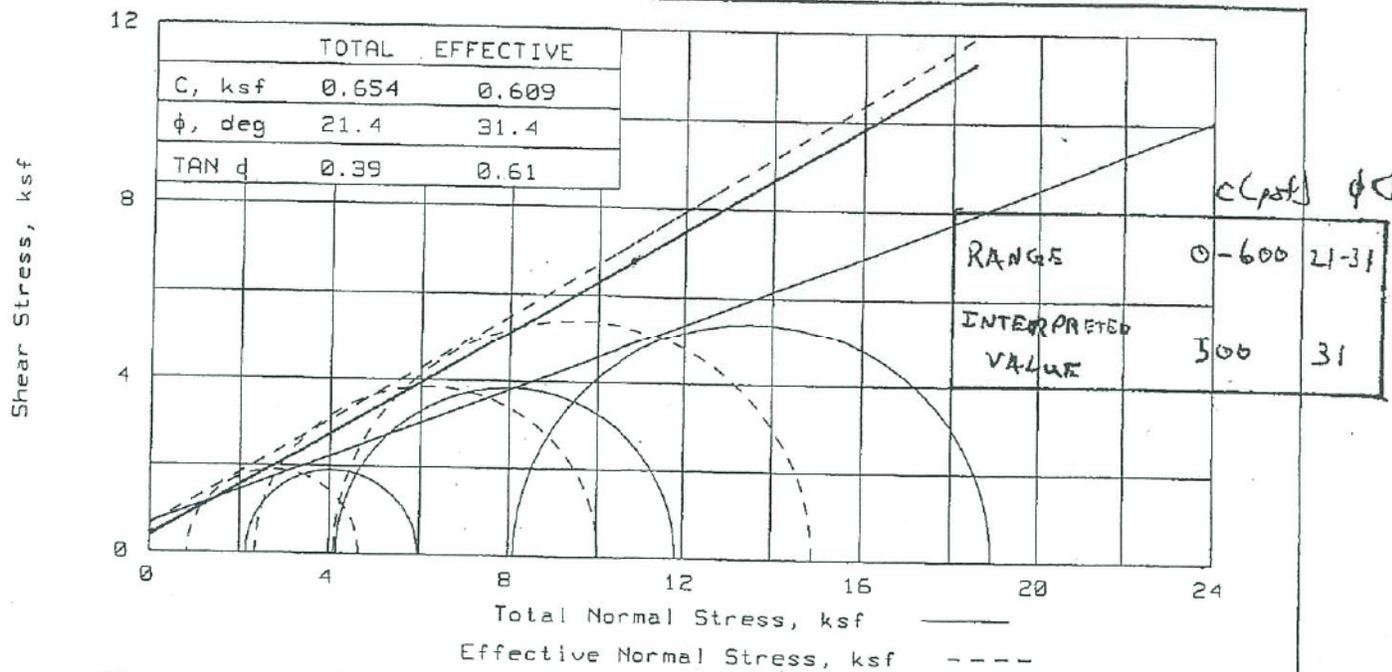
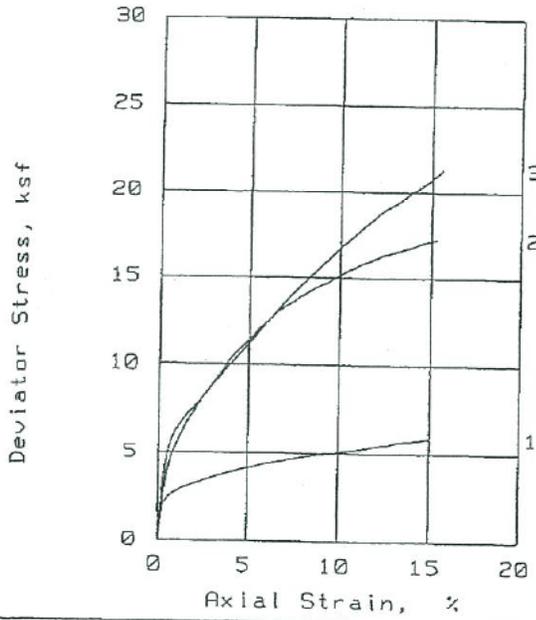
SAMPLE NO.:		1	2	3
INITIAL	WATER CONTENT, %	28.9	18.6	14.5
	DRY DENSITY, pcf	89.6	106.6	116.9
	SATURATION, %	88.4	86.2	88.4
	VOID RATIO	0.881	0.582	0.441
	DIAMETER, in	2.870	2.870	2.870
	HEIGHT, in	6.000	6.000	5.940
AT TEST	WATER CONTENT, %	27.2	18.6	16.1
	DRY DENSITY, pcf	97.2	112.2	117.5
	SATURATION, %	100.0	100.0	100.0
	VOID RATIO	0.734	0.503	0.434
	DIAMETER, in	2.767	2.810	2.899
	HEIGHT, in	5.950	5.946	5.795
Strain rate, %/min		0.03	0.03	0.03
EFF CELL PRESSURE, ksf		2.15	4.15	8.11
DEVIATOR STRESS, ksf		3.81	7.68	10.83
EXCESS PORE PR., ksf		1.30	1.80	4.02
STRAIN, %		3.6	2.2	4.7
ULT. STRESS, ksf				
EXCESS PORE PR., ksf				
STRAIN, %				
$\bar{\sigma}_1$ FAILURE, ksf		4.66	10.03	14.92
$\bar{\sigma}_3$ FAILURE, ksf		0.85	2.35	4.09

TYPE OF TEST:
CU with Pore Pressures

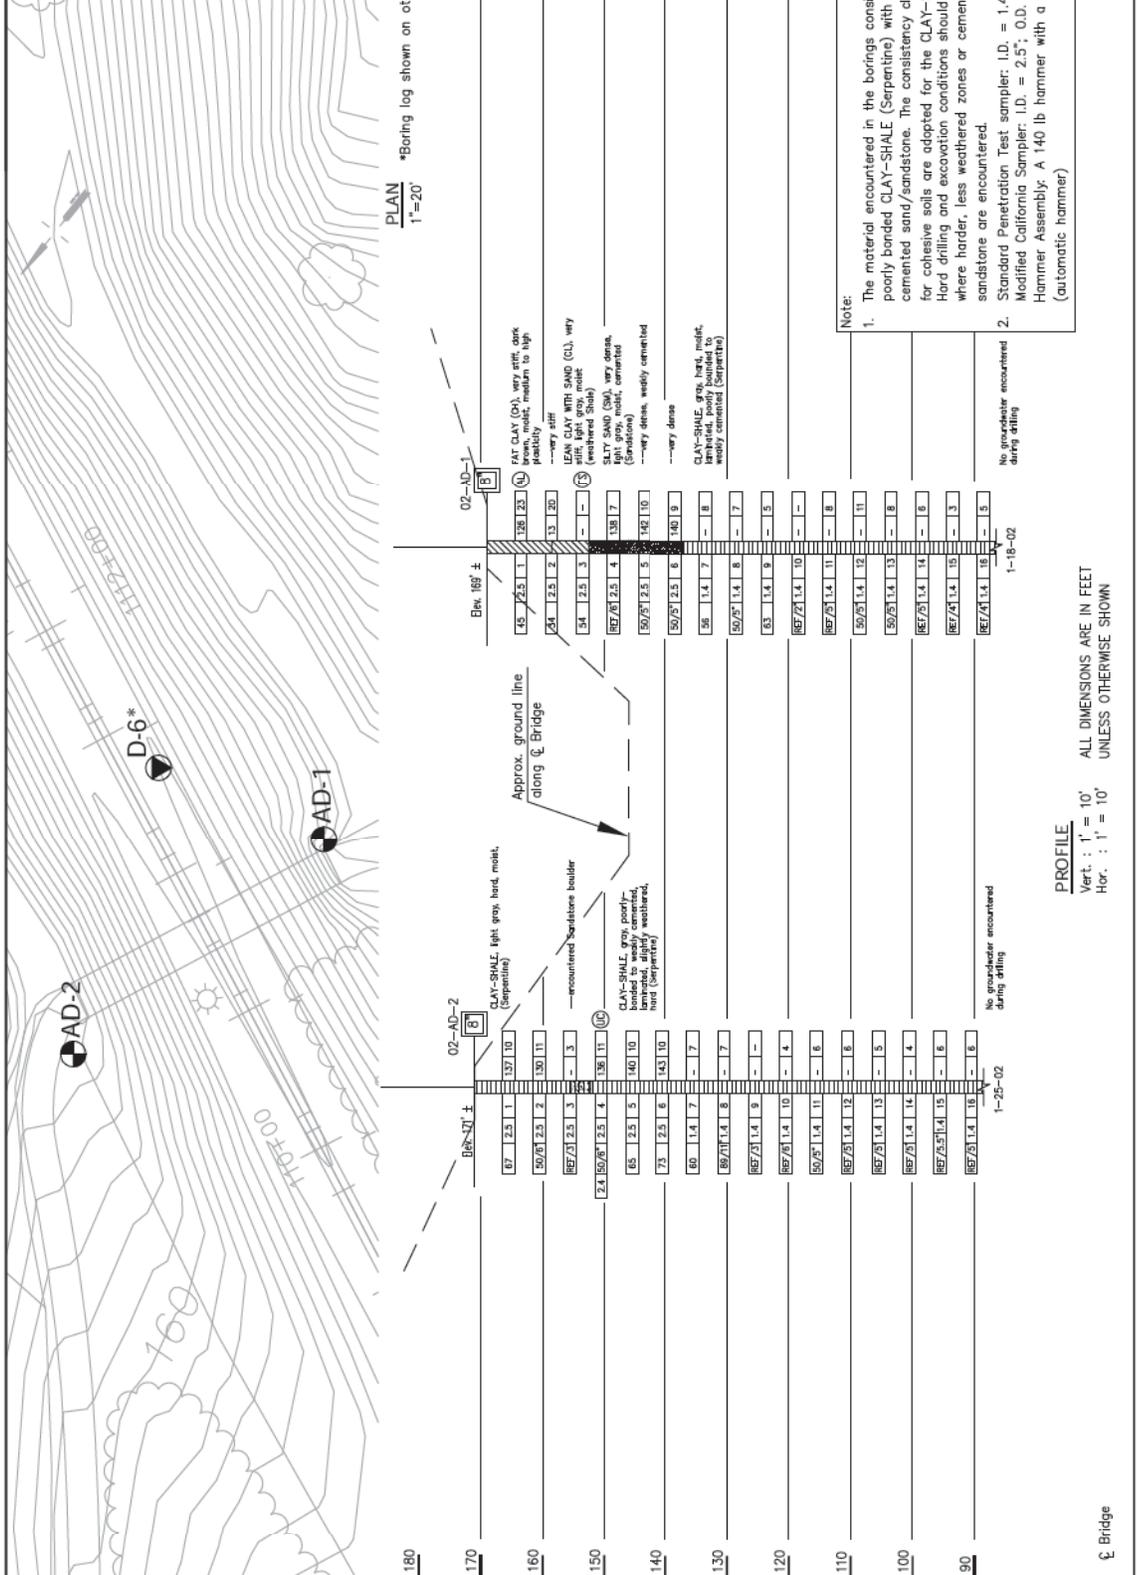
PLAN
1"=20'

4. Elevation: Shows the vertical scale in feet, ranging from 90 to 180.

5. Plan View: Shows the location of borings AD-1, AD-2, and D-6* relative to the bridge structure.

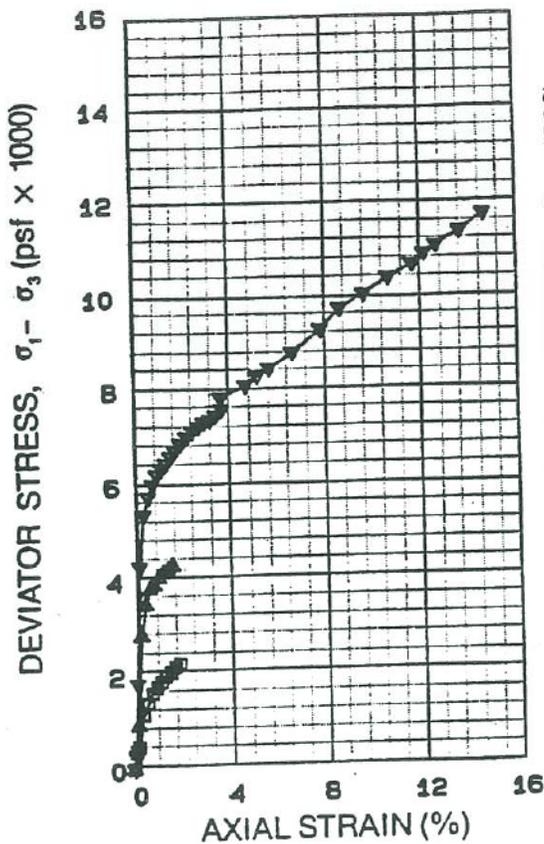
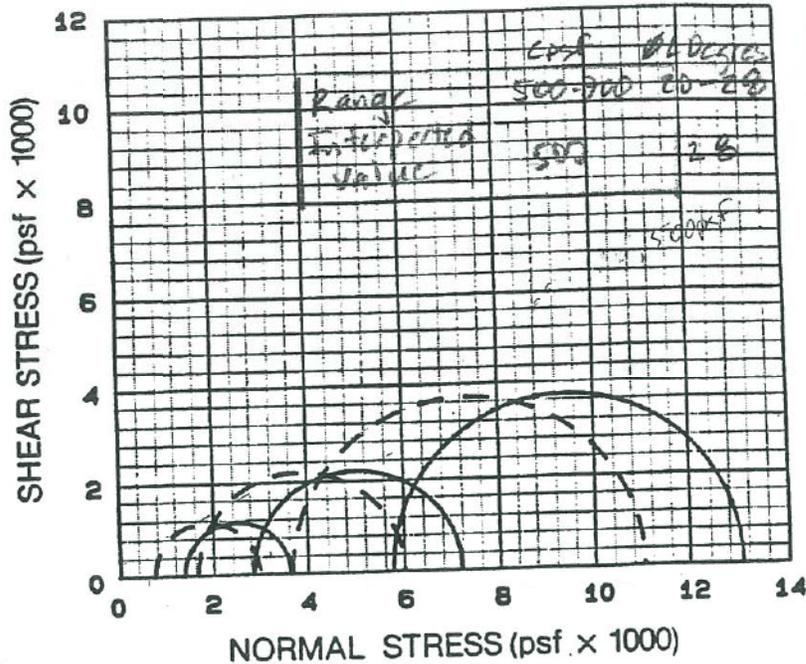
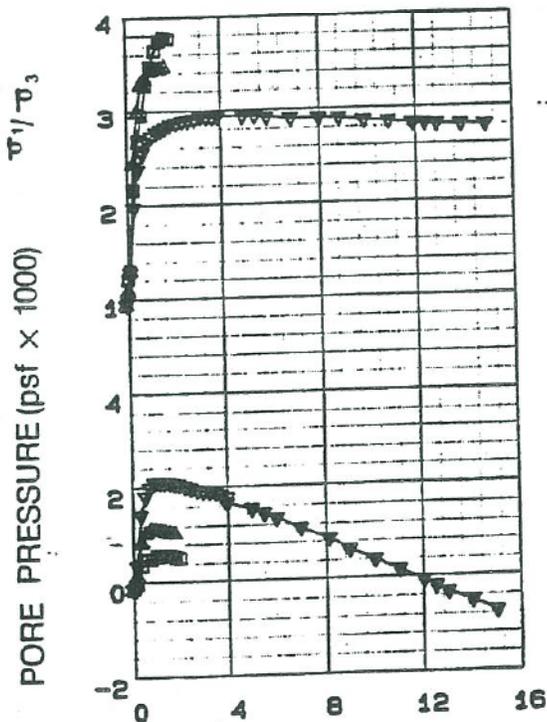
Bechtel – Pullman Way Maintenance Facility – Laboratory Data (not on-site)

TEST TYPE: CONSOLIDATED UNDRAINED Controlled STRAIN

PHYSICAL CONDITIONS		TEST NO.		
		A □	B ▲	C ▼
INITIAL	Diameter (in.)	2.88	2.88	2.88
	Height (in.)	5.86	5.86	5.86
	Water Content (%)	14.8	14.8	14.8
	Void Ratio	0.441	0.441	0.441
	Saturation (%)	90.7	90.7	90.7
	Dry Density (pcf)	117	117	117
BEFORE	Consolidation Pressure (psf)	1440	2880	5760
	Backpressure (psf)	7488	7488	7488
	Water Content (%)	16.3	15.5	14.5
	Void Ratio	0.441	0.419	0.392
FINAL	Water Content (%)	17.1	16.7	16.3
	Dry Density (pcf)	115	116	117
	Void Ratio	0.463	0.452	0.439
FAILURE	Saturation (%)	100.0	100.0	100.0
	σ_1 Major Principal Stress (psf)	3010	5998	10996
	σ_3 Minor Principal Stress (psf)	792	1714	3701
	Pore Pressure (psf)	648	1166	2059
	Axial Strain at Failure (%)	2.0	1.8	3.3
	Time to Failure (min.)	44	35	18
Sample Source: Y-11		70.0 FT		
Classification:		G _s		
GRN. CLAYEY SAND (SC) SERPENTINE		2.70

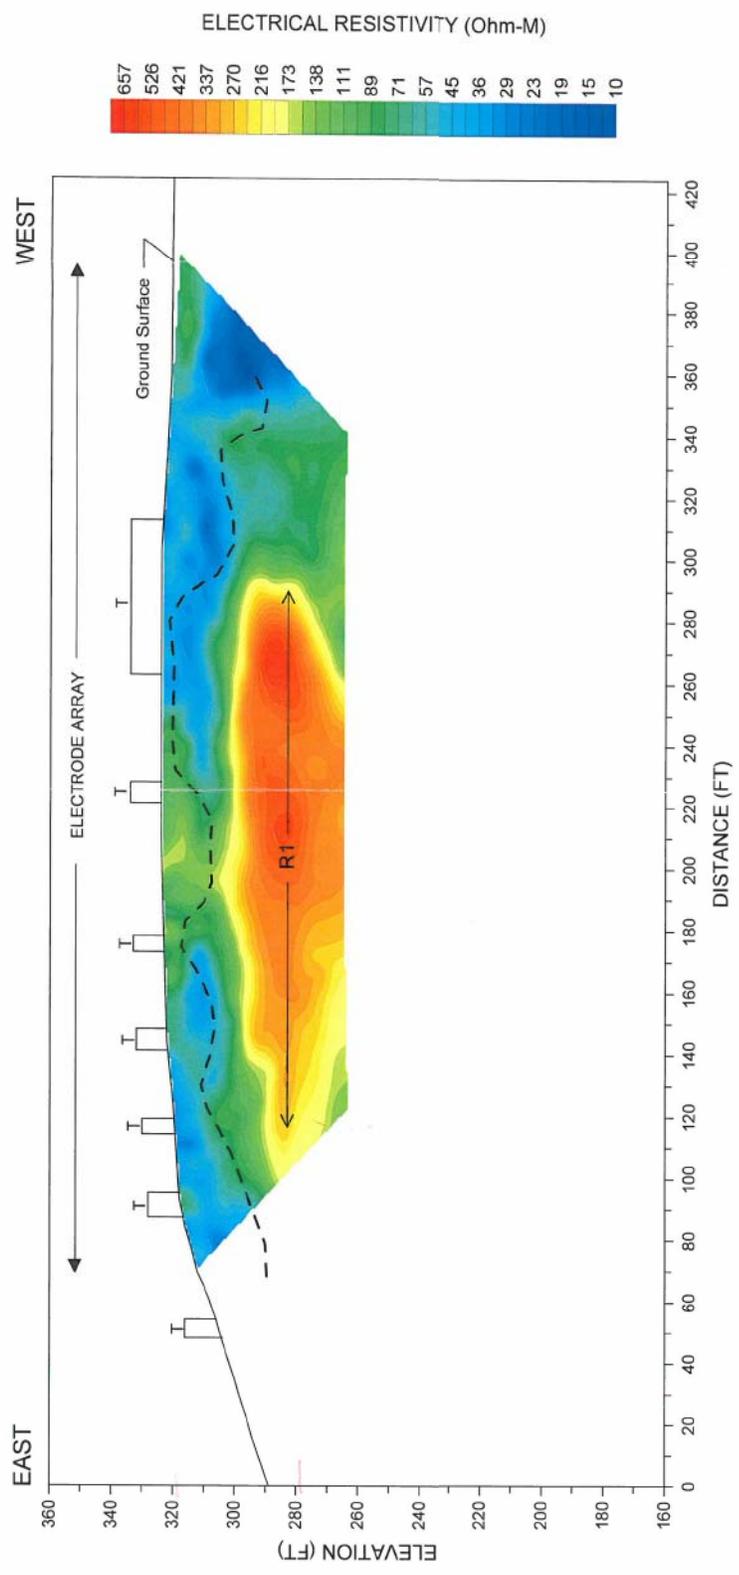
LINE 1 ELECTRICAL RESISTIVITY PROFILE HILLSDALE MERCURY MINE	PLATE 2
	CLIENT: Strategic Engineering & Sciences, Inc. LOCATION: San Jose, California NORCAL GEOPHYSICAL CONSULTANTS INC.	DATE: Aug, 2007 DRAWN BY: WEB APPROVED BY: WEB

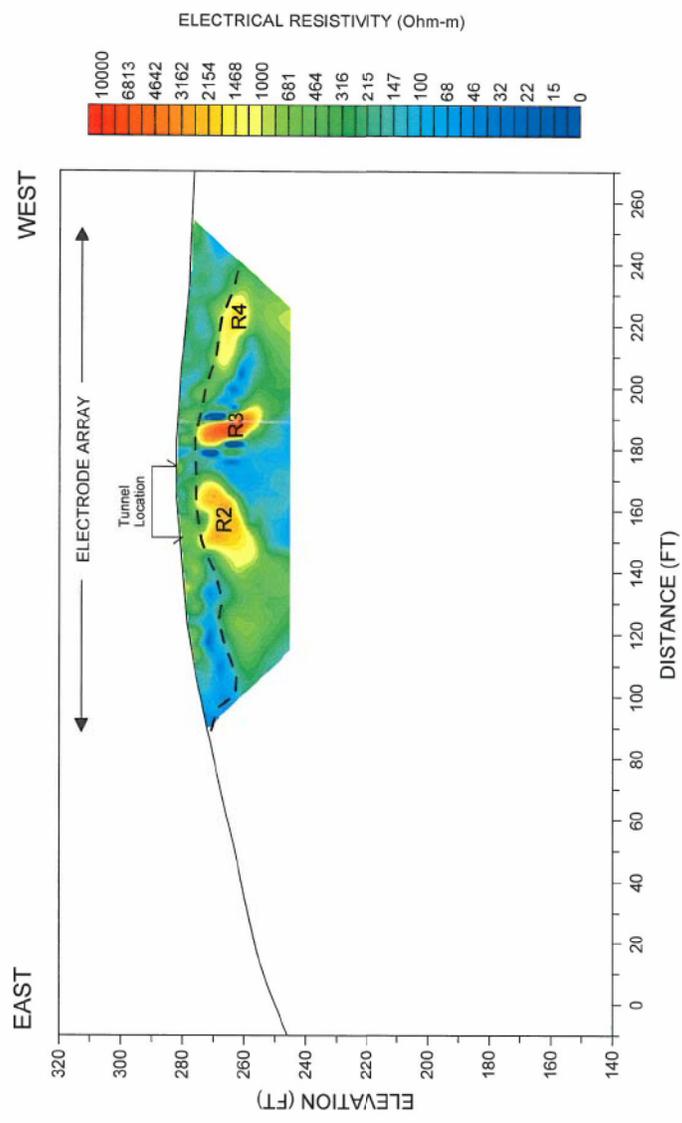
PLATE
3

T [] Tunnel Location

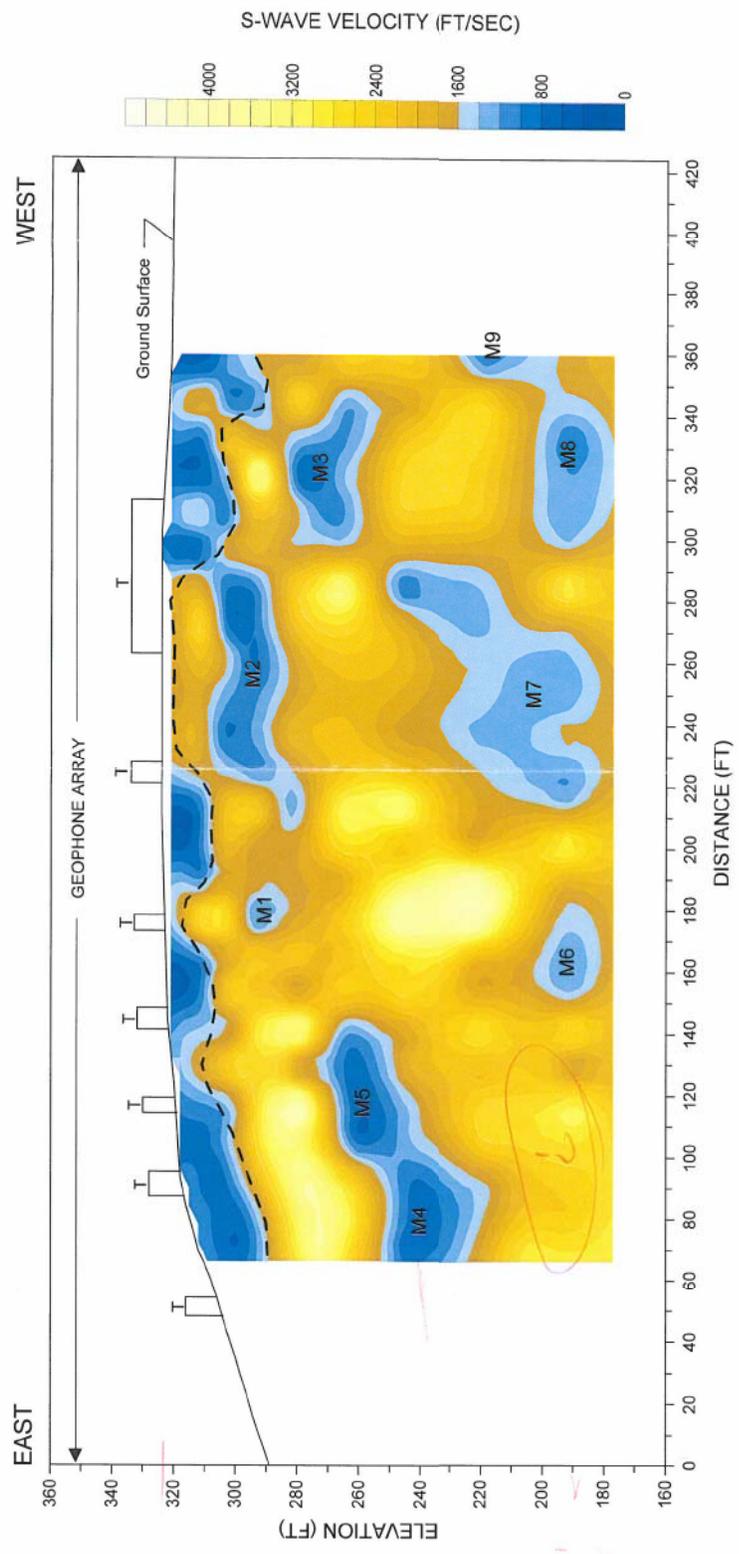
PLATE **4**

- T Tunnel Location
- - - - - Interpreted bedrock surface

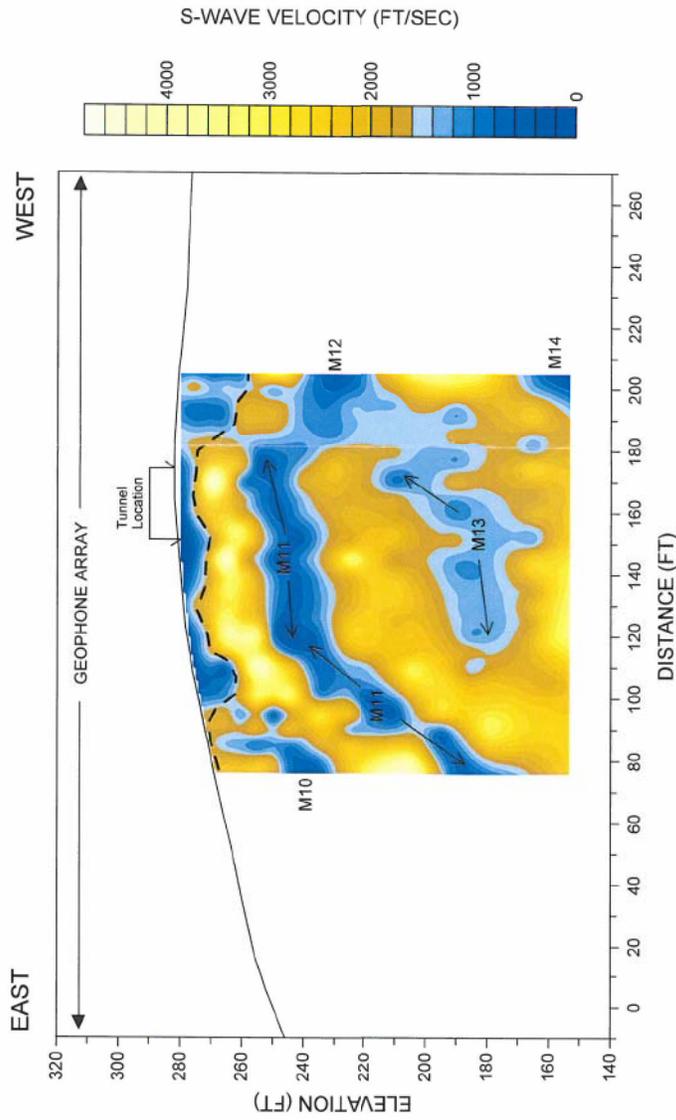
PLATE
5

- T [] Tunnel Location
- - - - - Interpreted bedrock surface

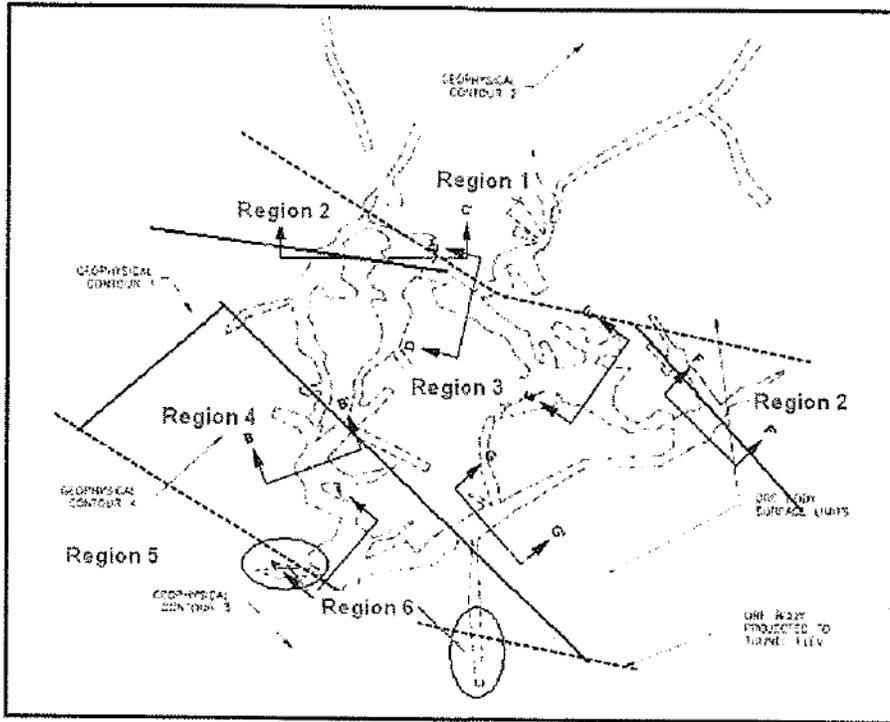
Figure 31: Proposed Remediation Regions

Vector Engineering, Inc. – Communications Hill Project – Figure 31

The evaluation and mitigation of the potential impacts of the former mine are outside our work scope. Vector Engineering, Inc. has provided remedial recommendations to address the hazard of mine collapse based on the “regions” presented in their Figure 31 which we have included in the appendix of this report. Based on review of the current grading plan, it appears that a majority of the mine workings will be removed during grading, and those that are to be mitigated in place with acceptance of the southern tunnel will not be overlain by structures. It is noted, that for geotechnical slope stabilization, over-excavation will be performed which will remove additional portions of the mine tunnels. Our Mine Mitigation Summary, Figure 8 and 9, which includes the mitigation recommendations of the Vector report, indicates workings to be removed, and those to be mitigated in place. Where mine workings are encountered during grading which are to be left in place SRK has developed backfill recommendations.
