# CERTIFIED ARBORIST REPORT

## Tree Assessment of Current Conditions

Date: July 10<sup>th</sup>, 2017

Project #JN4823 ST. JAMES PARK  
North 2<sup>nd</sup> Street and East St James Street  
San Jose, CA 95112

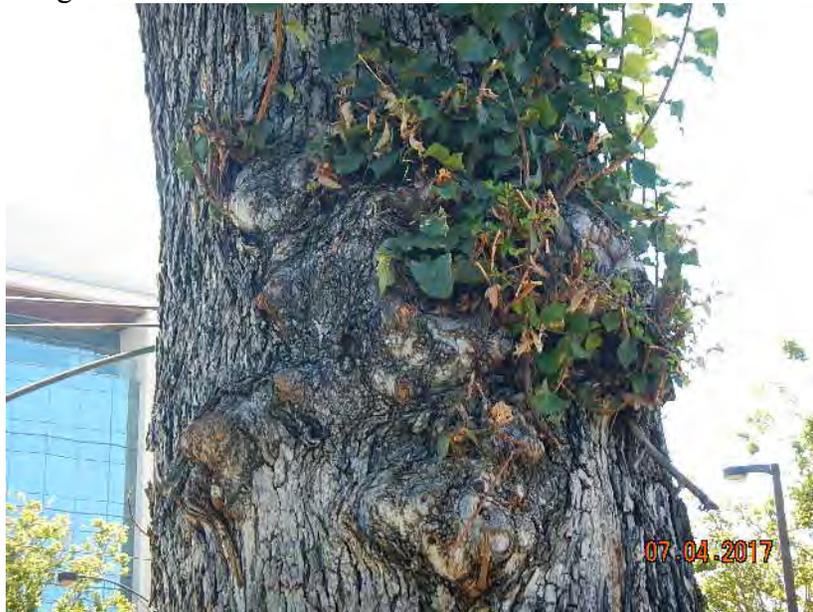
Tree #1 *Ulmus procera* English Elm epicormic shoots.

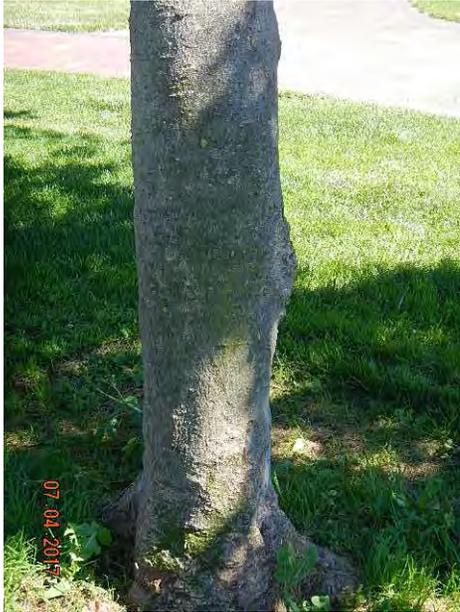
Tree#3 *Celtis sinensis* Chinese Hackberry possible stem damage that has sealed up.

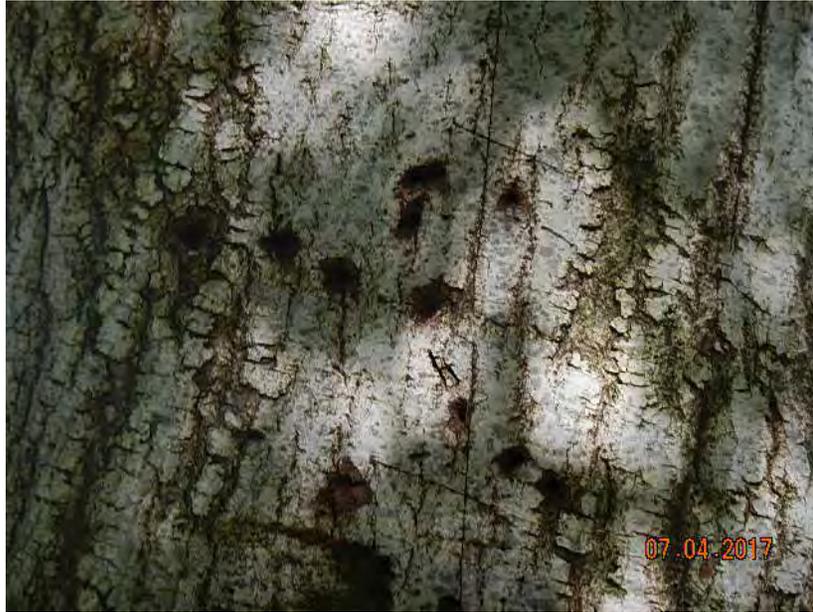
Tree #54 *Quercus agrifolia* Coastal Live Oak Bark Beetle Strikes and Woodpecker.

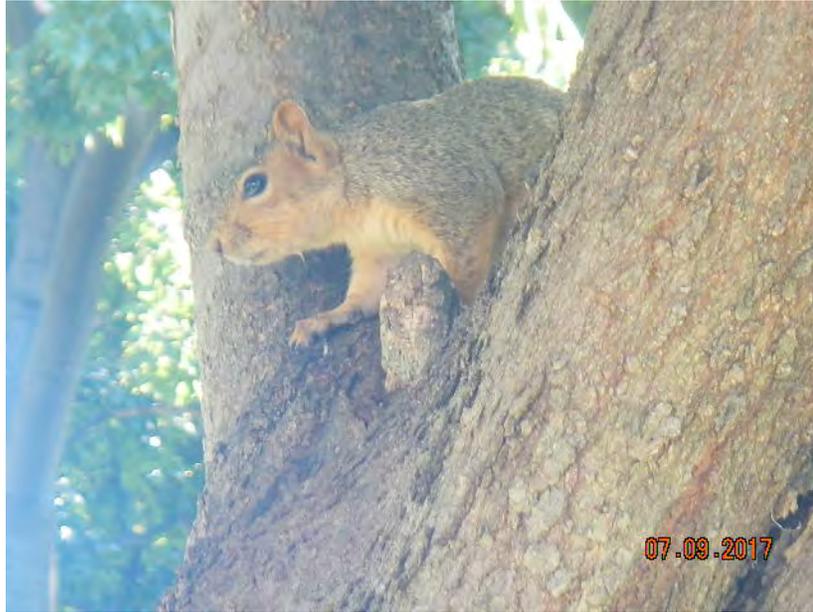
**Squirrel Damage** – Squirrels are damaging the trees due to over population. Squirrels are gnawing on the limbs of the trees and damaging the cambium layer. In some instances the it is only small twigs that are damaged, die and fall off. In other cases it is branches and limbs that are dying. These limbs have to be removed or they eventually fall if left in the tree. Squirrel populations should be controlled to reduce the impact on trees.

Eastern fox squirrels (*Sciurus niger*)

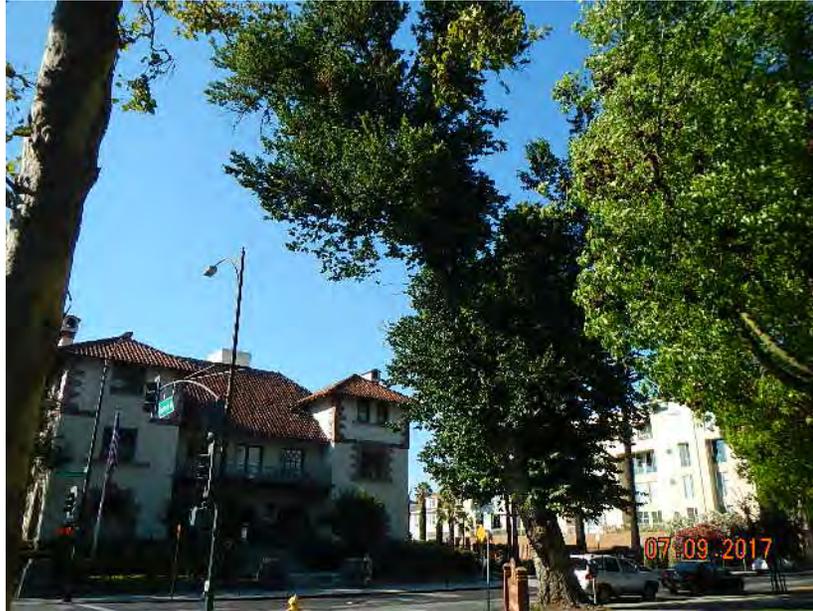
Tree #119 *Ulmus procera* English Elm leans

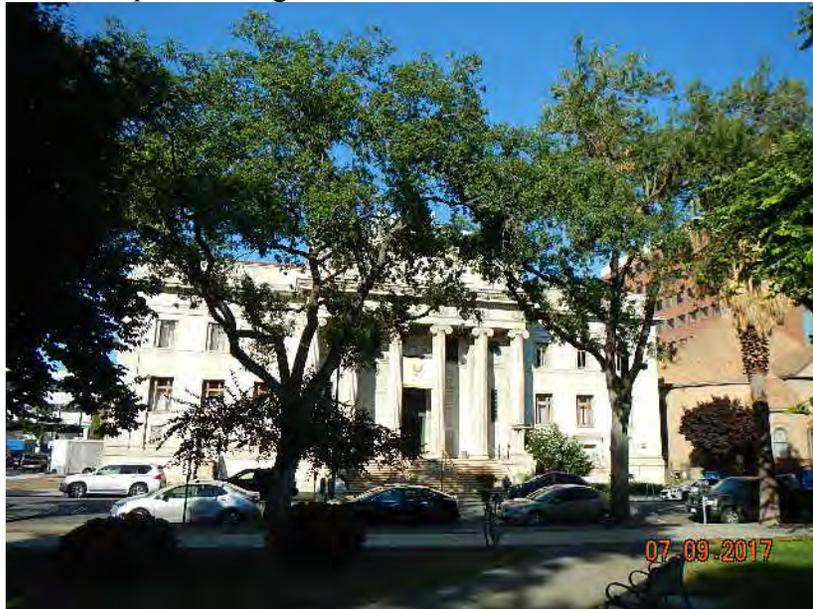
Trees #121 & 122 *Ulmus procera* English Elm

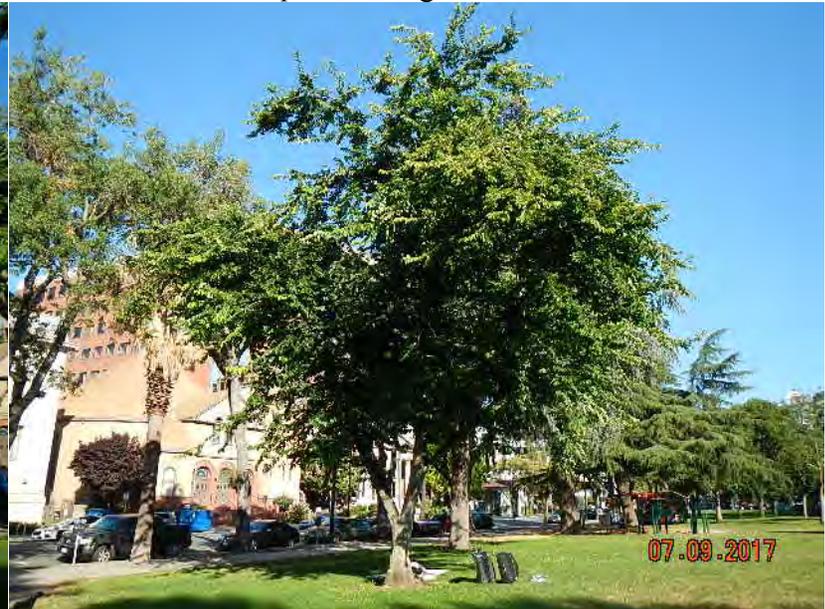
Tree #128 & 129 *Fraxinus spp.* Ash

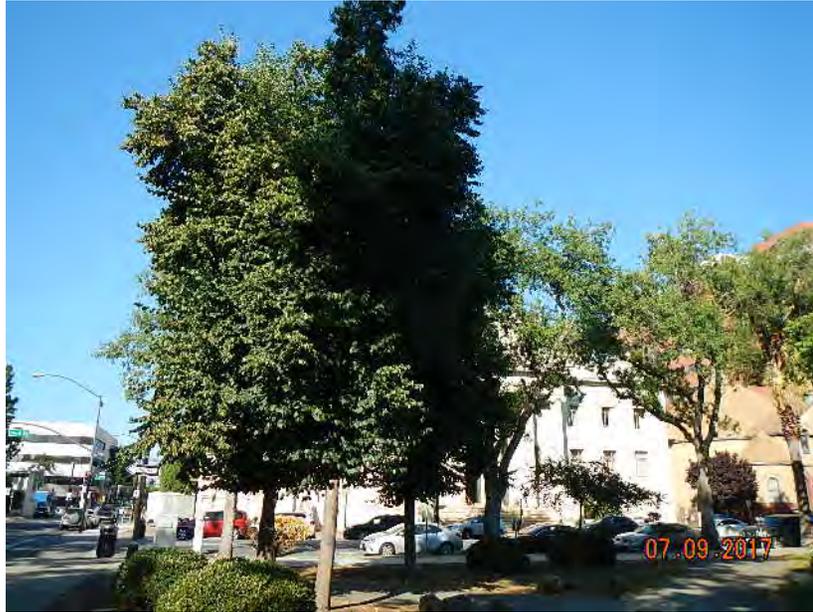
Tree #217 *Ulmus procera* English Elm leans

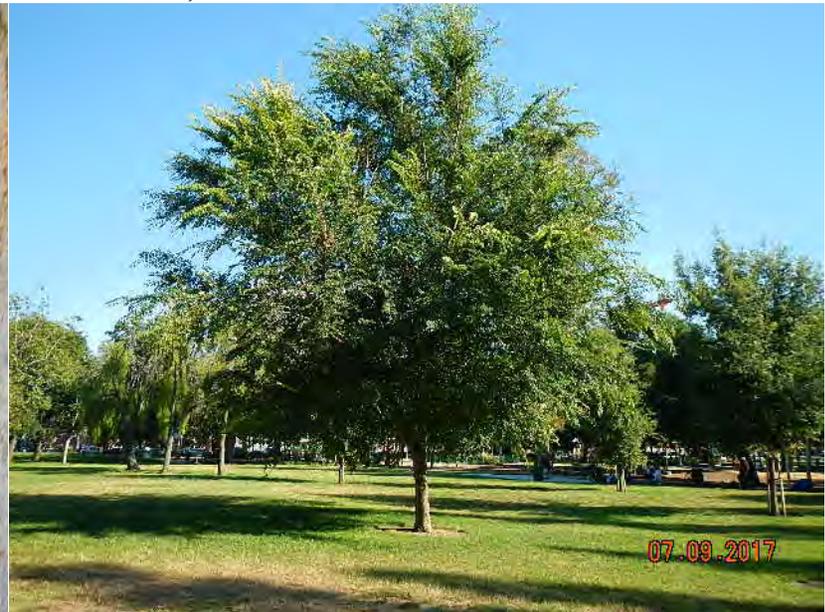
Tree #124, 125 & 126 *Tillia cordata* Tillia included bark.

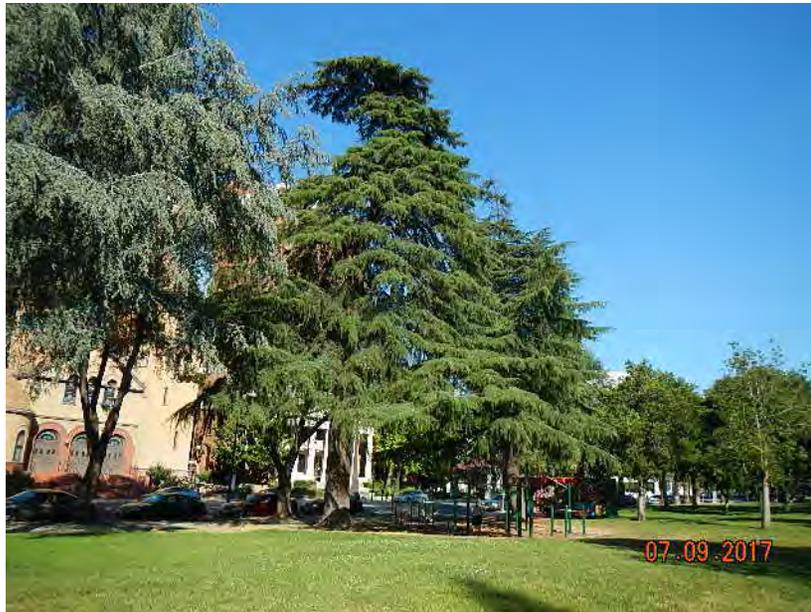
Tree #218 *Cedrus atlantica* Atlas Cedar severely stressed.

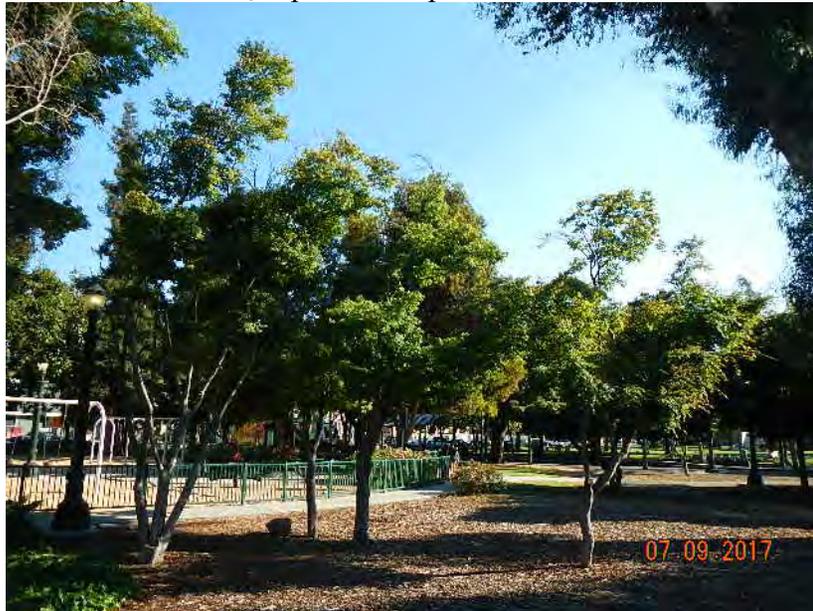
Tree #178 & 179 *Acer palmatum*, Japanese Maple limb dieback.
